# **Horrocksford Old Hall Farmhouse Clitheroe**

## **Archaeological Building Recording Draft**

**JUNE 2026**

**Kathryn Sather & Associates  
Heritage Conservation Consultants  
87 Oldfield Road  
Altrincham  
WA14 4BL**

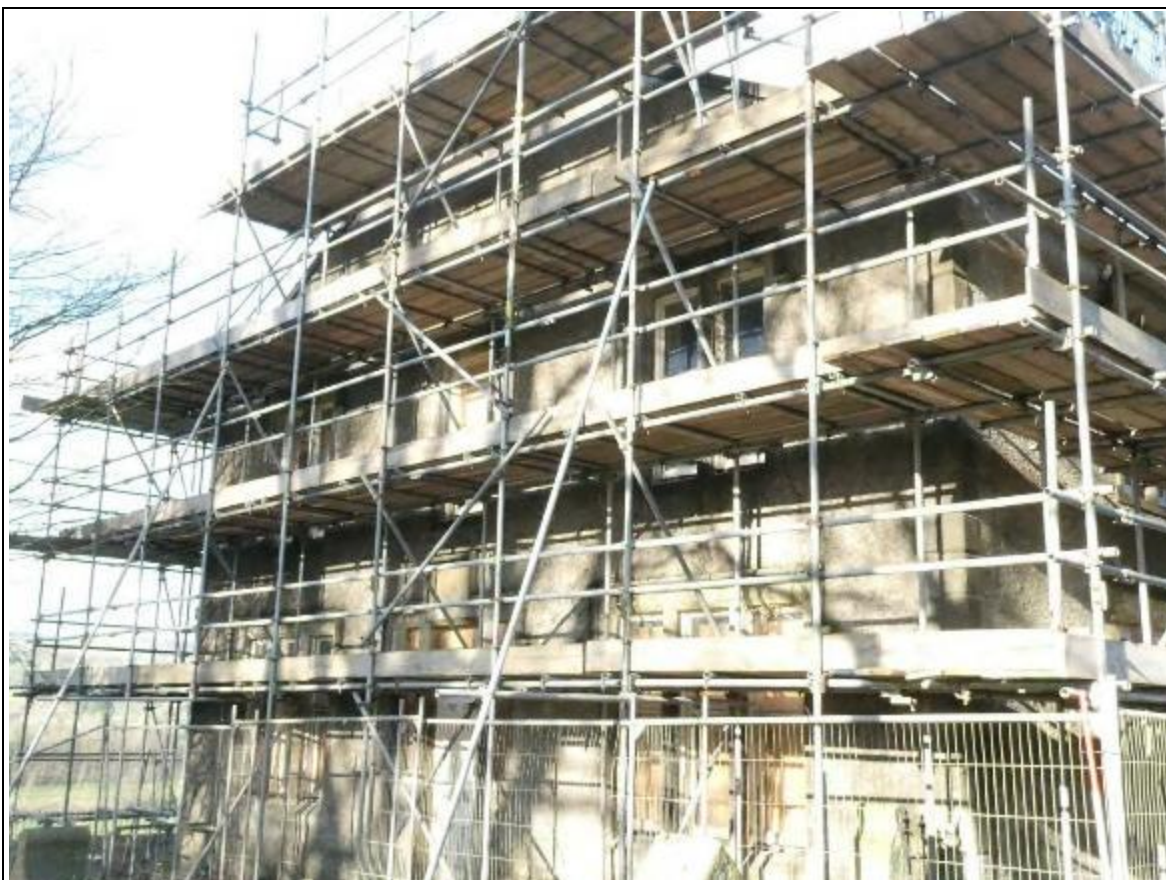
*Photograph 070*

The west elevation (Ph 070) has a painted central timber door with side lights and stained glass (Ph 027). The door is surrounded by a stone architrave (Ph 037) with scrolls to the base (Ph 029) and surmounted by a hoodmould. Either side of the entrance there are tripartite timber sash windows (Ph 030) under stone hoodmoulds (Ph 036). The elevation has dressed quoin, with coping stones (Ph 032) to the gable, finished with ball finials. At the first floor there is a stone date tablet of E 1898 (Ph 069) above the single central window (Ph 050) at the first floor. Either side of the central window there is a double sash timber window (Ph 051) also under a hoodmould.

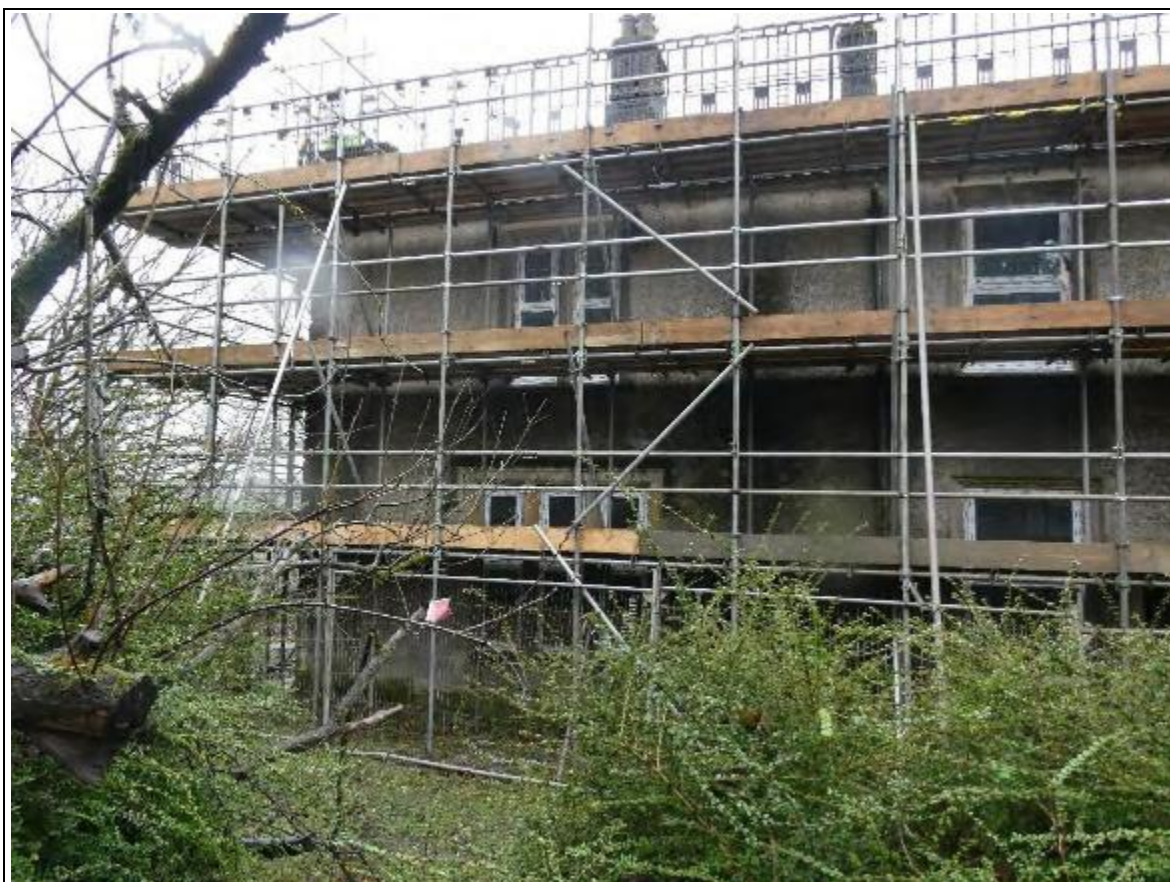
***Photograph 016***

The south elevation is divided into the western late 19<sup>th</sup> Century section (Ph 016) and the earlier eastern vernacular 17<sup>th</sup> century section. The western section has a tripartite replacement window to the ground floor (Ph 017) and a double replacement window to the first floor (Ph 018). Both windows have dressed stone surrounds and hoodmoulds. The ground floor of the eastern section consists of a painted timber door (Ph 009) with stone surround flank by two replacement windows also with stone surrounds (Ph 014). There is also a dressed stone boot scraper recess (Ph 006) to the east of the door. The first floor of the eastern section has two replacement windows with stone surrounds (Ph 015). All first floor windows are located close to the roofline. There is a cast iron down pipe at the centre of the elevation and two cast iron air vents (Ph 019) at the plinth of the western section. There are three chimneys, one to the east gable end, one central and a larger chimney with four pots (Ph 068) to the western section. There is also a rooflight at eastern section.

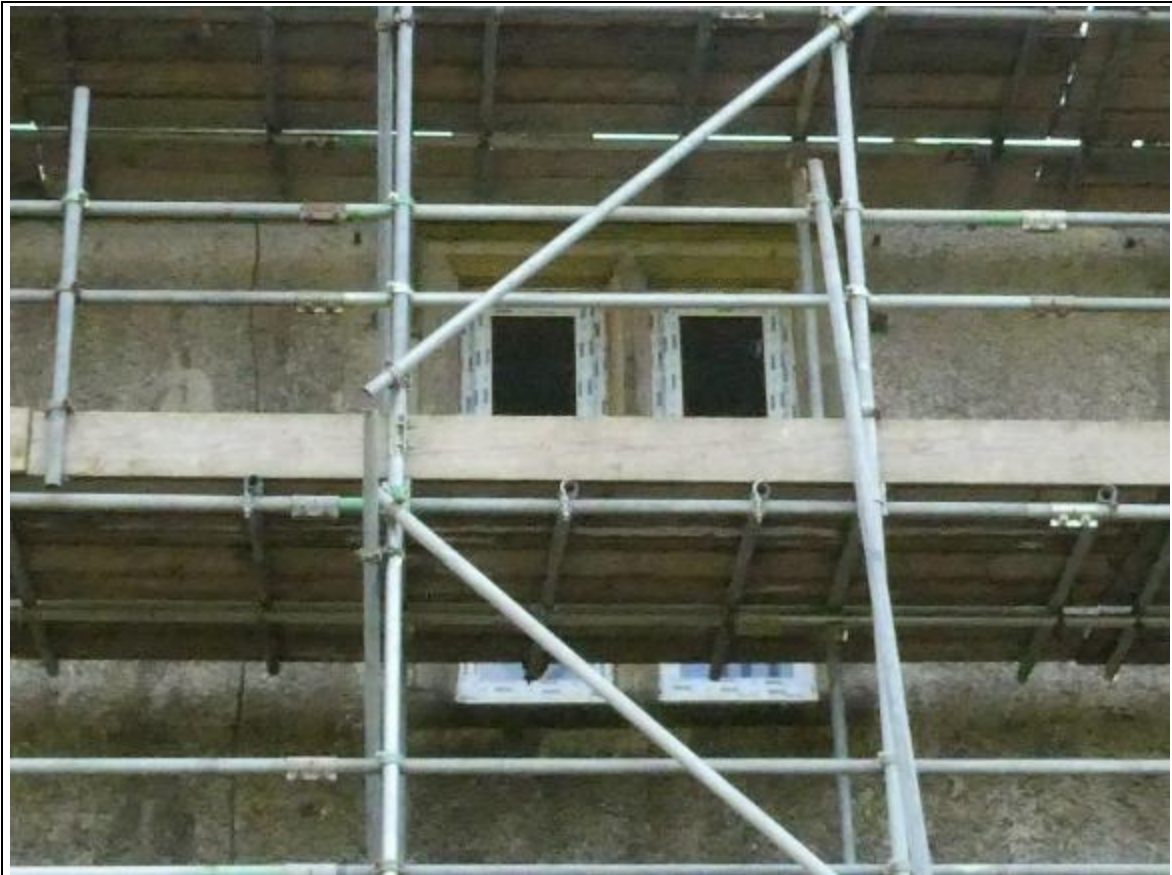
*Photograph 062*

The north elevation (Ph 062) reflects the architectural design of the south elevation with quoins and coping stones (Ph 040) at the shared corner with the west elevation. The ground floor of the western section has a tripartite replacement window (Ph 061) with stone surround and under hoodmould. There are two replacement windows at the first floor, one double (Ph 062) and one single (Ph 060) with stone surrounds and under stone hoodmoulds. There are two air cast iron vents at the plinth as well as two down pipes, one plastic and the other cast iron (Ph 043). The eastern section of the elevation has a central timber door with transom (Ph 057) with two replacement windows with stone surround (Ph 047) on either side. There is a basement timber framed window with metal bars and stone lintel (Ph 048) to the west of the timber door. To the first floor of the eastern section are two replacement windows with stone surround. There is a rooflight at the centre of the elevation.

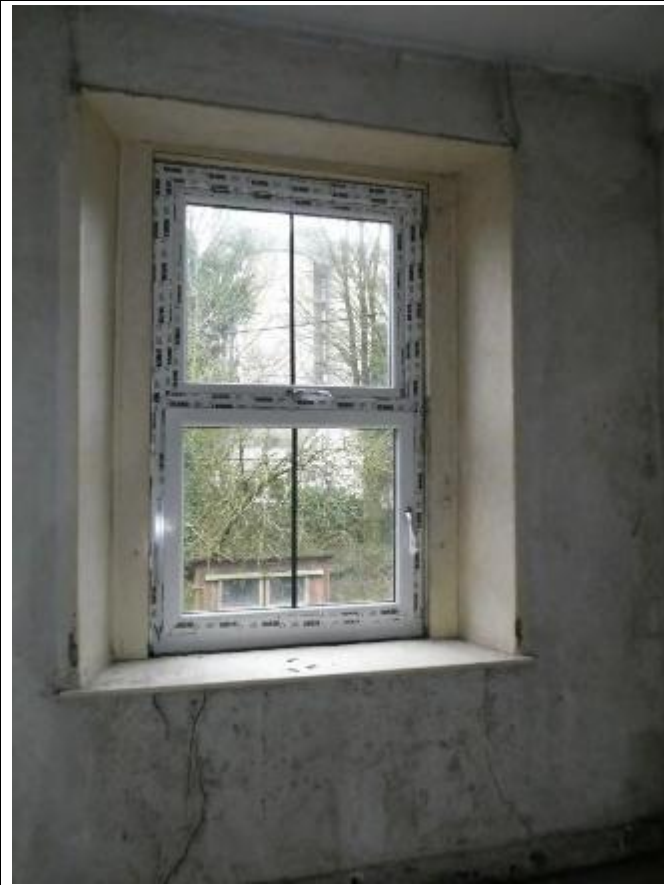
*Photograph 169*

| 169 | Replacement window to the south wall of Bedroom 4, taken from northeast |

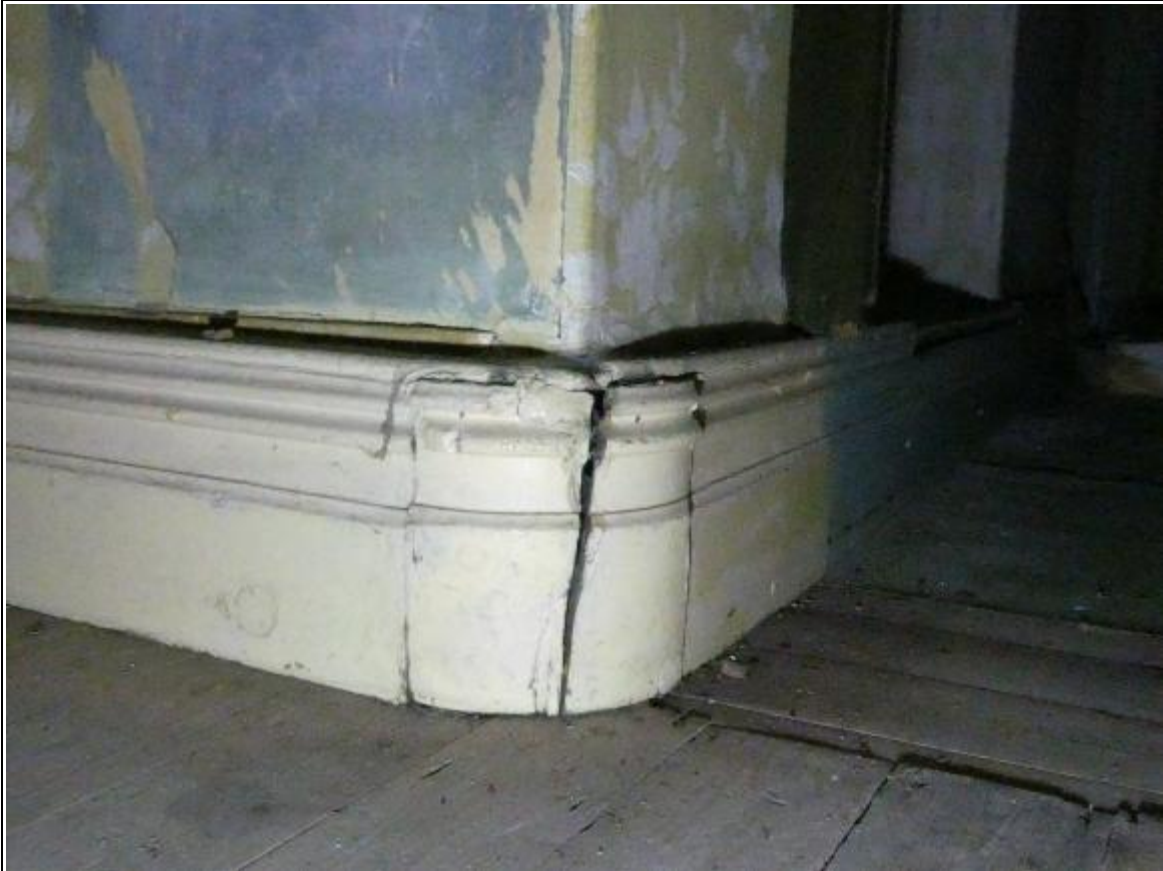
*Photograph 183*

| 183 | Damaged skirts board at the east wall of Hall 4 at the arched doorway the first floor, taken from southwest |
