**BAT SURVEY  
AT  
15 MOOR LANE  
CLITHEROE**

DATE AND TIME OF VISIT  
27<sup>TH</sup> Aug 2026 9.15am

REFERENCE NO 7397

Insertion of a roof light in the rear roof pitch of the property.

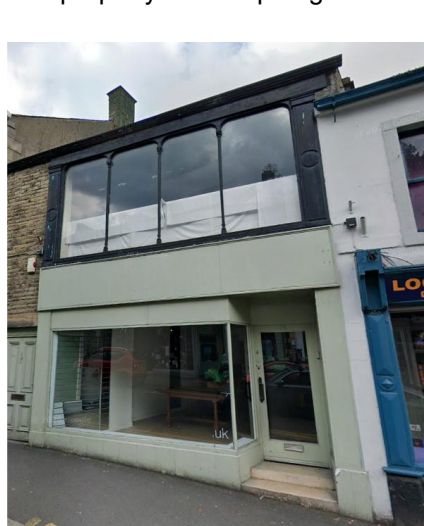
Front Elevation

The property is a shop at ground floor with living accommodation being formed at first floor.

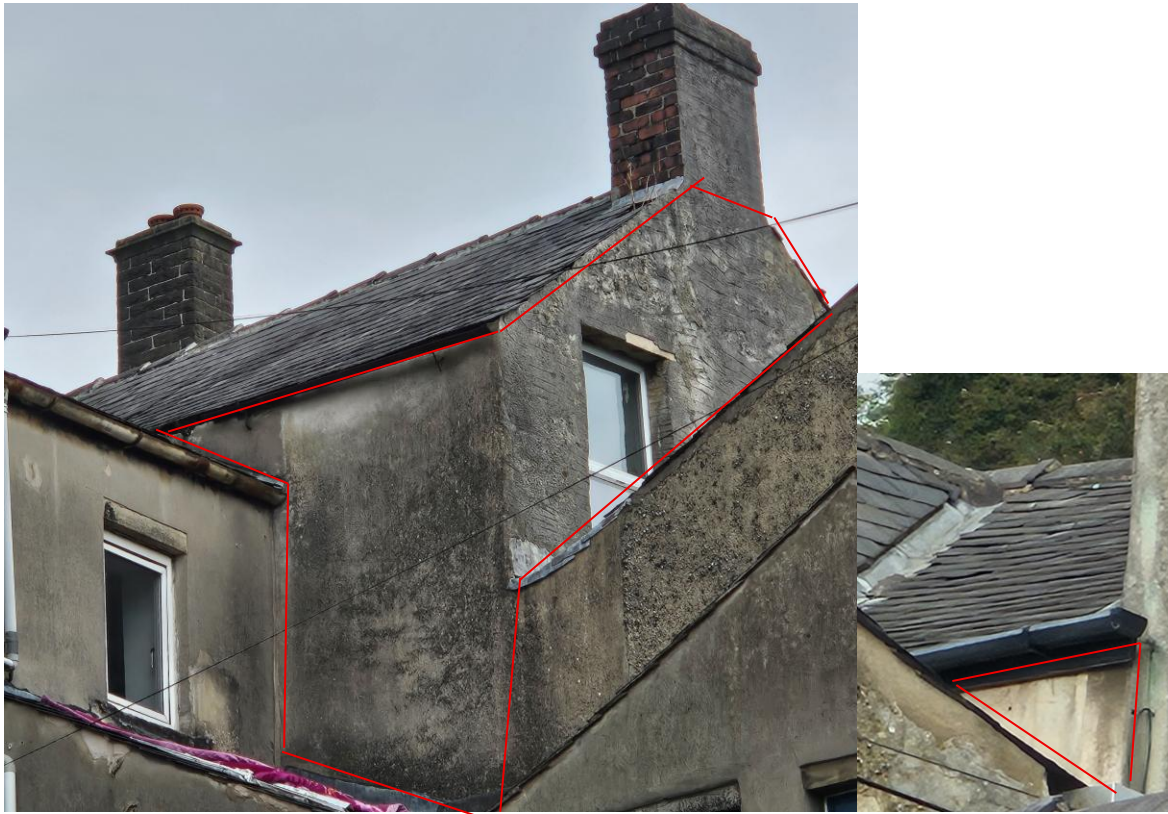
The rear walls are only partially visible (lined in red) being adjacent to other properties all are rendered

The render walls are aged however there are no cracks or crevices present.

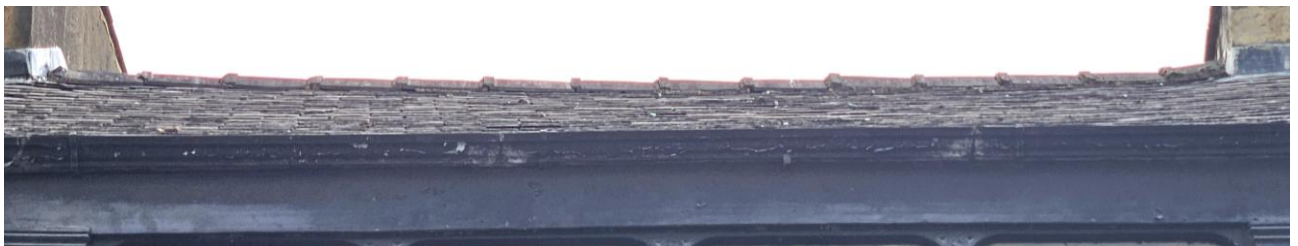
The roof to the front elevation is pitched with a blue slate finish with ridge tiles. the gutter is flush against the timber fascia

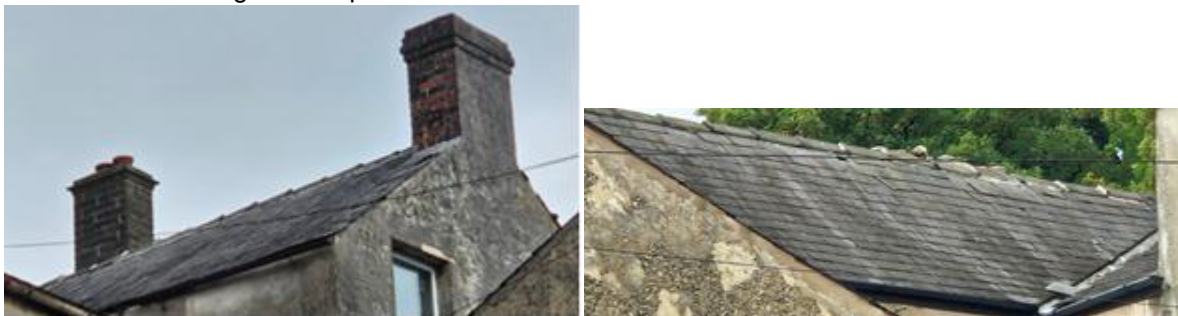
There is a blue slated outshot to the rear with a pitched roof and lead valley gutters at the roof abutments. The verges were pointed.

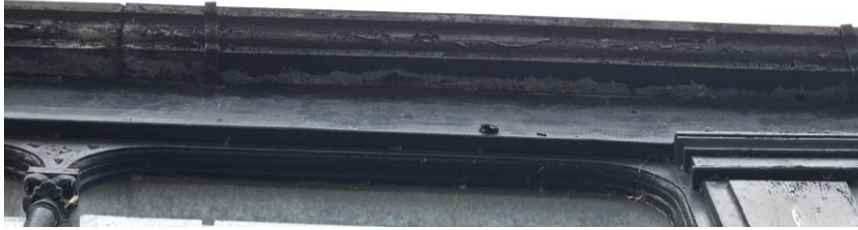
The front roof pitch was aged however no significant gaps were noted the front gutter was very tightly fitting to the timber frame.

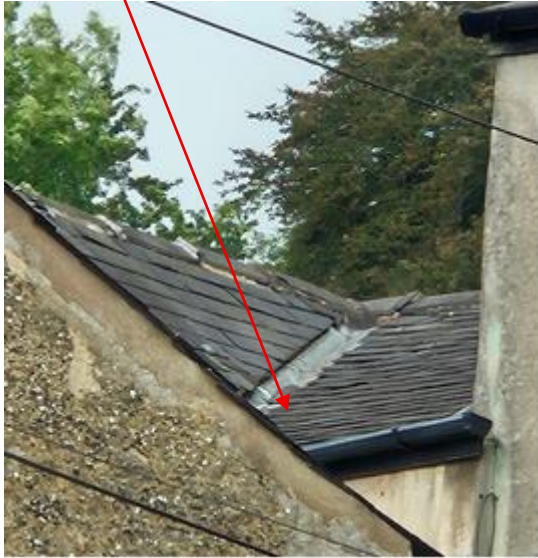
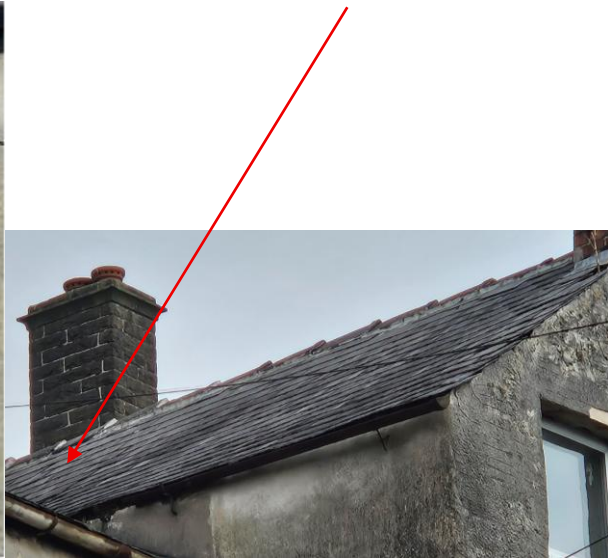
The slates are generally tight fitting. The verge pointing is in reasonable condition. The timber fascias are flush fitting to the walls.

There was a slipped slate noted in the valley gutter adjacent to the proposed location of the roof window.

Location of the missing slate in the south pitch of the outshot.

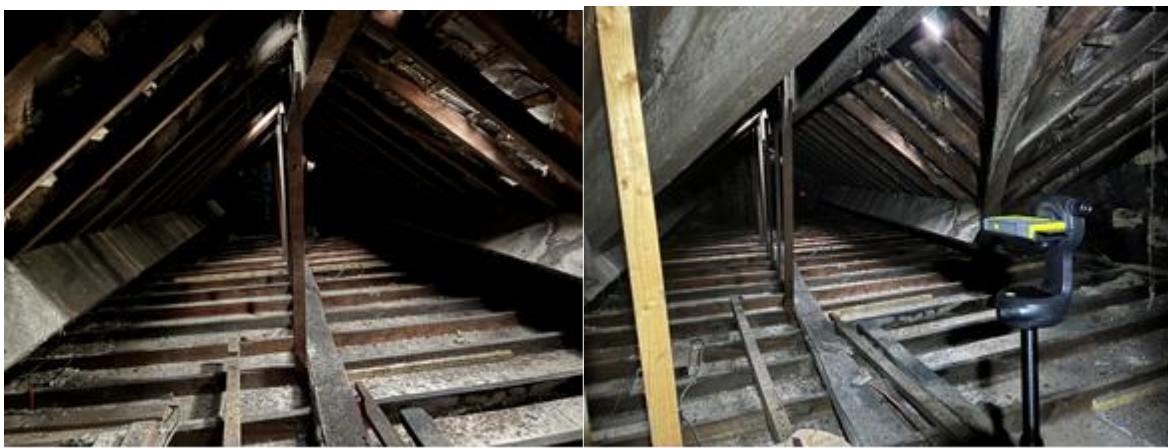
The roof space was accessible via a ceiling hatch. The structure is a timber and rafter construction with the slates pointed over the timber battens. There is no insulation present nor any underlay.

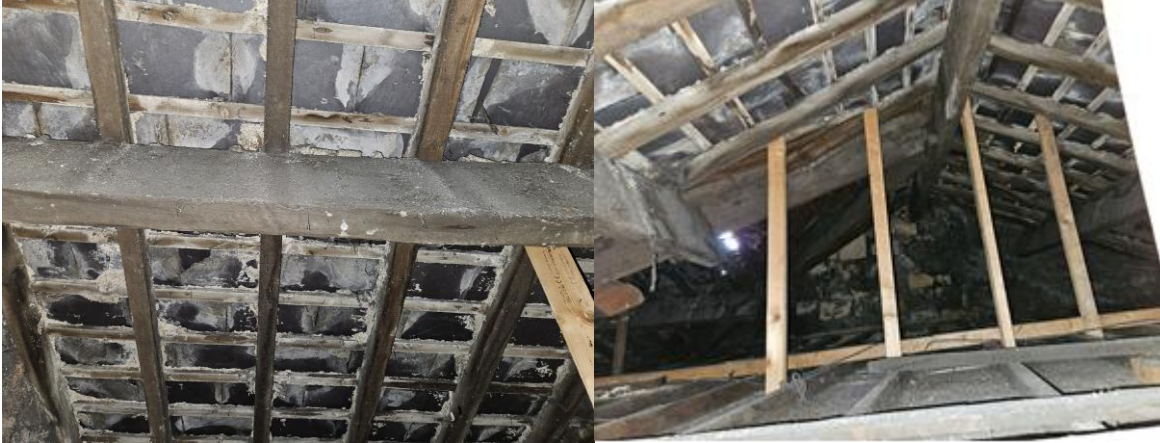
All the timbers are in reasonable condition with no signs of rot nor are any cracks or crevices present

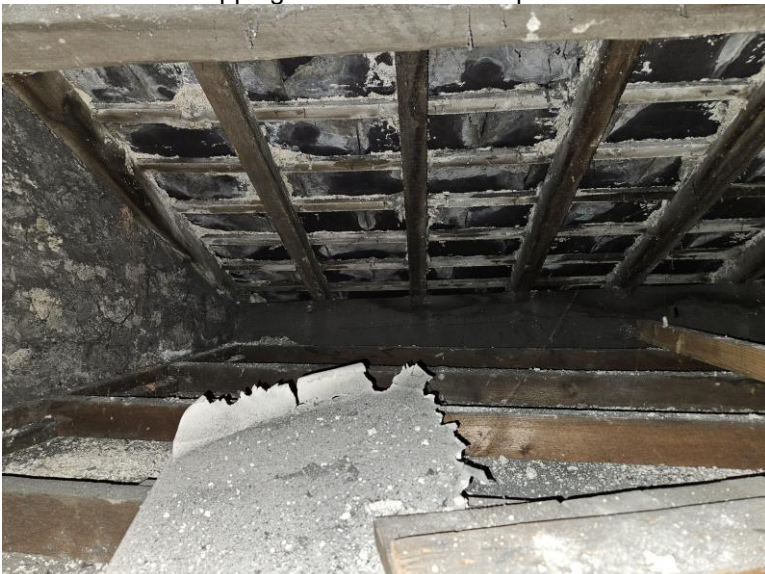
The floor between the ceiling joists is dusty and covered with some degraded pointing from the slates. There were no droppings or insect remains present.

The space does not provide any potential roost habitat for bats.
