**Re. Proposed development at Cowley Brook Farm, Higher Road, Longridge PR3 2YX, Grid Ref: SD 64160 39144**

Thank you for your request for a bat and bird survey at the above site.

I understand that the proposal is for the conversion of an existing barn building in order to extend the existing living space to the existing, adjoining dwelling house.

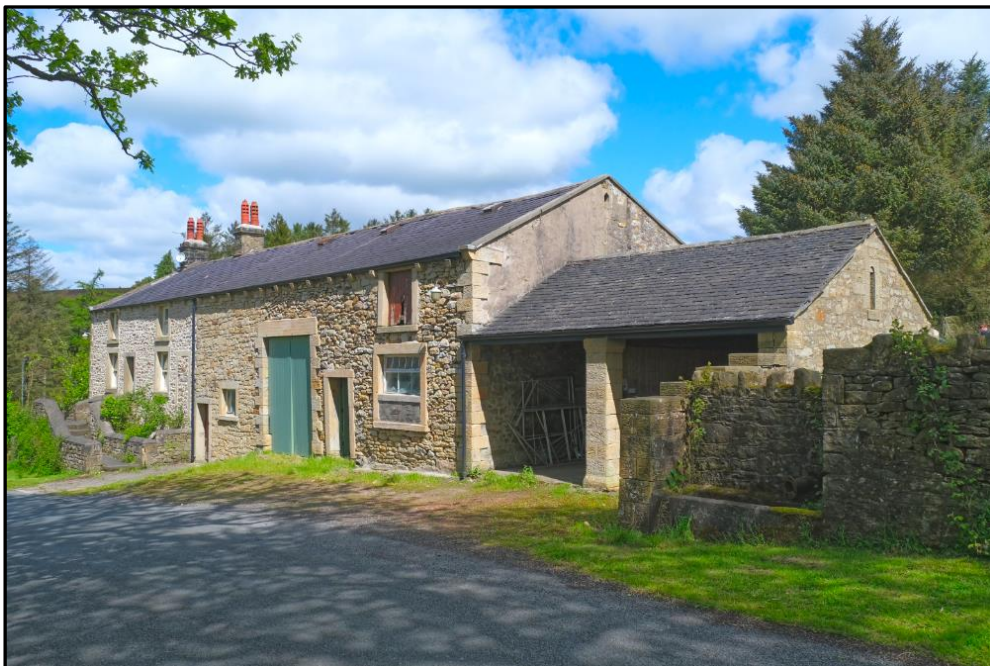
Cowley Brook Farm comprises an occupied two-storey dwelling house with an adjoining barn with two car port units to the east.

***Image 1. South elevation of Cowley Brook Farm showing dwelling house (lhs), barn (middle) and car ports(rhs).***

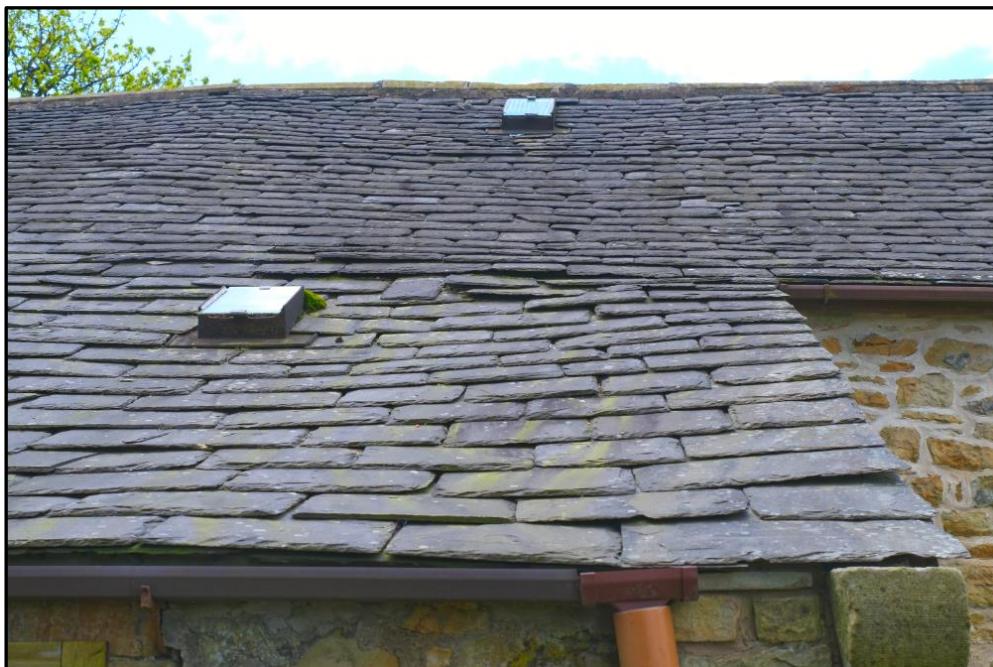
**The barn building** adjoins the dwelling house to the east and is a two-storey structure with stone walls and slate roof with roof lights. There is no roof liner and majority of the internal areas are light, open and draughty. The only suitable dark shelter spaces suitable for bats are limited to small overlaps associated with roof coverings and cavities associated with some wall cavities and part of the roof edges.

***Image 2. Roof coverings on barn building (north elevation).***

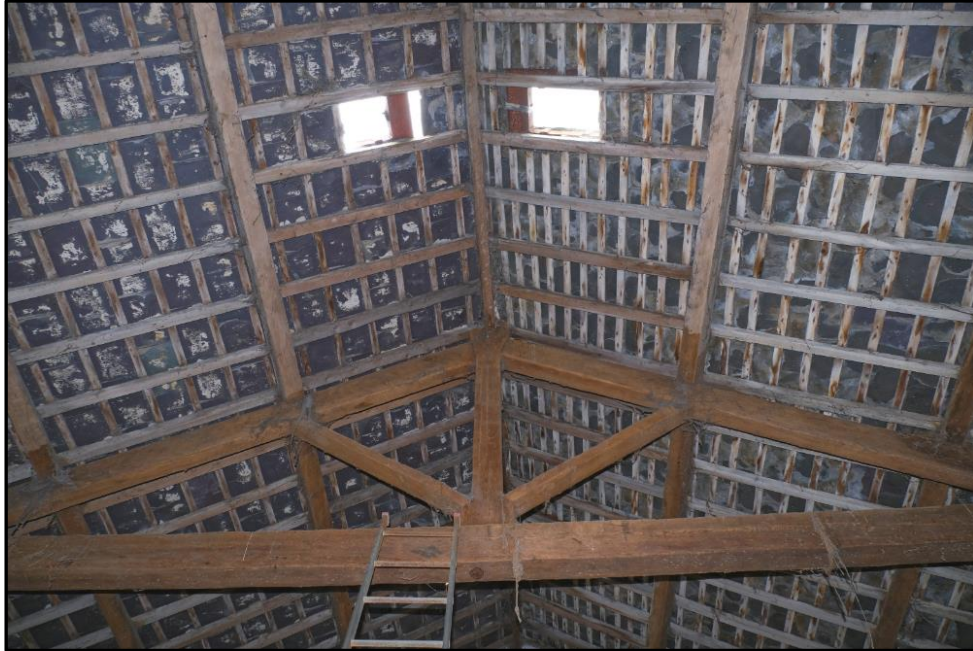
***Image 3. Roof underside of barn, unlined with roof lights (limited sheltered dark spaces)***

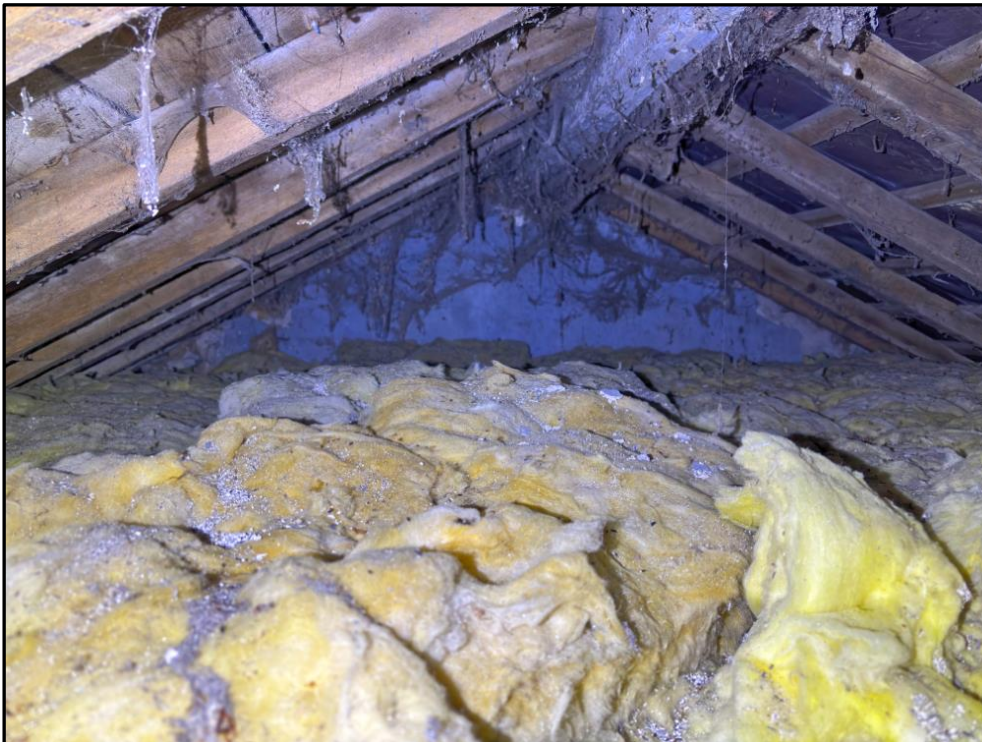
**The dwelling house** has been previously renovated both internally and externally with mortared external stone walls and an intact dual-pitched roof covered with slate. There is a shallow roof void with dense rock wool insulation, the underside of the roof is part unlined and part sarking. The roof void is not connected to the barn building and no signs or evidence of use by bats was found.

***Image 4. Roof void of dwelling house, no connection to adjoining barn building.***

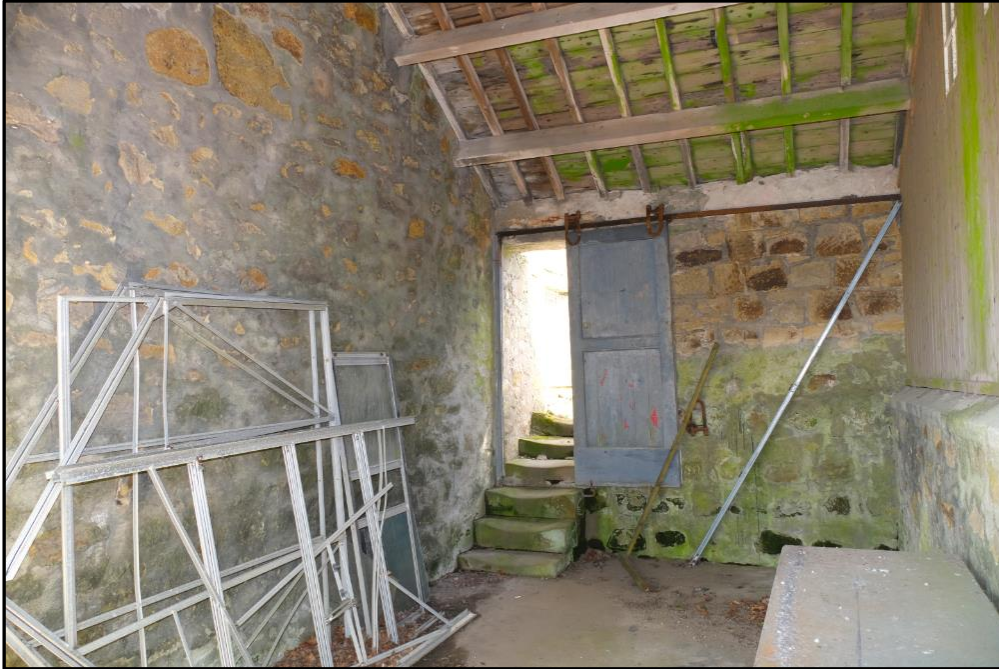
**The car port building** is a single storey structure, with two separate units that adjoin the barn to the east. There is a dual pitched slate roof, underlined with timber boards. The roof and roof edges are intact and in good condition. The external and internal stone walls are mortared and all roof coverings and roof edges are tight with no suitable gaps for use by bat present. There are active swallow nest and old, disused swallow nests amongst the roof timbers within both units.

Two active swallow nests were present within the roof structures inside the car port units and old unoccupied swallow nests were also found present within the main barn as well the car port.

***Image 5. Internal view of car port. There is clear evidence of past and current use by nesting swallows within timber under boarding and roof structures.***

| Protected species | Impacts /Predicted Impacts | Action Required |
|---|---|---|
| Nesting birds continued | | <b>Recommendation (mitigation and enhancement):</b> The renovated building should either retain features suitable for use by swallows and blue tit e.g. open and accessible canopy structures for swallows and deep wall cavities for blue tits or the renovated building should incorporate suitable bird nesting features e.g. a minimum of 3 x integral nesting boxes or external bird boxes suitable for use by hole nesting birds and at least 2 swallow cups should be installed under a roof overhang or canopy. <b>During and/or post development.</b> |

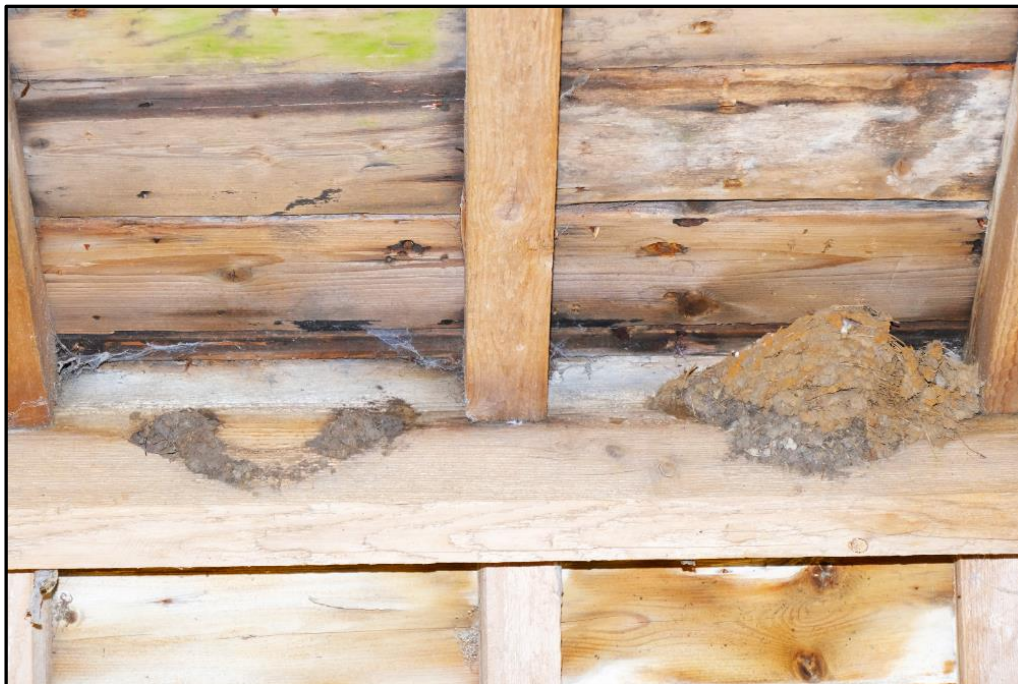
***Image 6. Close up image of old and recent swallow nests in car port.***

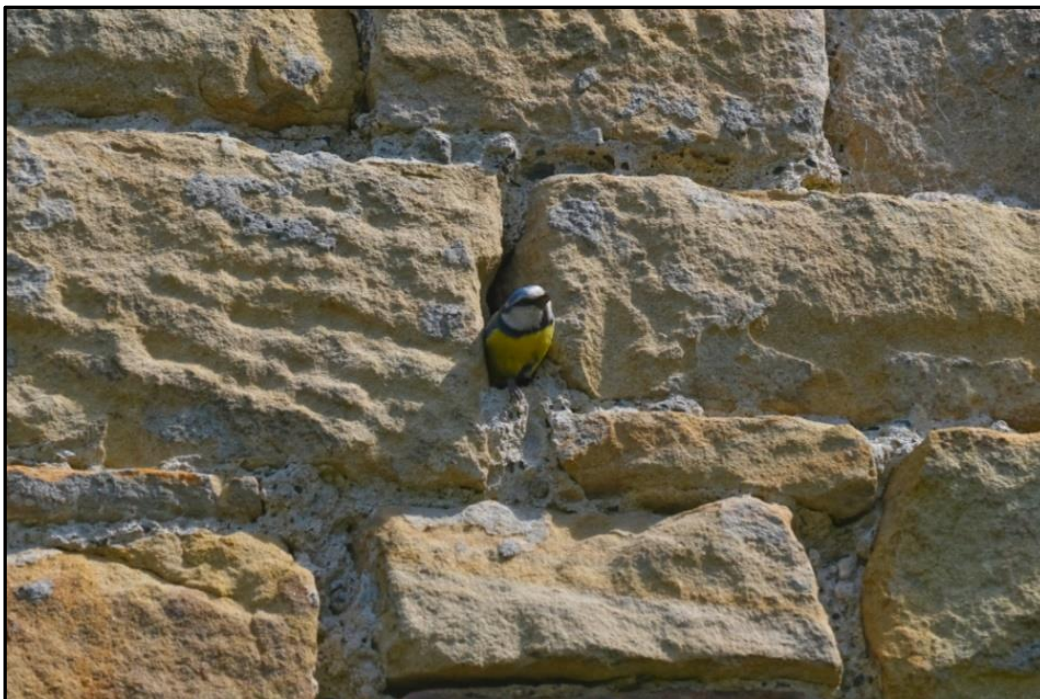
Three blue tit nests were found in external wall cavities; two of the nests were located on the south elevation and one nest is on the north elevation of the car port building, beneath a gutter.

*Image 8. Close up view of nesting blue tit exiting wall cavity.*

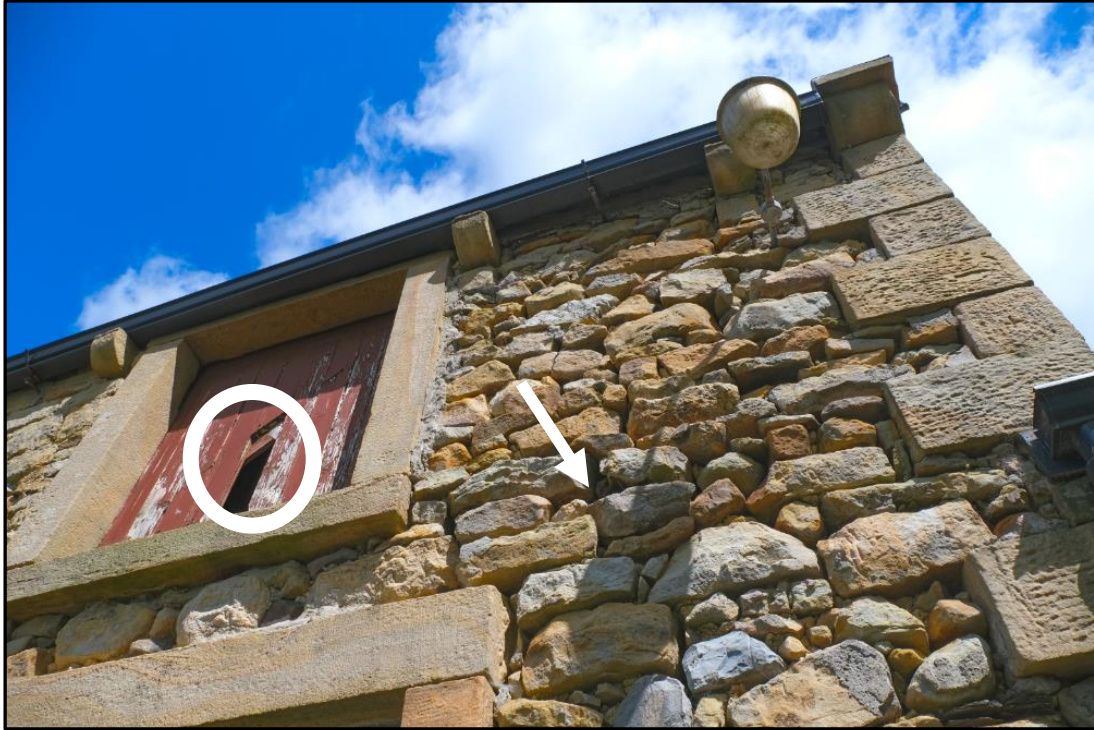
Signs of use by barn owl were found in the first-floor room of the barn to the east and a single adult barn owl was observed flying in an adjacent field during the bat emergence survey. There are two suitable access point for use by barn owl into the first-floor room. One access point is located at the apex of the east gable and the second is a gap due to a missing timber board on the south elevation.

***Image 8. Wall cavities in external walls. White arrow is the location of a second blue tit nest and the white circle is potential access for barn owl.***

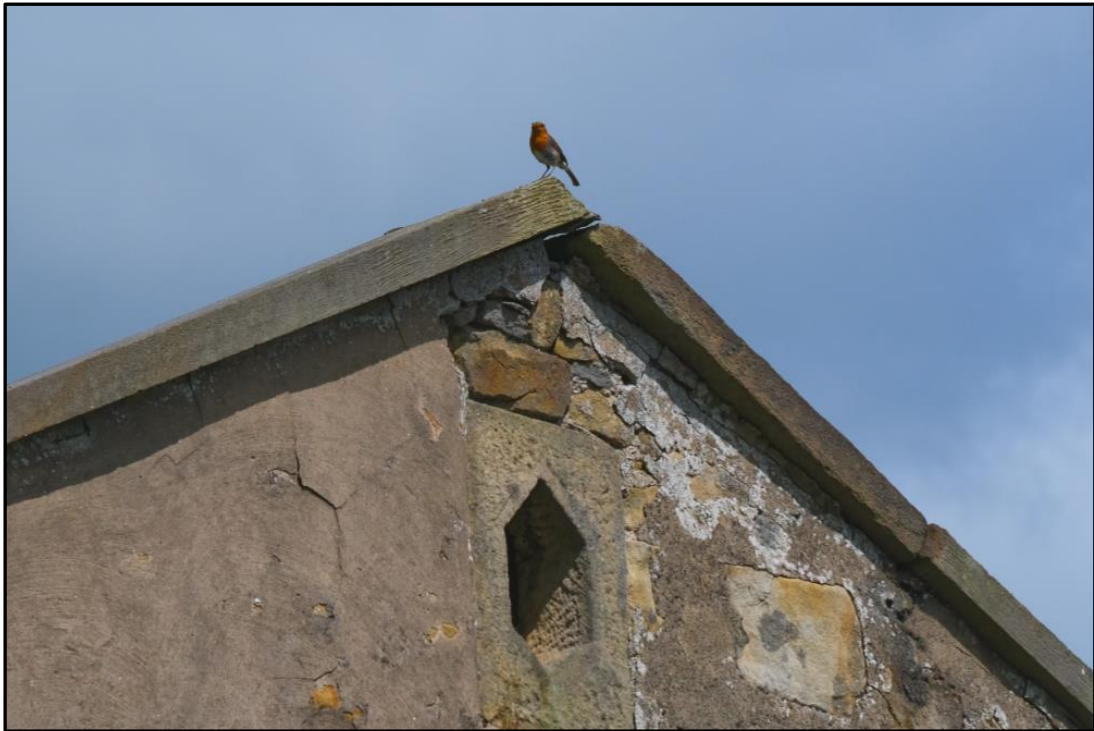
***Image 9. View of suitable access for barn owl east gable and robin perched on roof during daytime surveys.***

| Protected species | Impacts, Issues & Rationale | Action Required |
|---|---|---|
| Barn owl | <p>There are <b>potential</b> impacts to barn owls (disturbance, damage, destruction). Current evidence suggests at least one barn owl has roosted in the buildings prior to the 2026 survey.</p> <p>There is a reasonable likelihood that barn owls could be roosting within the barn building at any time of the year.</p> <p>Under Schedule 1 of the Wildlife and Countryside Act 1981 (as amended), wild birds are protected from being killed, injured or captured, while their nests and eggs are protected from being damaged, destroyed or taken. In addition, certain species such as barn owls are included under Schedule 1 of the Act and are protected against disturbance while nesting and when they have dependant young. Offences against birds listed on Schedule 1 of the Wildlife and Countryside Act 1981 (as amended) are subject to special penalties.</p> | <p><b>Advice (mitigation):</b> A pre-commencement check should be carried out by an ecologist prior to works commencing. <b>Prior to any proposed works.</b></p> <p><b>Advice (mitigation):</b> It is advised all personnel involved in works to the buildings and their surroundings should be carefully advised about barn owls by an appropriate person, so that all works are undertaken with a clear understanding about legal aspects, precautions to be adopted and what to do if barn owls are present and/or if an active nest is found. <b>Prior to any work.</b></p> <p><b>Advice (mitigation):</b> If there is any doubt about the status of barn owls at this site, it is advisable to adopt a precautionary approach, assume that birds are present and nesting and avoid doing anything that may constitute disturbance and seek further advice before proceeding. <b>At all times.</b></p> <p><b>Recommendation (mitigation and enhancement):</b> As barn owl roosting and potential nesting is to be lost, it is recommended that an internal barn owl box is installed on the inside of the east gable. A specification and more details are available from the Barn owl trust website. <a href="#">Barn Owl nestboxes: Free owl nest box plans</a></p> |

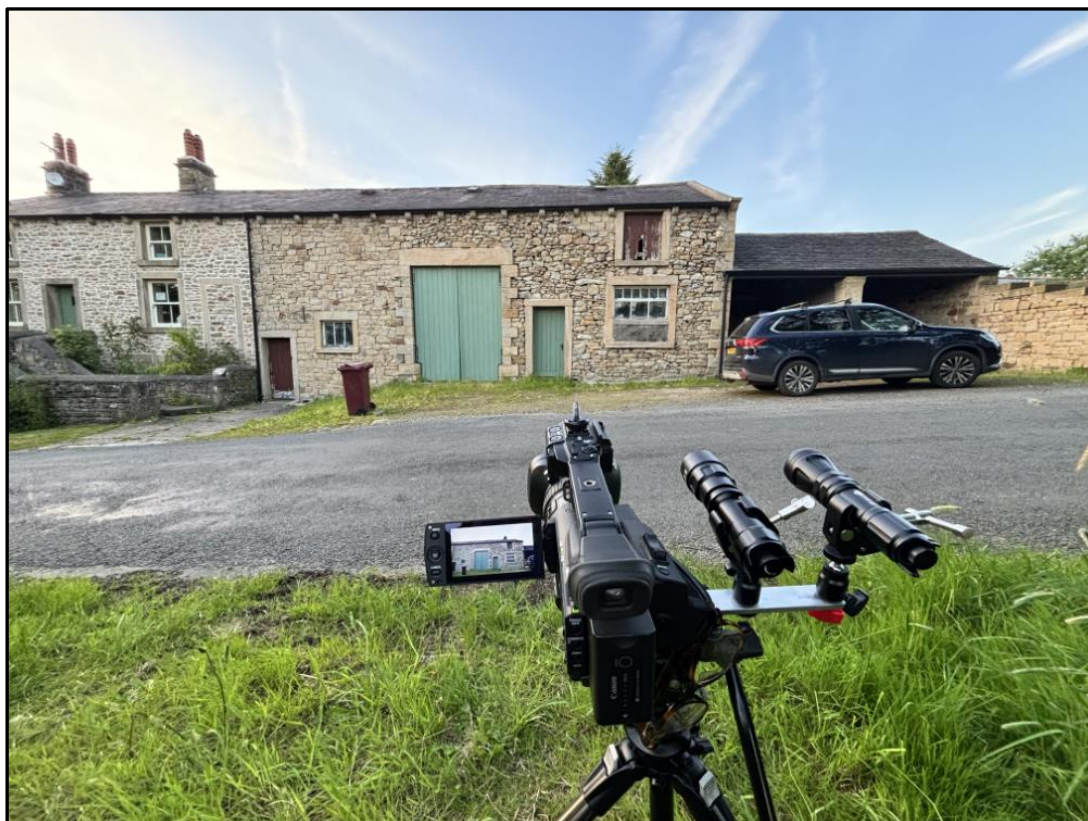
*Image 10. View of south elevation prior to bat emergence survey.*

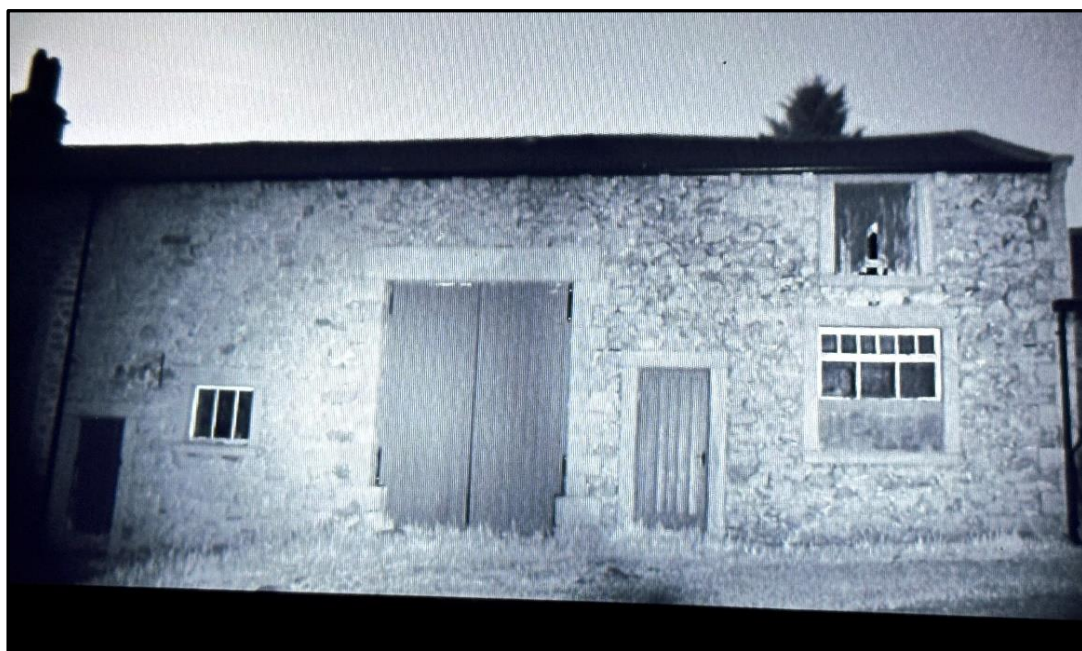
No bats emerged from the buildings during the surveys.

*Image 11. View of south elevation at end of bat emergence survey.*
