# **Method Statement - European Protected Species (Bats)**

## **Reasonable Avoidance and Mitigation Measures**

**2 Walled Garden,  
Woodfold Park,  
Mellor,  
BB2 7QA**

**20.07.2026**

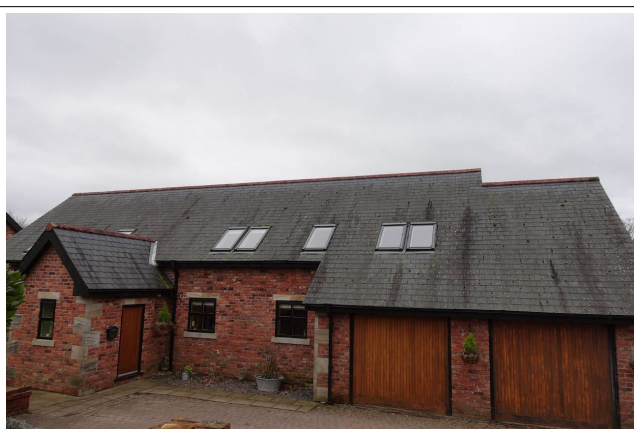
Northern frontage

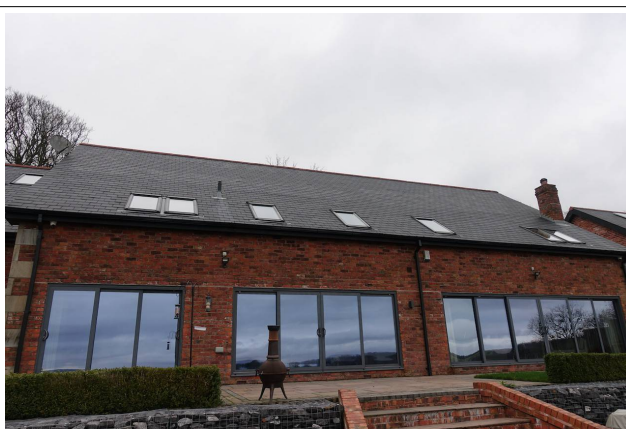
South facing facade

The development proposals are not considered likely to affect the roost or roost entrances. Solar panels will be installed on the south facing roof section. Panels will be mounted on a rail system which requires temporary lifting of individual roof tiles to fix the mountings.

Roof slates/tiles should be lifted by hand and under supervision where necessary.

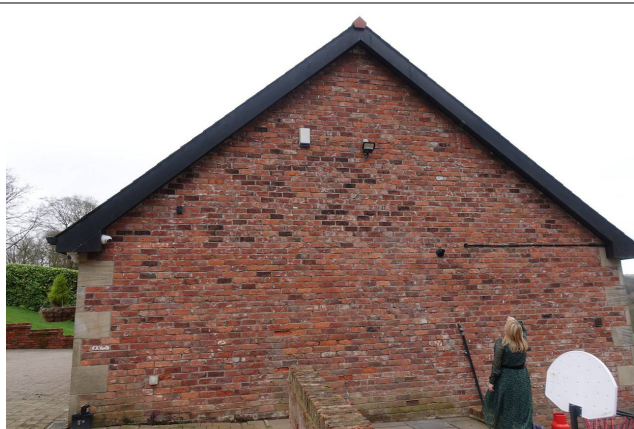
Timber soffits are generally close fitting and well sealed, however gaps were present at both gable ends allowing access to the cavity wall.

Western gable end

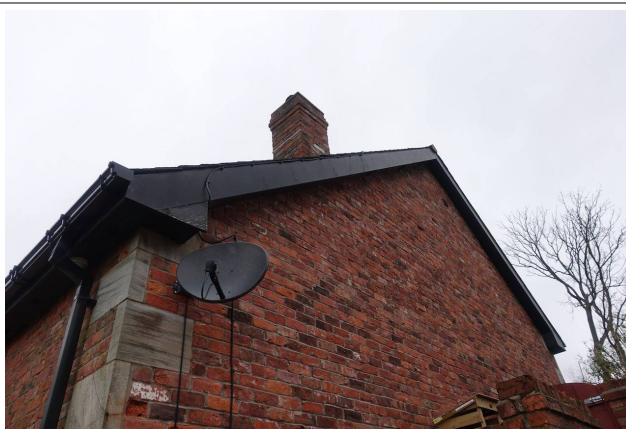
Eastern gable end

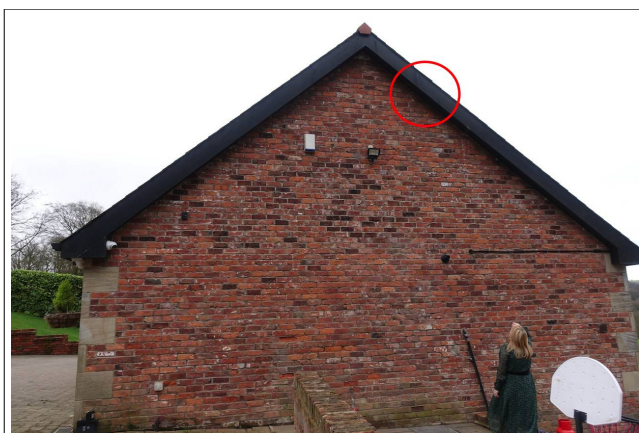
Gaps were present at the apex of both the eastern and western gable ends allowing access to the wall tops.

*Location of roost entrance on western gable*

Scaffolding should avoid areas of the western and eastern gable ends identified as roost entrances to ensure flightlines remain undisturbed.

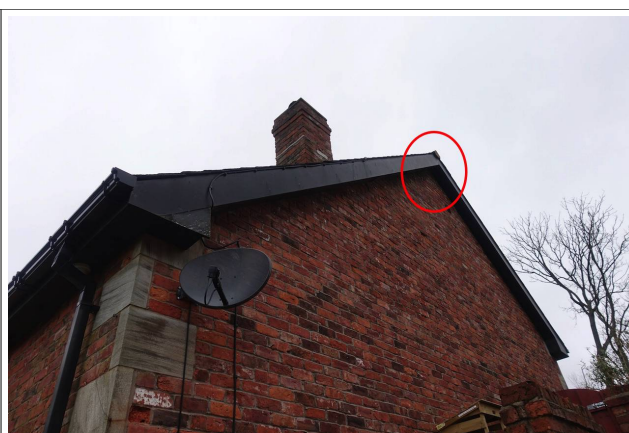
Inspection of the eastern gable within the loft revealed pipistrelle droppings overspilling from the wall top to the interior.

Droppings were consistent with a maternity roost of pipistrelle bats being present within the gable cavity walls.

*Location of roost entrance on eastern gable*
