## TECHNICAL NOTE:

- PRELIMINARY BAT ROOST ASSESSMENT (UPDATED)**

| SITE NAME & ADDRESS | |
|---|--|
| Nos. 16-20, Castle Street, Clitheroe, BB7 2BX | |
| 06 October 2026 | |

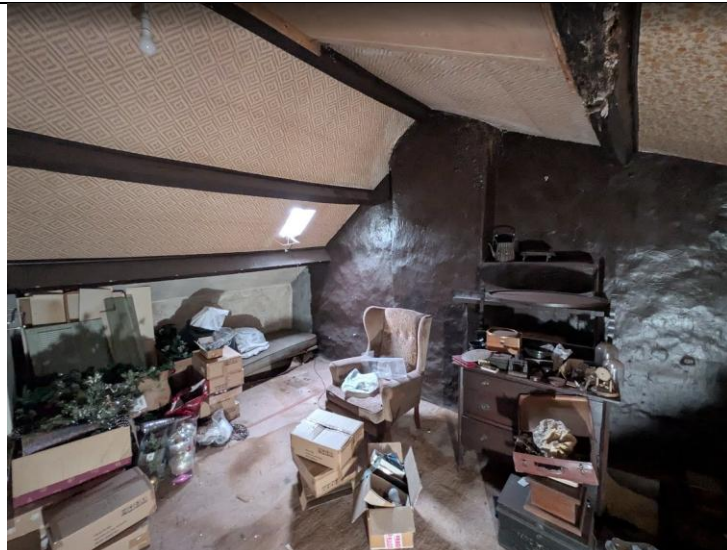
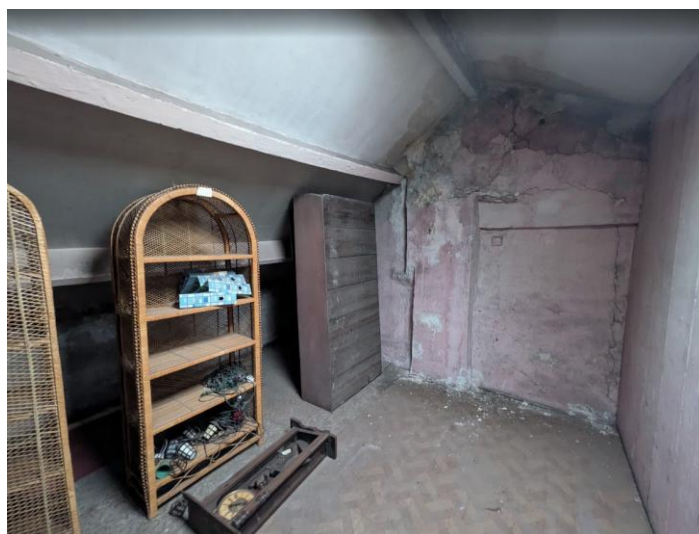
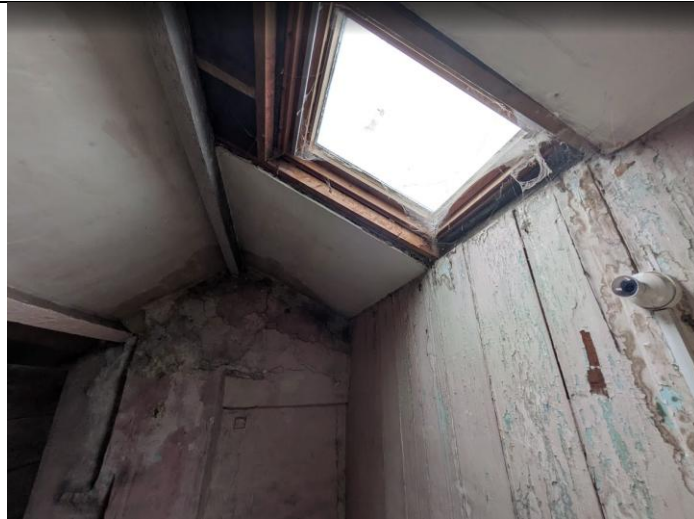
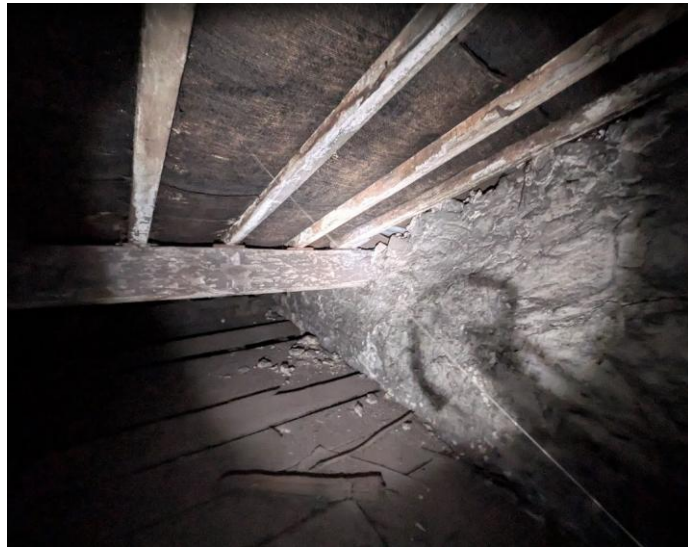
### Photos 1a – 1d

The vast majority of upper floor areas are converted and used as storage space. The roof underside and walls are lined and feature skylights. Only a small, shallow area of enclosed loft space was present. The floor space was boarded with timbers and the roof underside had traditional bitumen-based underlining. No evidence of a bat roost was observed.

Upper floor and loft areas of 18-20 Castle St.

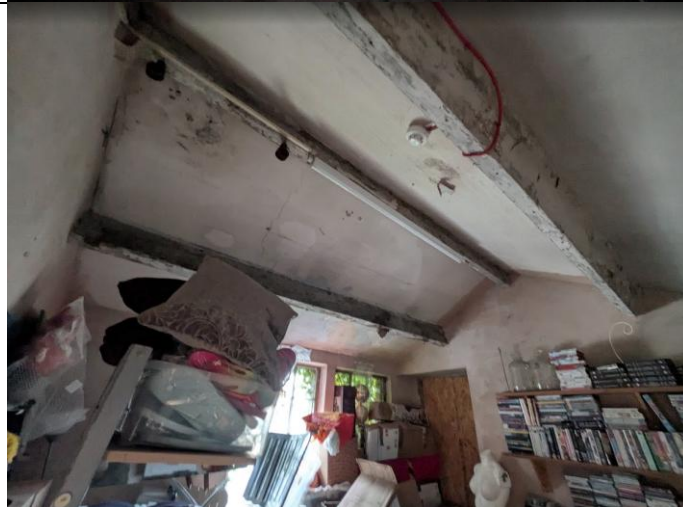
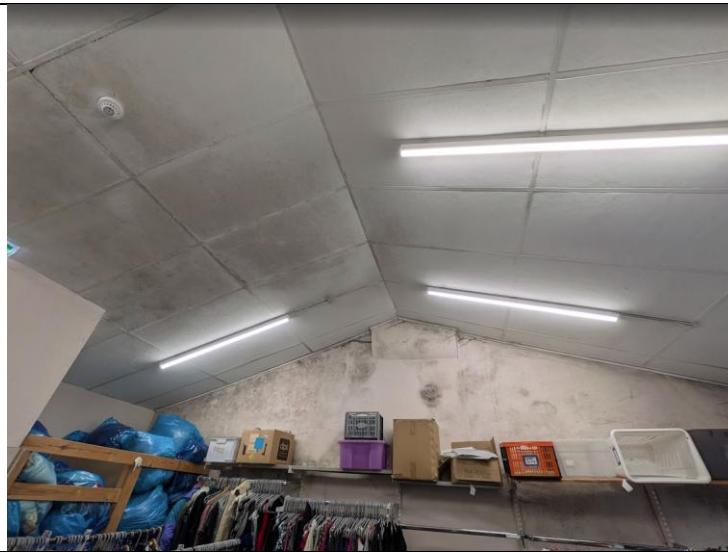
**Photos 2a – 2b**

No loft space was present within the upper floor of 16 Castle Street. All rooms featured vaulted ceilings and all were actively used for storage.

View of upper floor  
of 16 Castle St.

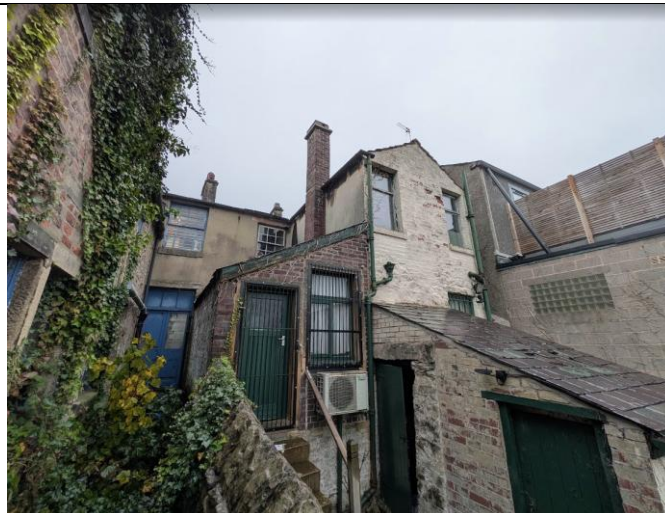
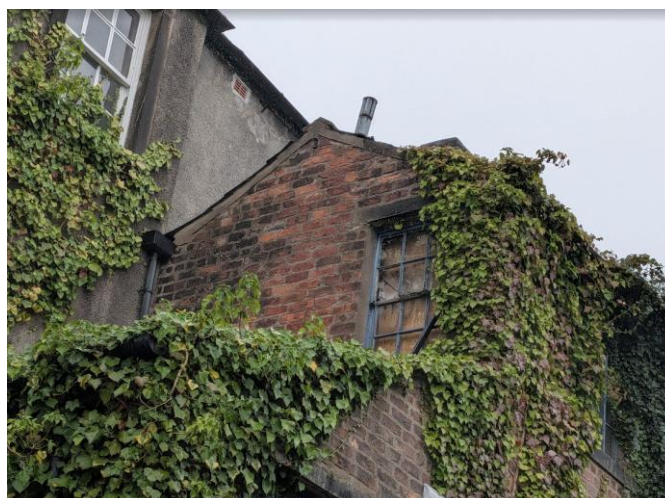
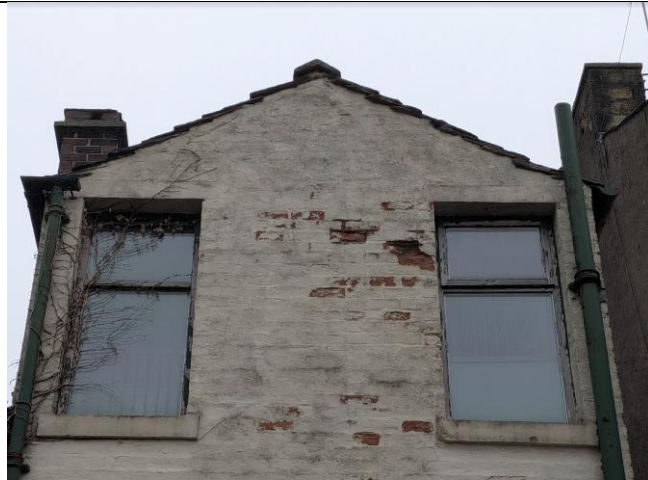
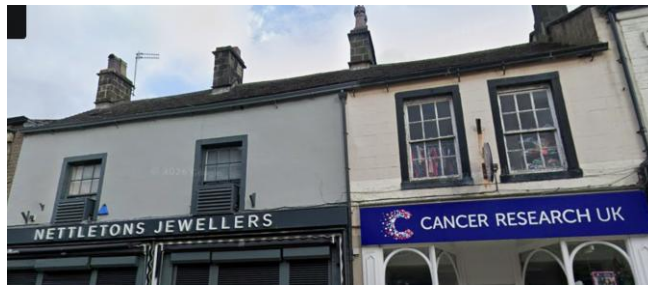
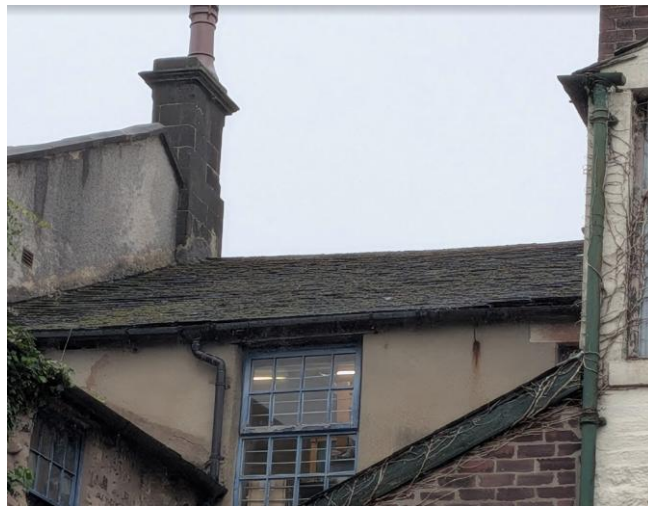
**Photos 3a – 3e**

The roofs of the terraced properties, including the rear extensions, comprise a mix of concrete roof tiles, slates and traditional stone tiles. No obvious potential roost features were identified, including gaps associated with lifted or missing slates. The slates at the rear verges appeared to be well bedded in mortar, with no obvious gaps at the verge.

Various views of external elevations.
