# **Bat Survey Report and Method Statement European Protected Species (Bats)**

## **Reasonable Avoidance and Mitigation Measures**

**Unit 4, George Street,  
Longridge,  
Preston,  
PR3 3NN**

**09.04.2026**

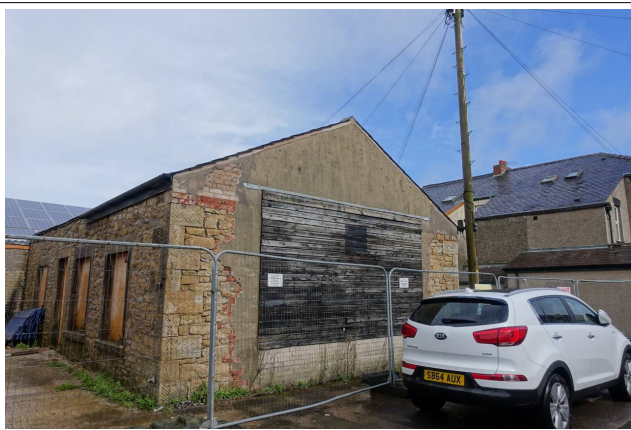
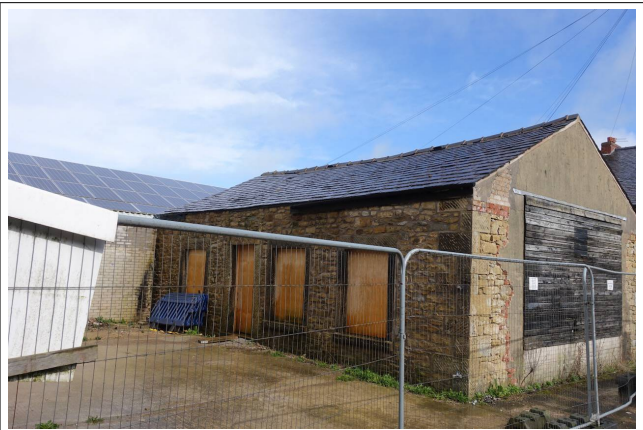
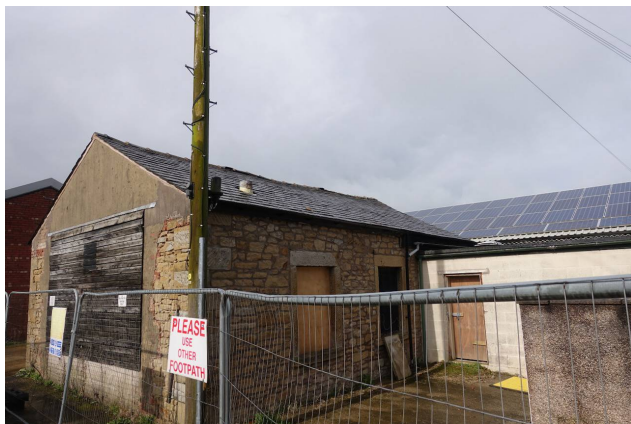
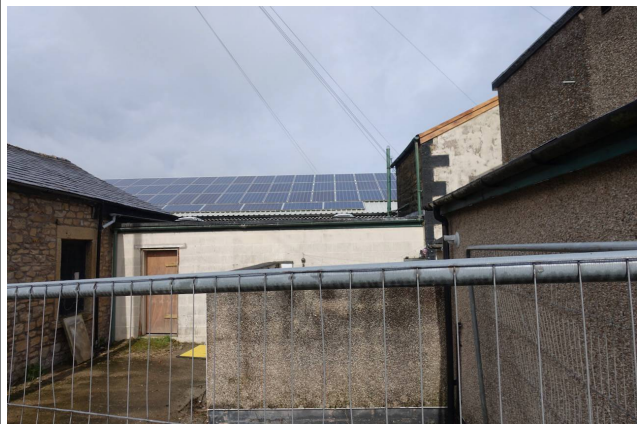
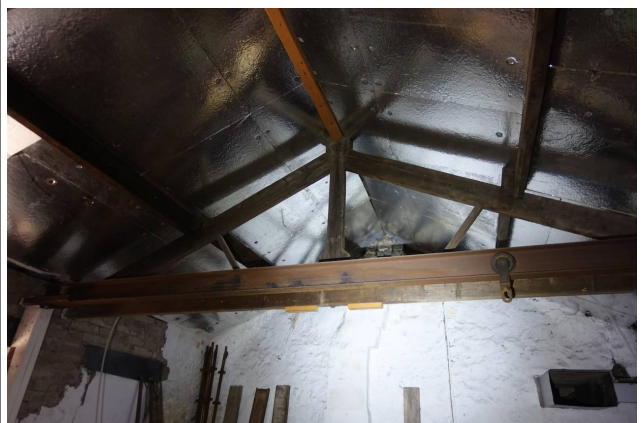
The property consists of a single storey stone built former garage building with a double pitched slate roof. A flat roofed extension is present on the eastern facade.

Stone walls are generally well pointed with no cracks, gaps or crevices present. Fascia boarding has gaps present. Gable ends are pointed and sealed. Roof slates are close fitting with no obvious lifted, slipped or missing slates observed. The ridge is close fitting however gaps were noted in pointing. Lead flashing where present is close fitting. Internally the ceiling is vaulted and slates are underlined with kingspan insulation boards..

**Overall the property was assessed as offering low bat roost potential when surrounding habitat and areas of street lighting were taken into consideration.**

Work to affected roof areas will take place under supervision of the batworker.

Roof slates should be removed by hand and under supervision where necessary. Slates should be checked for dormant bats prior to stacking.

The reverse of fascia boarding should be checked for dormant bats prior to moving.

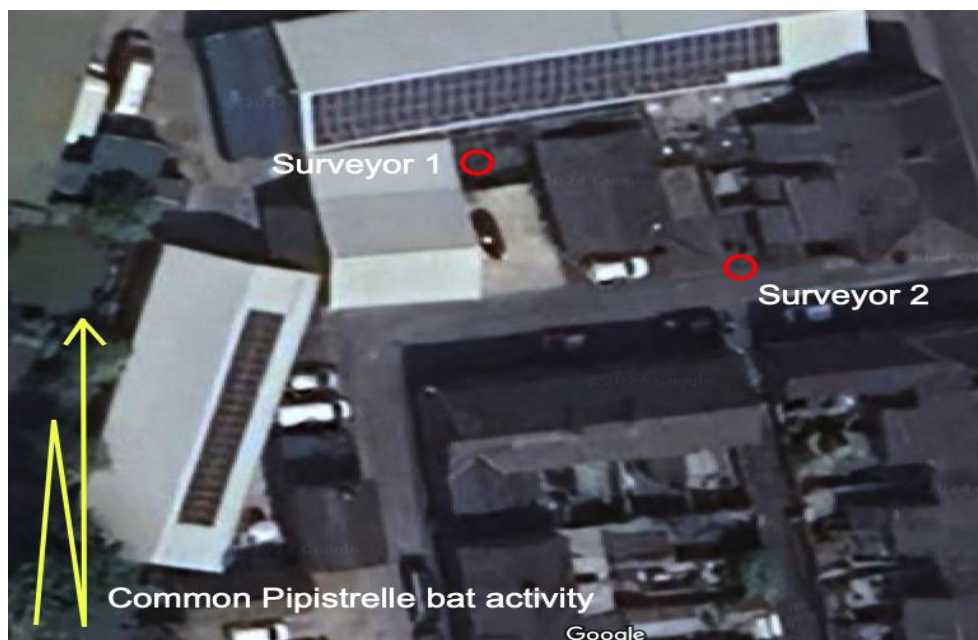
*Survey Summary*

Between 22.14 and 21.25 a single Common Pipistrelle bat was observed foraging along trees to the south west of the property.

No bats were observed emerging from the building on site, and general bat activity can be considered low.
