# **Preliminary Bat Roost Assessment Report**

**13 Higher Ramsgreave Road,  
Ramsgreave,  
BB1 9DJ**

**18.09.2026**

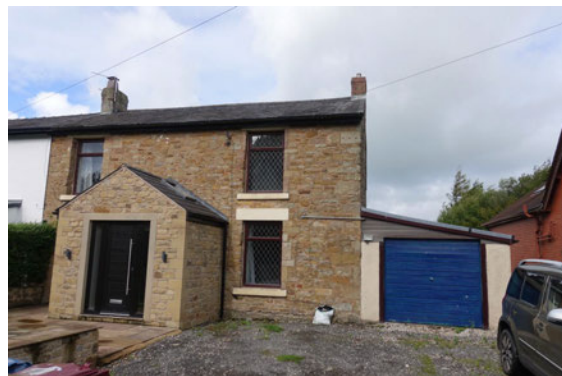
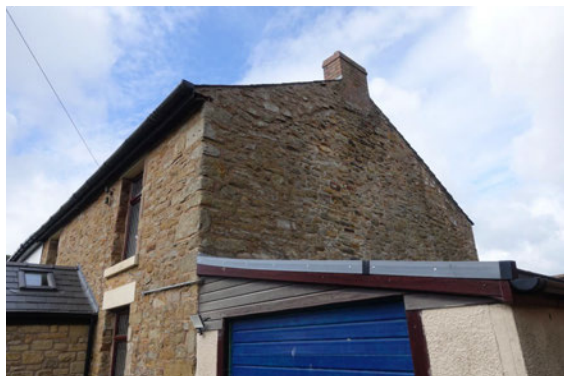
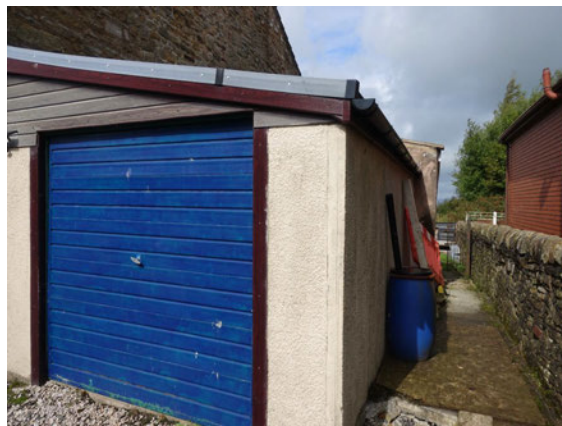
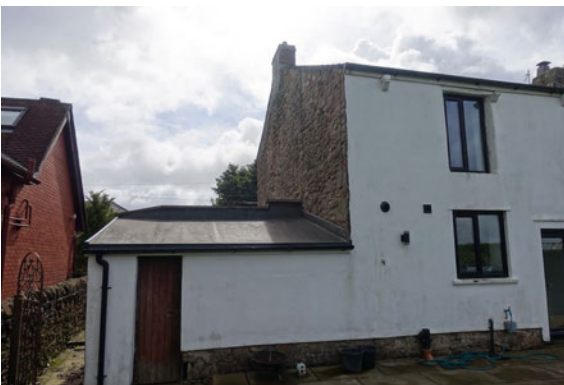
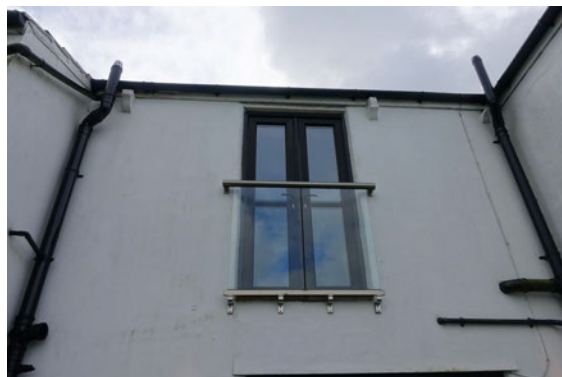
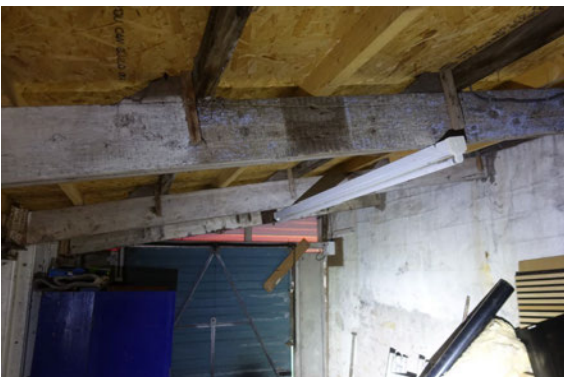
The property consists of a two storey semi detached stone built house with a double pitched slate roof, a single storey garage is present on the gable end

External walls are generally well pointed, and partially rendered, with no obvious cracks, gaps or crevices. The gable end is pointed and sealed. Fascia boardinf and soffits are close fitting.

Roof slates are in good condition with no lifted, slipped or missing slates present. The garage roof is exposed to the interior.

The building can be considered to offer negligible roosting potential
