## **Method Statement and Reasonable Avoidance Measures**

**Lower Reaps Farm,  
Whinney Lane,  
Mellor,  
BB2 7EL**

**17.09.2026**

**Report prepared by:  
Dave Anderson  
Batworker.com**

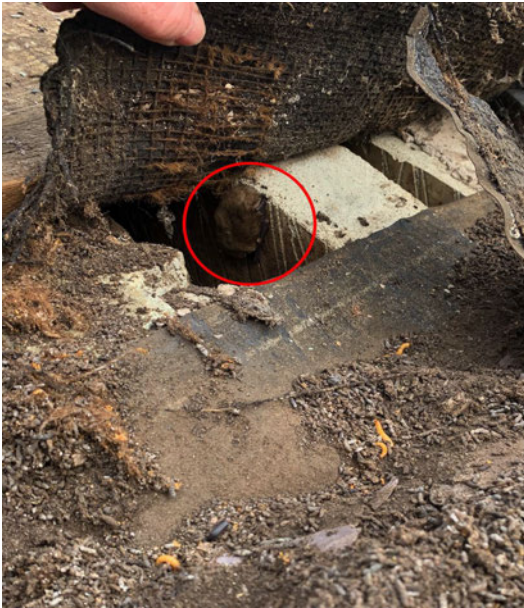
*Pipistrelle bat below roofing felt.*

Bats are likely to be found during day in masonry, between masonry and timbers, under roofing felt/lath, behind fascias (or anything else attached to wall) under ridge tiles.

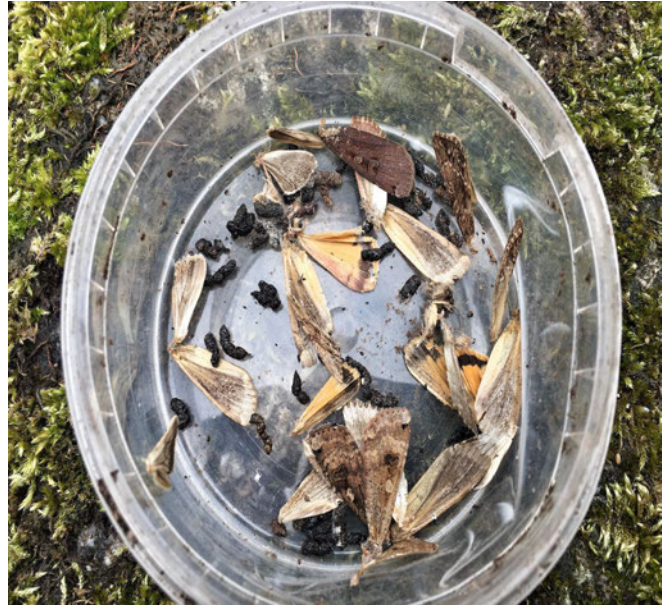
*Feeding remains and bat droppings.*

Look out for bat droppings – dark brown or black, about 4 to 8 mm in length. They look like mouse droppings but crumble easily, as they are made up of insect fragments.
