# Land at Malt Kiln Brow, Chipping, Lancashire

## Heritage Assessment

**Oxford Archaeology North**

August 2015

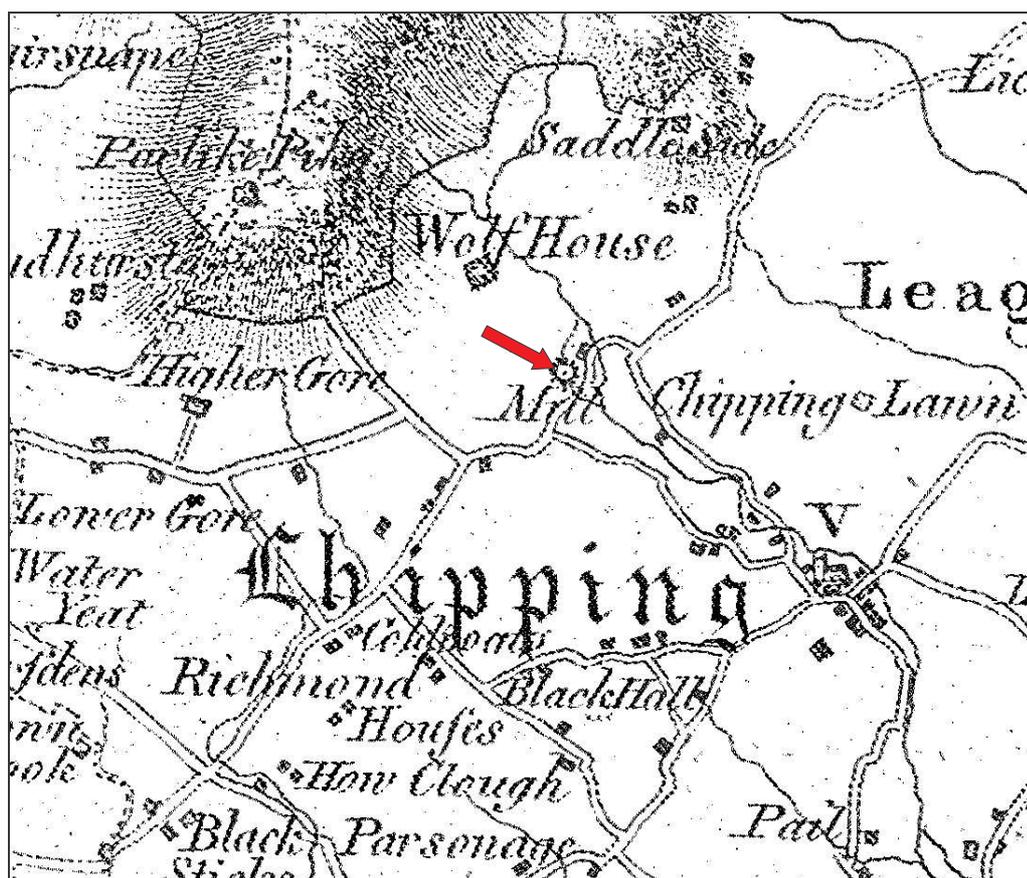
Plate 2: Extract from Yates' map of 1786, with arrow marking the position of the corn mill

- 3.3.2 This mill is marked on William Yates' *Map of the County Palatine of Lancaster* (Plate 2), which was published in 1786, but had been surveyed several years earlier; it is thus likely that Yates recorded the corn mill rather than the cotton mill, even though the latter was in operation by the time that the map was finally published. The detail of Yates' map reinforces the relatively isolated location of the mill, situated beyond the fringe of the late eighteenth-century village

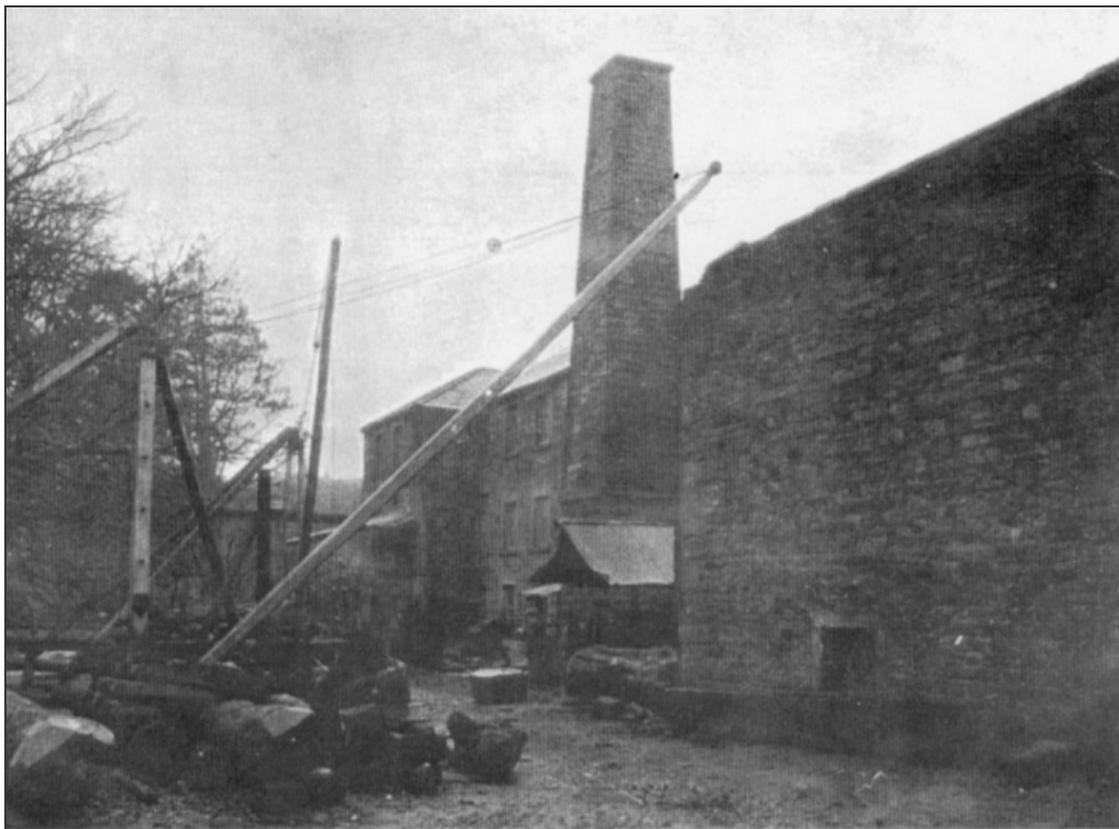
*Plate 5: Kirk Mill in 1924*

- 4.4.2 The wheel house was also extended by approximately 4ft (1.21m) to the north during this phase. The rationale for this remodelling is unclear, although may have been associated with the requirement for an even larger waterwheel. It is possible that this was associated with the installation of a steam engine, which was added to the mill at this time. This would have been a relatively small, vertical beam engine, occupying the bay adjacent to the spinning floors. The engine house was marked by an indicative tall vertical window above a doorway, which was installed in the southern façade of this bay. An associated boiler house would have been required, and this appears to have occupied the ground floor of an extension to the east range, referred to as the south wing. It cannot be determined whether the original boiler house was of a single storey, or the two-storey structure depicted in historic photographs (Plates 5 and 6), with preparation or storage space above.

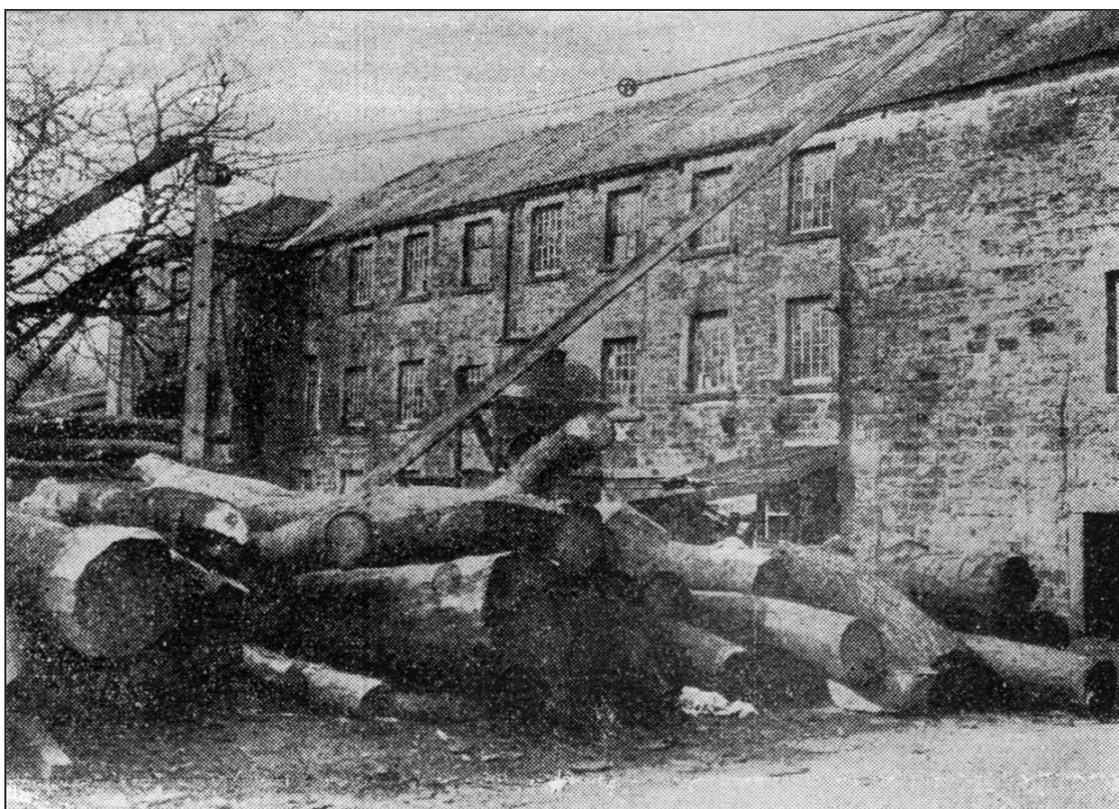
*Plate 6: Kirk Mill in 1933*

- 3.3.16 John Berry, the son of Henry James, joined the family firm following the First World War, and appears to have contributed to the great expansion of the business. It was during this period that the waterwheel was used to generate electricity for lighting in the mill and also the adjacent properties. A view of the mill during this period is provided by a photograph dating to 1924 (Plate 5). This shows part of the main former spinning block, with a tapering square-section chimney abutting the approximate centre of the elevation. An insubstantial structure at the foot of the chimney was presumably intended to provide shelter for workers converting timber into planks. The photograph also shows in the foreground the south wing that was added to the eastern end of the original mill block (*Section 4.4.2 below*). A similar view of the mill is provided by a photograph taken some nine years later, and printed in the *Northern Daily Telegraph* (Plate 6).

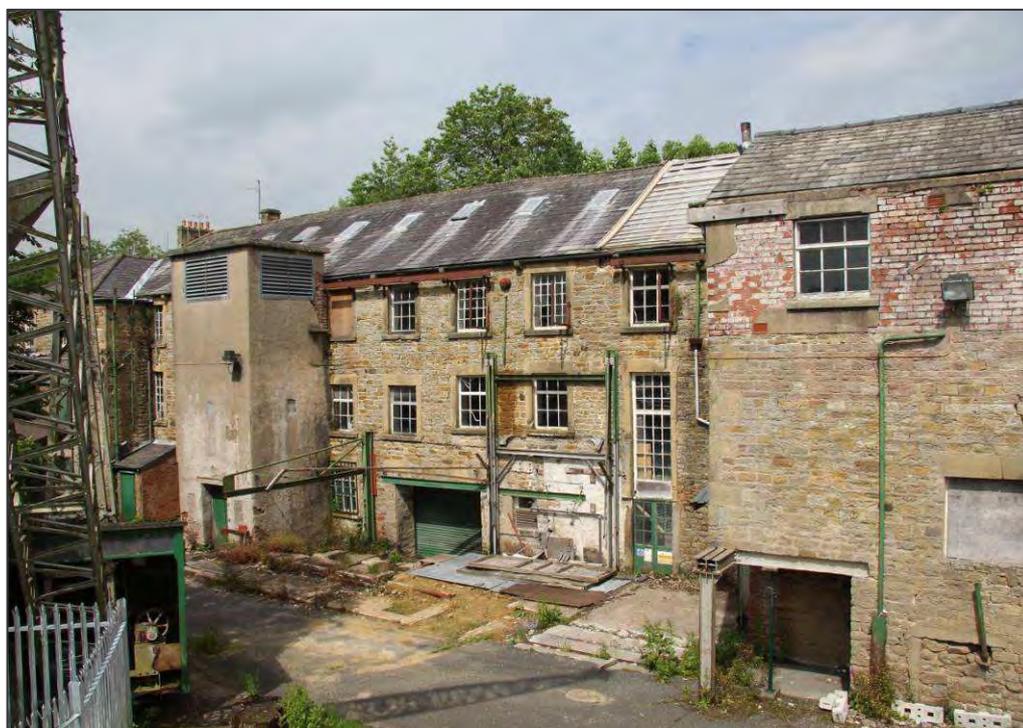
*Plate 7: View of the southern elevation of Kirk Mill*

- 4.1.1 Kirk Mill clearly represents an important multi-phase building, and provides a rare surviving example of a largely intact water-powered textile mill in Lancashire. The extant structure comprises a three-storey, 14-bay rectangular mill, with projecting wings at both ends, and a stair tower against the northern external wall. All external elevations are of roughly dressed and coursed local sandstone rubble (Plate 7), bonded in a pale lime mortar, with dressed quoins to the elevation returns. The earliest extant element of the roof comprised king post trusses, with clasped ridge purlin and sandstone roof tiles, carried on three purlins to each pitch. The roofs over later extensions are carried on queen posts trusses and queen struts.

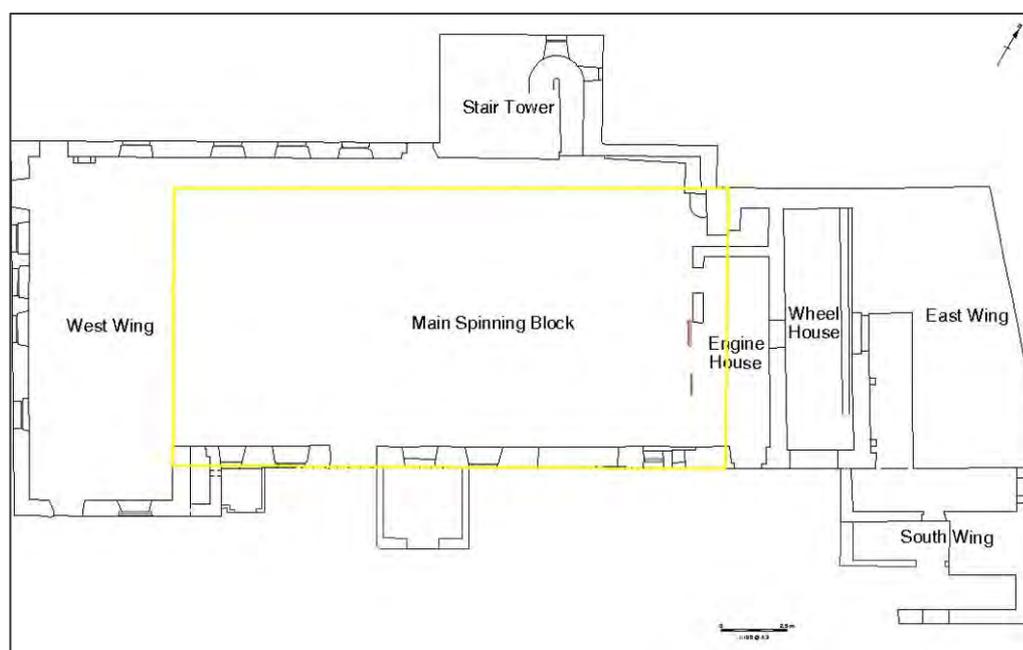
Plate 8: Plan of Kirk Mill, showing the footprint of the Phase 1 'Arkwright-type' mill (marked in yellow)

- 4.2.2 Internally, the mill was originally of non-fireproof construction, and was of a sufficiently narrow width for single large-scantling beams to span the entire floor without recourse to installing supporting columns. Examples of this type of construction rarely survive in a textile mill, as the loading stress almost always produces greater strain on the beams than was acceptable. No evidence survives for the position of access between the floors, although this is likely to have been in the north-west corner of the building.

- 4.2.3 The transmission of power from the waterwheel to the machinery during this initial phase will almost certainly have comprised timber members, driven directly from a pinion wheel on the axle of the waterwheel. There is physical evidence for numerous line shafts within the mill, and whilst the date of these cannot be ascribed with complete confidence, it is likely that deeply gouged scars visible to the north of the centre-line of the mill represent the position of the original shaft.

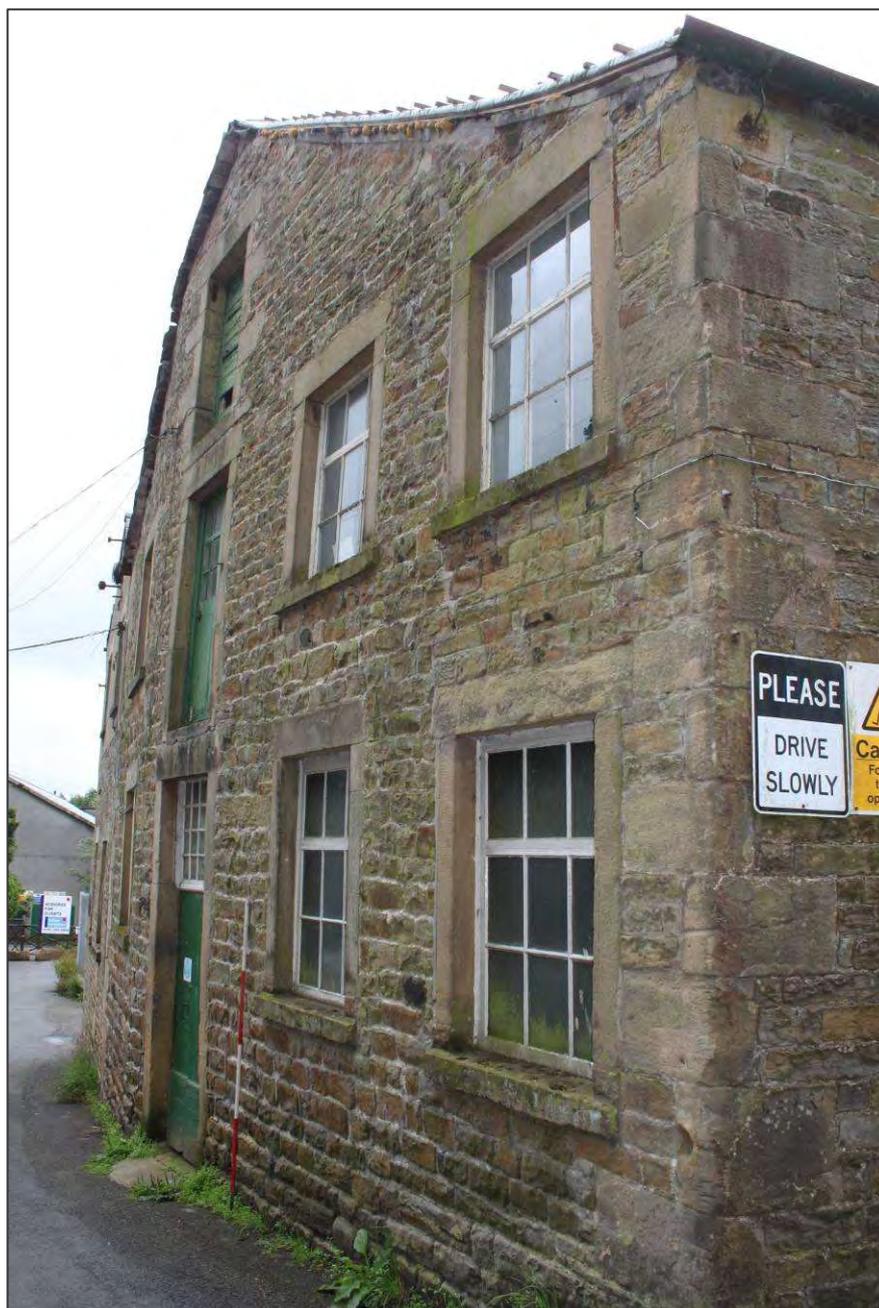
Plate 9: The eastern extension along Malt Kiln Brow

- 4.3.1 The mill changed ownership in the last years of the eighteenth century, and the documentary sources reveal plans for the west extension and a new waterwheel at this time. The new waterwheel was placed within a three-storey wheel house, located in a bay to the east of the original waterwheel. It seems probable that the original waterwheel was removed once its replacement was operational, and the original east wall of the mill was removed, extending it from eight to nine bays in length. The eastern extension of the building, along the angle of Malt Kiln Brow (Plate 9), also probably dates from this phase. The style of construction and apparent original fenestration suggest an early nineteenth-century date.

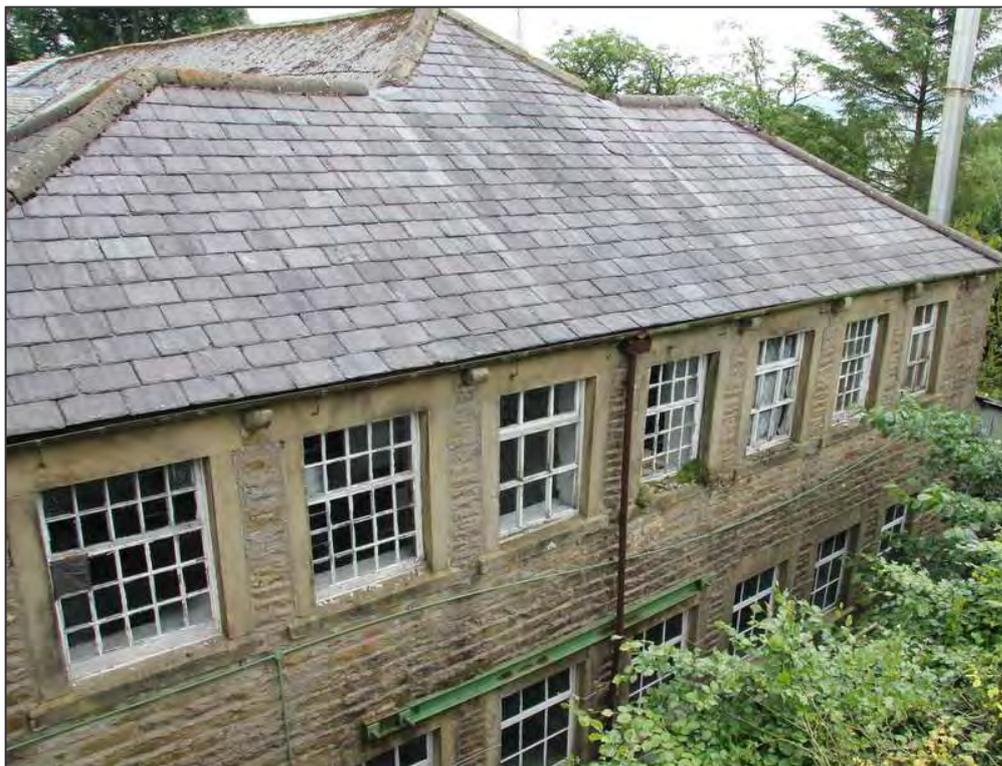
Plate 10: External west elevation of the west wing

- 4.3.2 Another significant addition to the mill during this phase was the western extension (Plate 10). This was in the form of a cross wing, and originally extended beyond both the front and north facades of the earlier structure (Plate 11). It was of more ordered coursed rubble construction, with dressed quoins to the elevation returns, and projecting convex corbels at eaves height, carrying the moulded gutters. At its south-eastern corner, the west wing was butted by a small rectangular privy tower.

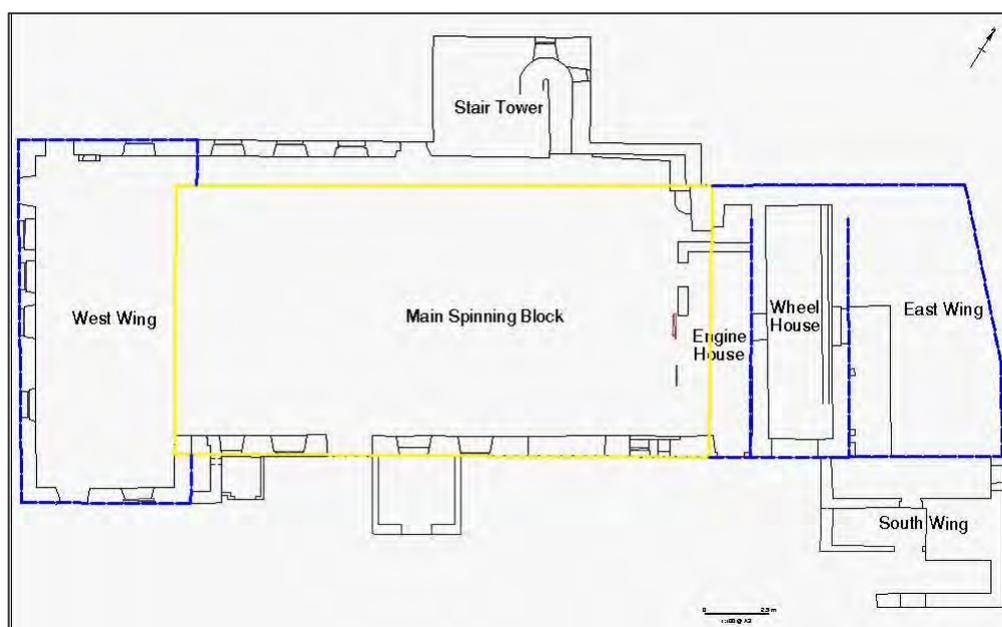
Plate 11: Plan of Kirk Mill, showing the footprint of the Phase 2 extensions to the buildings (marked in blue)

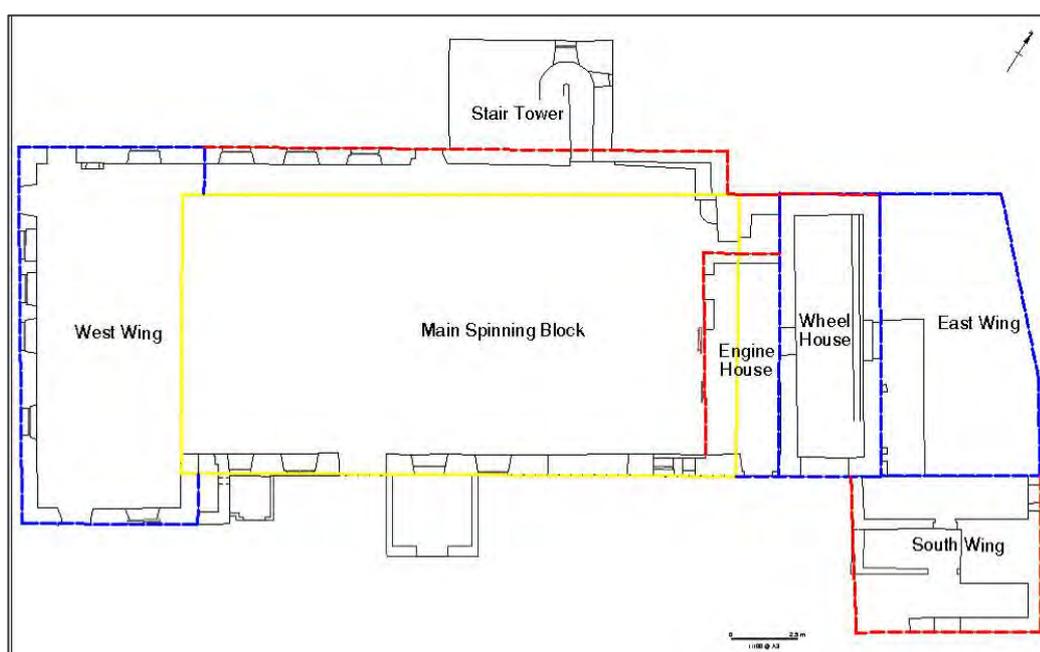
Plate 12: Plan of Kirk Mill, showing the footprint of the Phase 3 extensions to the buildings (marked in red)

- 4.4.1 Significant internal remodelling of the mill, coupled with external alterations on the northern side of the building, were carried out during the early nineteenth century (Plate 12). This involved repositioning the north wall of the mill by approximately 12ft (3.66m) to the north, which undoubtedly represented a significant structural challenge. The new northern bay of the mill block was built with its own pitched roof, obviating the need to replace the whole roof structure. This new roof was parallel to that of the earlier structure, and presumably draining through the parapet wall at either end. This alteration may have been carried out during Phase 2, although it certainly followed the addition of the west wing.

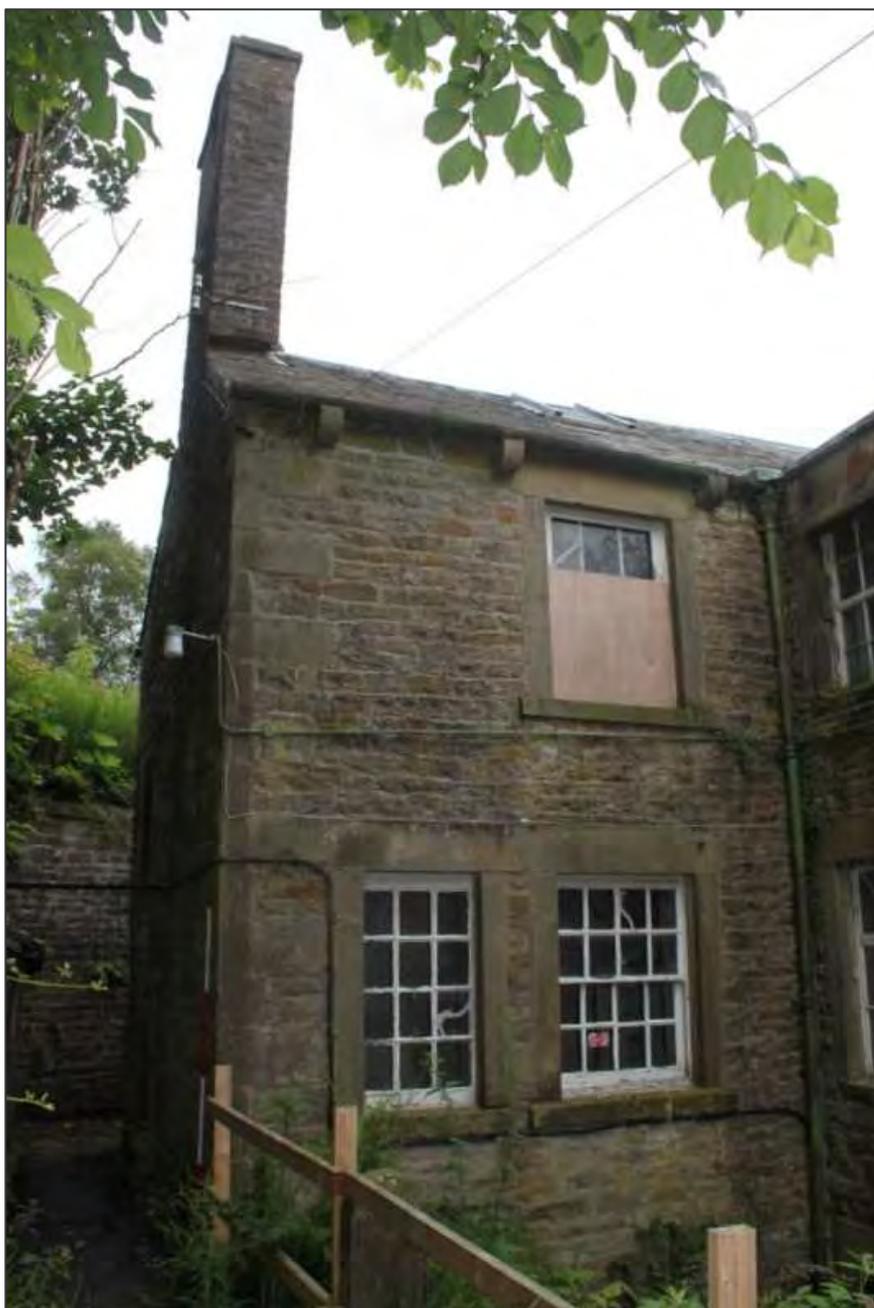
Plate 13: The west elevation of the tower, showing the bell cote

- 4.5.1 A rectangular stair tower appears to have been added to the northern side of the mill at this date. The north wall of the stair tower was capped with a simple bell cote, with over-sailing sandstone copings (Plate 13). It is not clear precisely when this tower was added, although its position was captured by the Ordnance Survey plan in 1844. The tower was somewhat larger than required for simply housing a stair, and also contained offices at first- and second-floor levels. Gas lighting was apparently also installed around this time, with the mill having its own gas retort, although no evidence for this structure survives above ground level, and its position remains unclear. Similarly, no internal evidence for gas lighting is clearly visible.

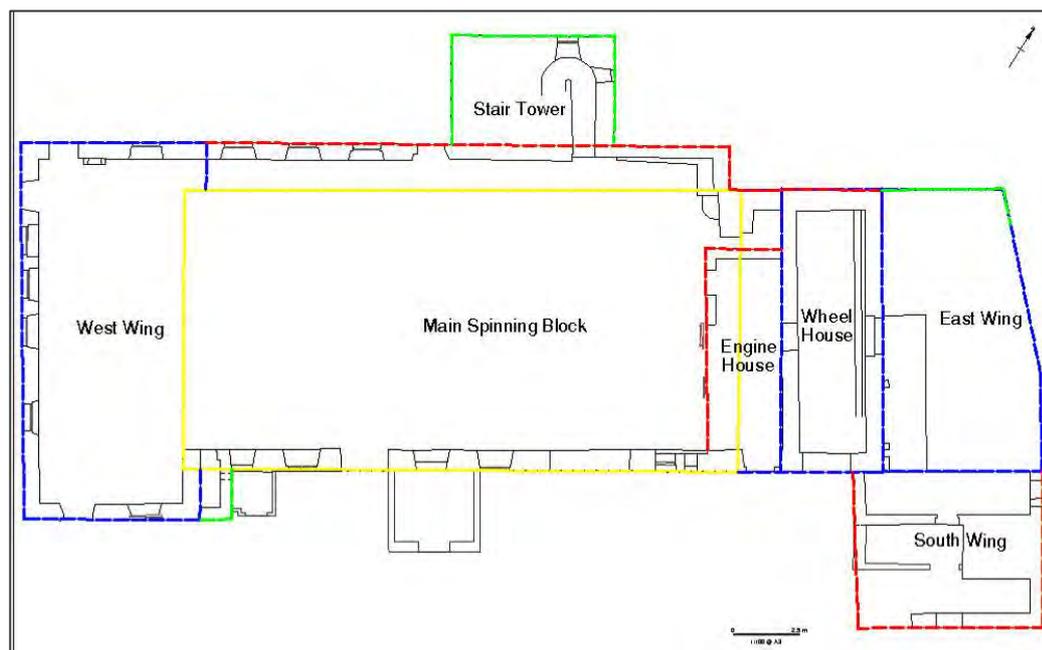
Plate 14: Plan of Kirk Mill, showing the footprint of the Phase 3 extensions to the buildings (marked in green)

- 4.5.2 It is unclear whether the repositioning of the north wall of the east range (Plate 14) was undertaken concurrently with the construction of the stair tower, or the southern extension to the east wing during the previous phase. Rather than replace the northern pitch of the roof, or add an additional roof, as with the expansion of the main mill, sprockets were added to the rafters of the north pitch, lessening the angle of its base, and extending it beyond the repositioned wall. This large-scale undertaking, for a minimal gain in floor space, is likely to have been prompted by an apparent change of use of the eastern extension to form the main office for the complex. Moving the wall allowed for extra windows to be inserted, and a large fireplace was also built into the new wall.

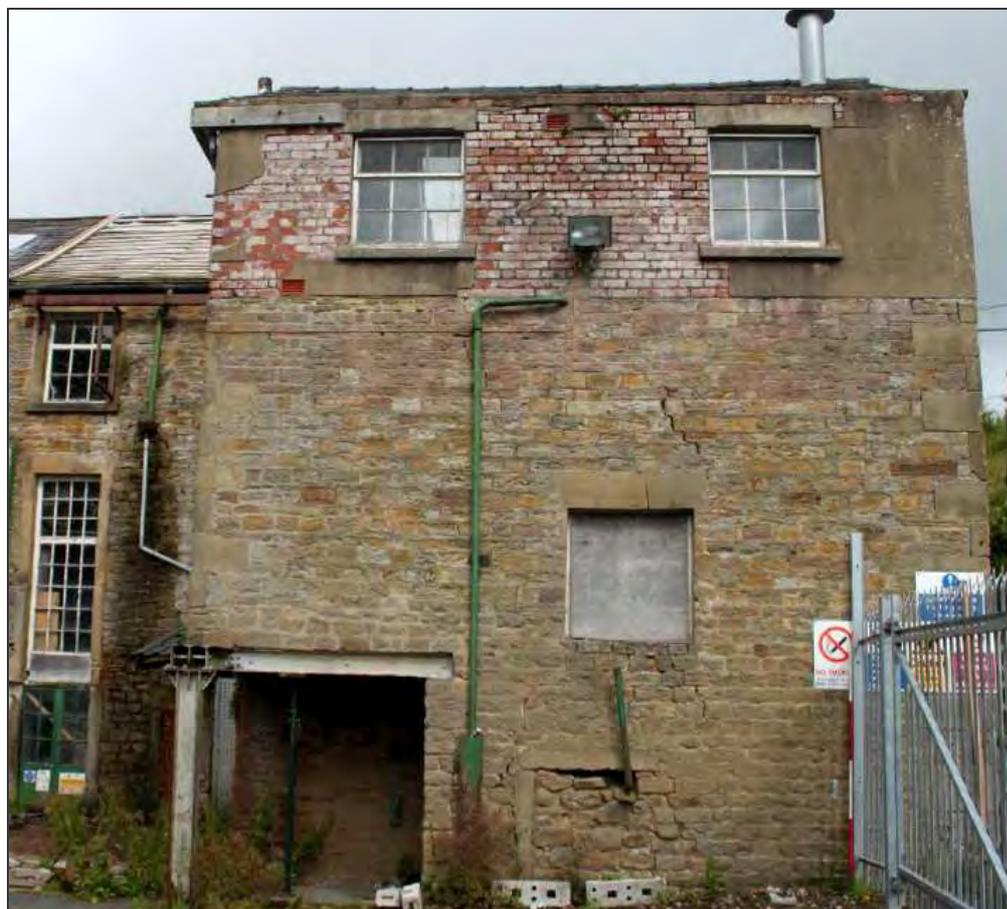
*Plate 15: The remodelled southern extension to the main mill block*

- 4.7.1 Several additions were made to the structure of the mill sometime after 1933. Most notable amongst these alterations was the addition of an upper floor to the southern extension. This addition was completed in brick, and incorporated two six-light windows. This remodelling also seemingly included the removal of the south-western corner of the building at ground-floor level (Plate 15).

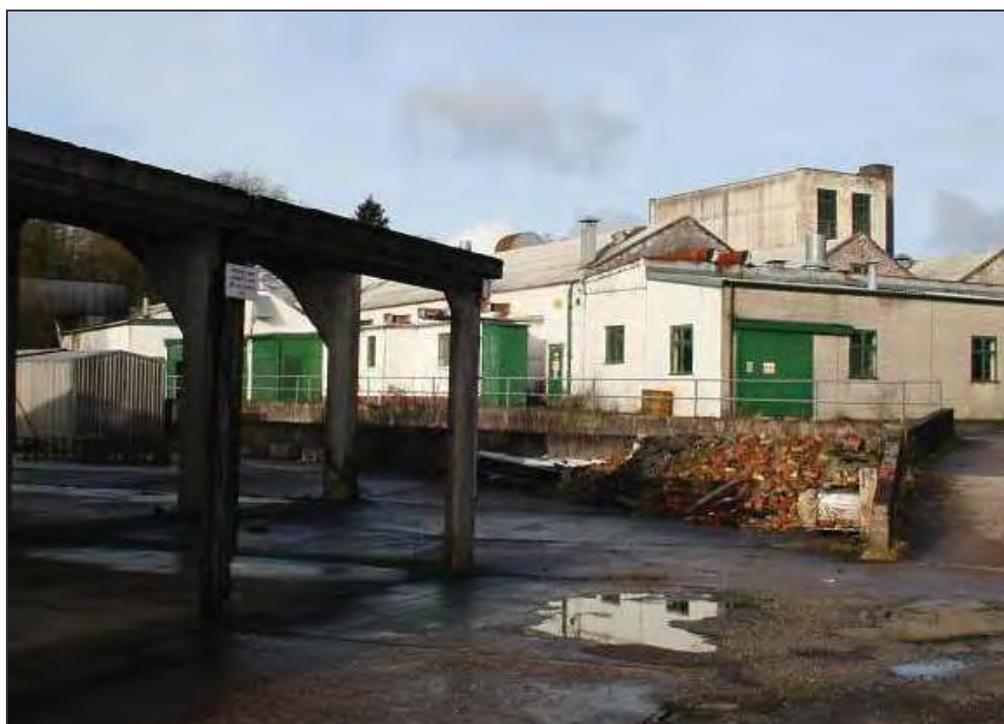
*Plate 17: View across the modern factory*

- 5.3.3 These factory buildings were developed by HJ Berry & Sons to enable an expansion of their chair-manufacturing business (Plate 17). The site comprises four principle elements: a nineteenth-century barn; the Windsor building; the main factory buildings; and a storage warehouse. It also comprises swathes of hard-standing, and an open-sided structure that was used as a timber store.

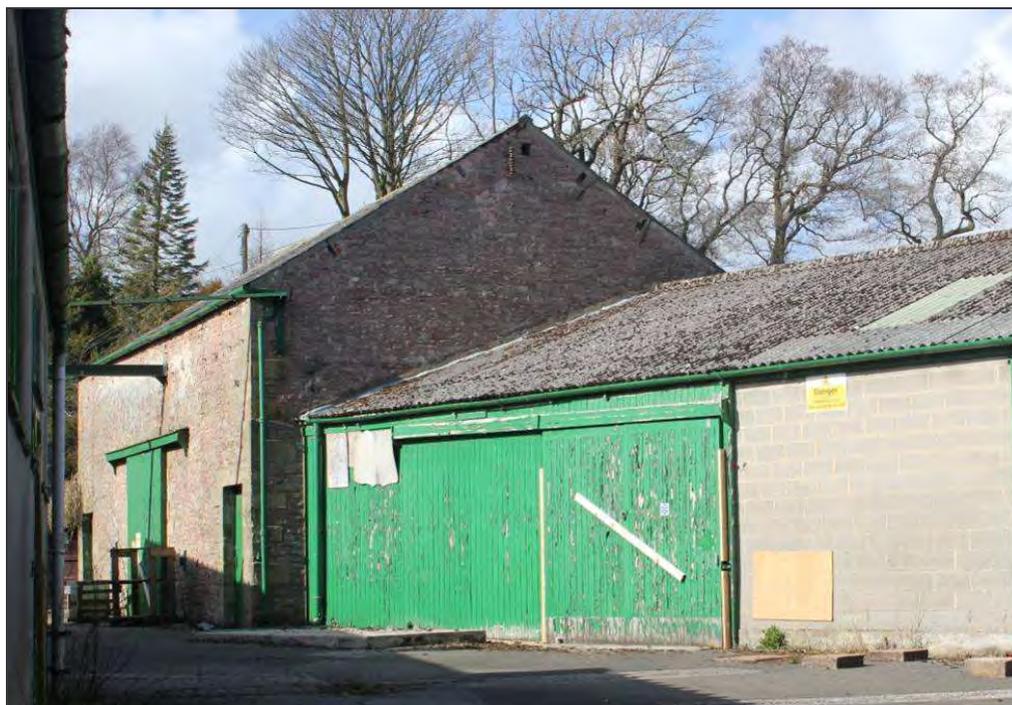
*Plate 18: View of the stone barn in the northern part of the Main Mills complex*

- 5.3.4 The barn, which appears on the Ordnance Survey map of 1893 (Fig 4), is of coursed stone rubble construction with quoins in each corner and a pitched slate-covered roof (Plate 18). The barn has a traditional rectangular plan form, with the principal entrance set in the long west-facing elevation. The tall entrance, set in the centre of the elevation, has a quoined stone surround, and is flanked by two pedestrian entrances at each end of the elevation; these also have quoined stone surrounds. Internally, the barn contains a timber mezzanine floor, although access is from a fixed metal ladder, implying that the mezzanine was used for temporary purposes only. The barn is abutted by a single-storey extension, which is of a mid-twentieth-century date. This is of cinder block construction, with an asbestos roof and a large sliding door in the north-western corner.

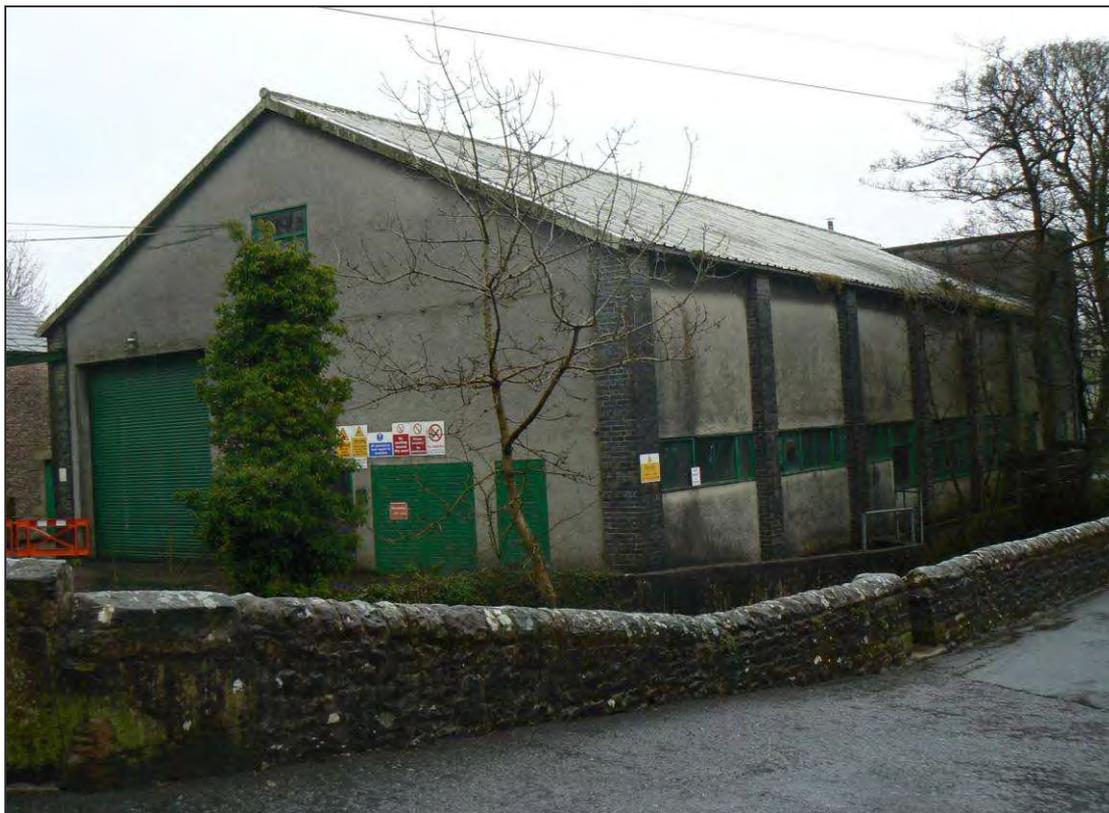
*Plate 19: The Windsor building*

- 5.3.5 The Windsor building lies opposite to the stone barn, on the eastern bank of the Chipping Brook, and comprises two floors of brick and block-work construction with a pitched asbestos roof. The footprint of this building is marked on the Ordnance Survey map of 1912, suggesting that it may have existed as an open-sided structure at that date. This appears to have been infilled with block-work subsequently, and windows inserted (Plate 19). The building will be demolished as part of the development proposals.

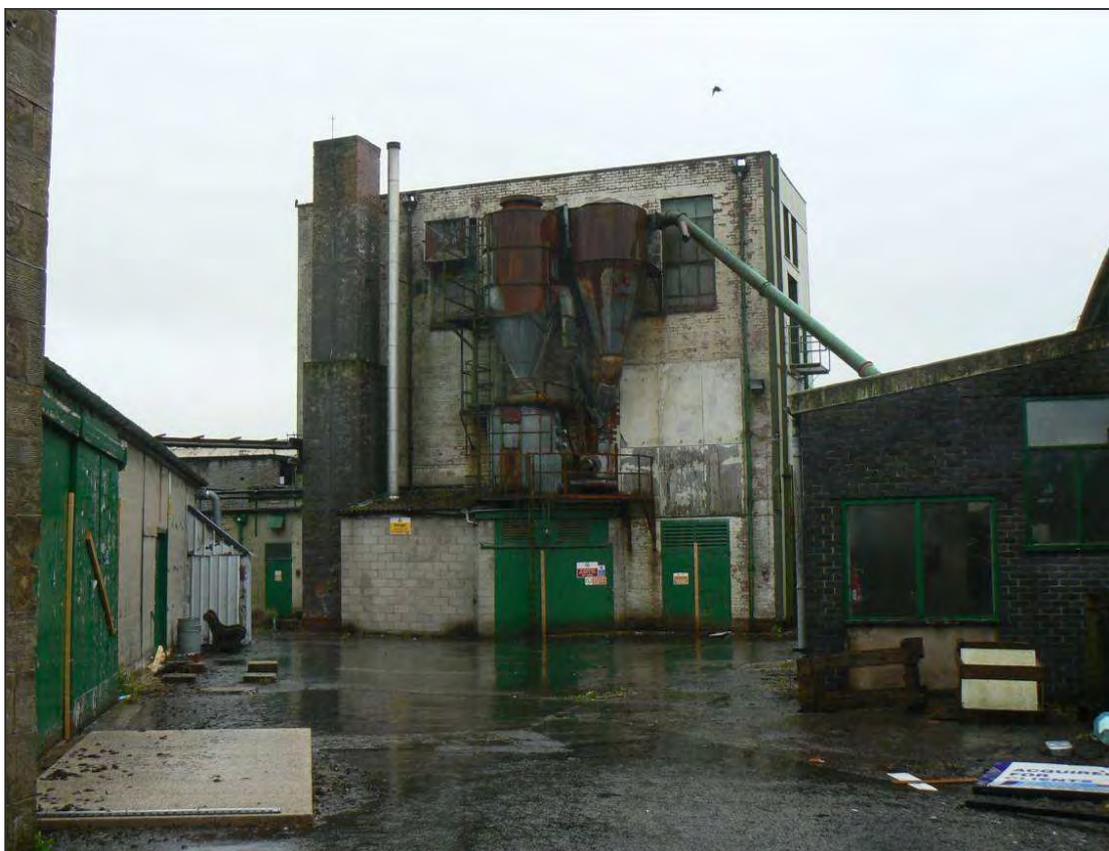
*Plate 20: The factory buildings*

- 5.3.6 The main factory sits to the south and is mainly single storey. It has a two-storey office building on its front elevation, with several ancillary buildings of brick construction to the rear. There is also a large tower section at the northern elevation, previously used to house machinery (Plate 20).

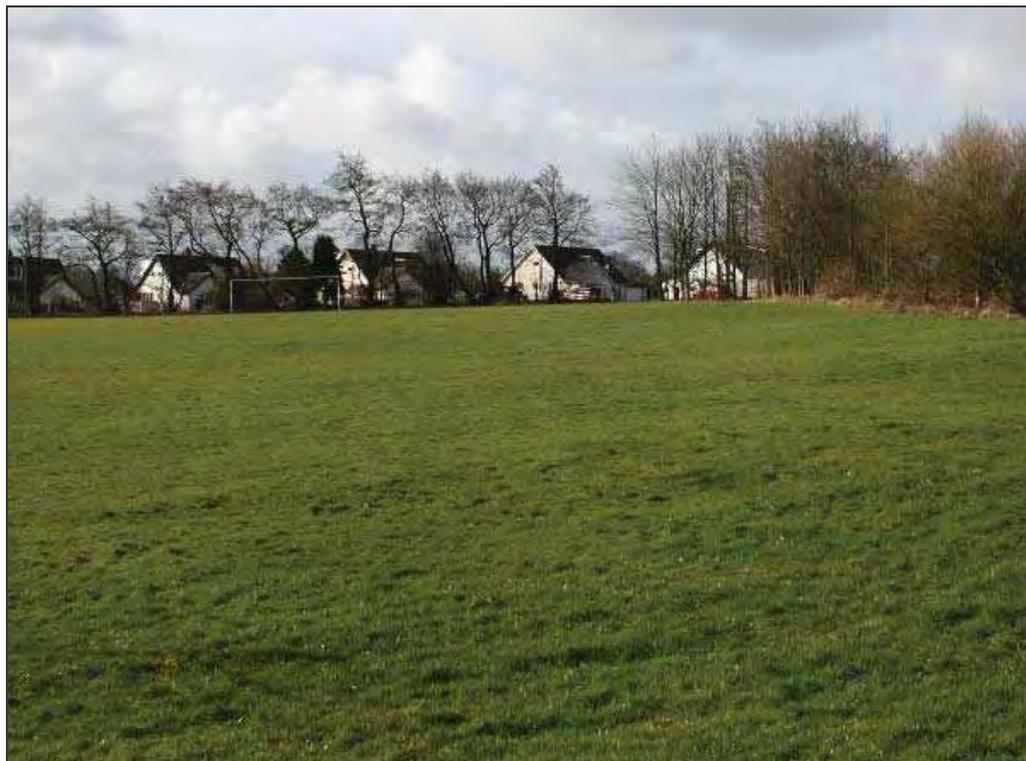
*Plate 21: View across The Hive*

- 5.4.1 This area is situated to the south-west of Malt Kiln Cottage and the wider Kirk Mills complex. It extends to approximately 1.82 ha, and comprises a largely open area of land (Plate 21), which is currently used as a cricket ground with a small pavilion towards the southern boundary. Land in the eastern part of this plot was planted with trees to provide some of the raw materials required for manufacturing chairs. The Hive lies between the Chipping and the Kirk Mill Conservation Areas, but is outside their boundaries. There are no known sites of archaeological interest in this area (Fig 2).

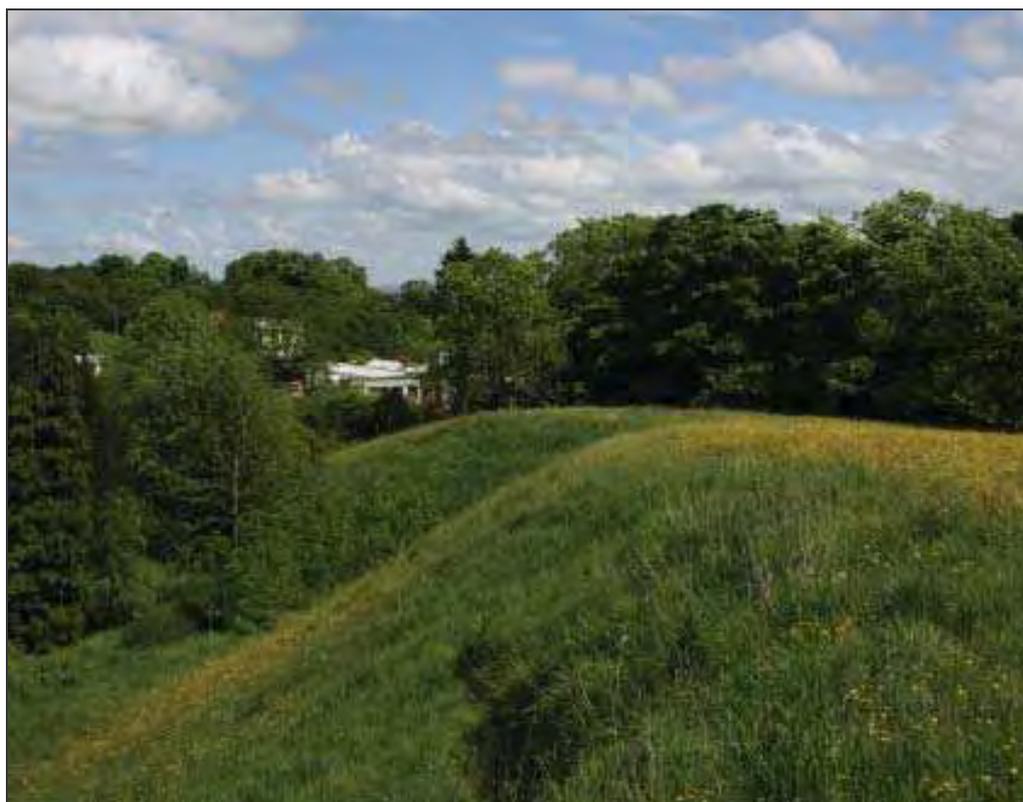
*Plate 22: Land to the rear of Malt Kiln House*

- 5.5.1 Malt Kiln House occupies a corner plot accessed from Malt Kiln Brow. It is a detached stone cottage, which has a small garden area to the front, overlooking the Main Mill complex (Area 2). The land to the west of Malt Kiln House rises up to join land to the rear of The Grove, and extends to approximately 0.81 hectare (Plate 22). This area lies astride the southern boundary of the Kirk Mill Conservation Area. There are no known sites of archaeological interest in this area (Fig 2), although any future design proposals will need to consider potential impacts of the character of the Conservation Area.

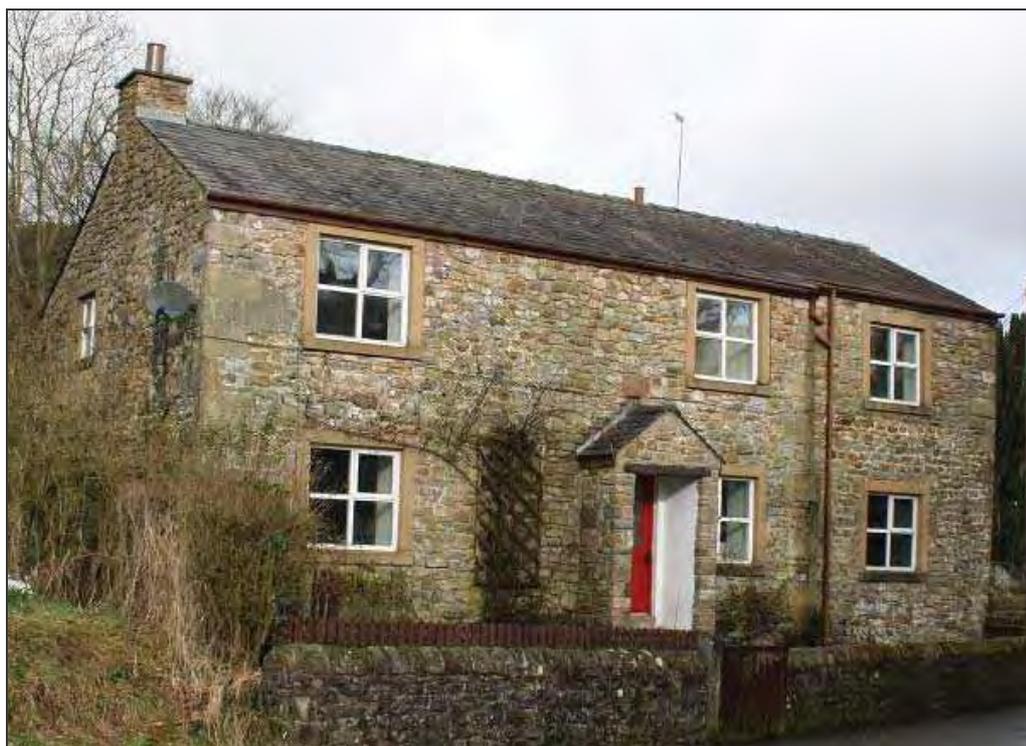
*Plate 23: Malt Kiln House*

- 5.5.2 The Ordnance Survey map of 1847 shows Malt Kiln House (annotated as Moat Kiln House) to have been established in the north-eastern corner of this area. The remainder of the area is depicted as entirely undeveloped (Fig 3). The same layout is shown on subsequent editions of Ordnance Survey mapping, published in 1893 (Fig 4), 1912 (Fig 5) and 1932.
- 5.5.3 Malt Kiln House comprises a two-storey cottage of random sandstone rubble construction and pitched roof (Plate 23). Until 2010, it formed part of the trading premises of HG Berry & Sons.

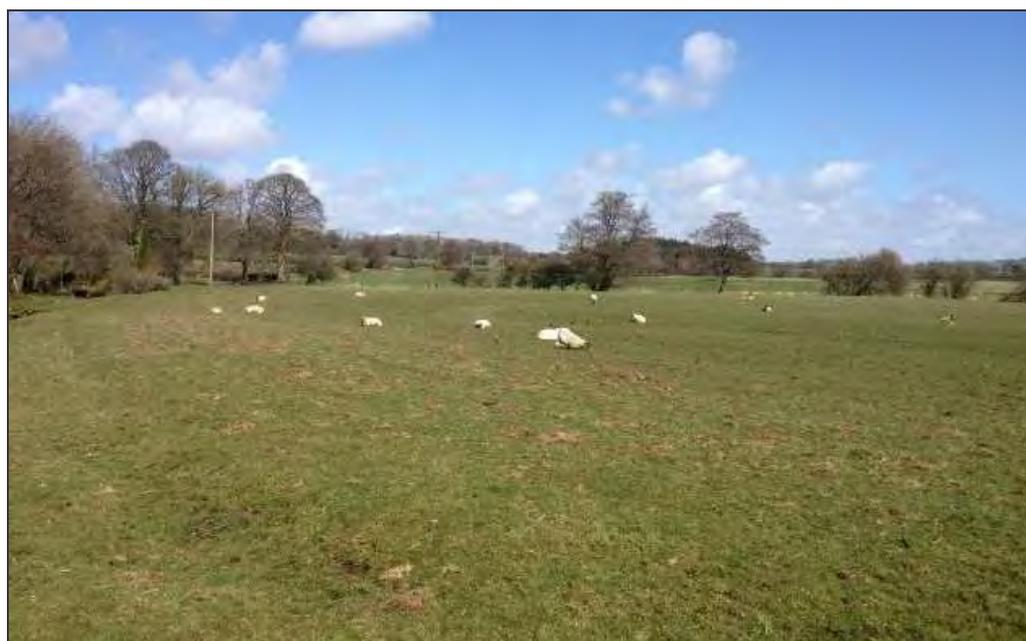
*Plate 24: View across the site of the proposed new cricket pitch*

- 5.6.1 The new cricket pitch lies to the south-east of the village centre, beyond the boundary of the Chipping Conservation Area. The sequence of historical mapping shows this area as undeveloped enclosed farmland on the eastern bank of the Chipping Brook (Figs 3-5), which characterises its present use (Plate 24). There are no known sites of archaeological interest in this area (Fig 2).
