# Land at Malt Kiln Brow, Chipping, Lancashire

## Heritage Assessment

**Oxford Archaeology North**

August 2015

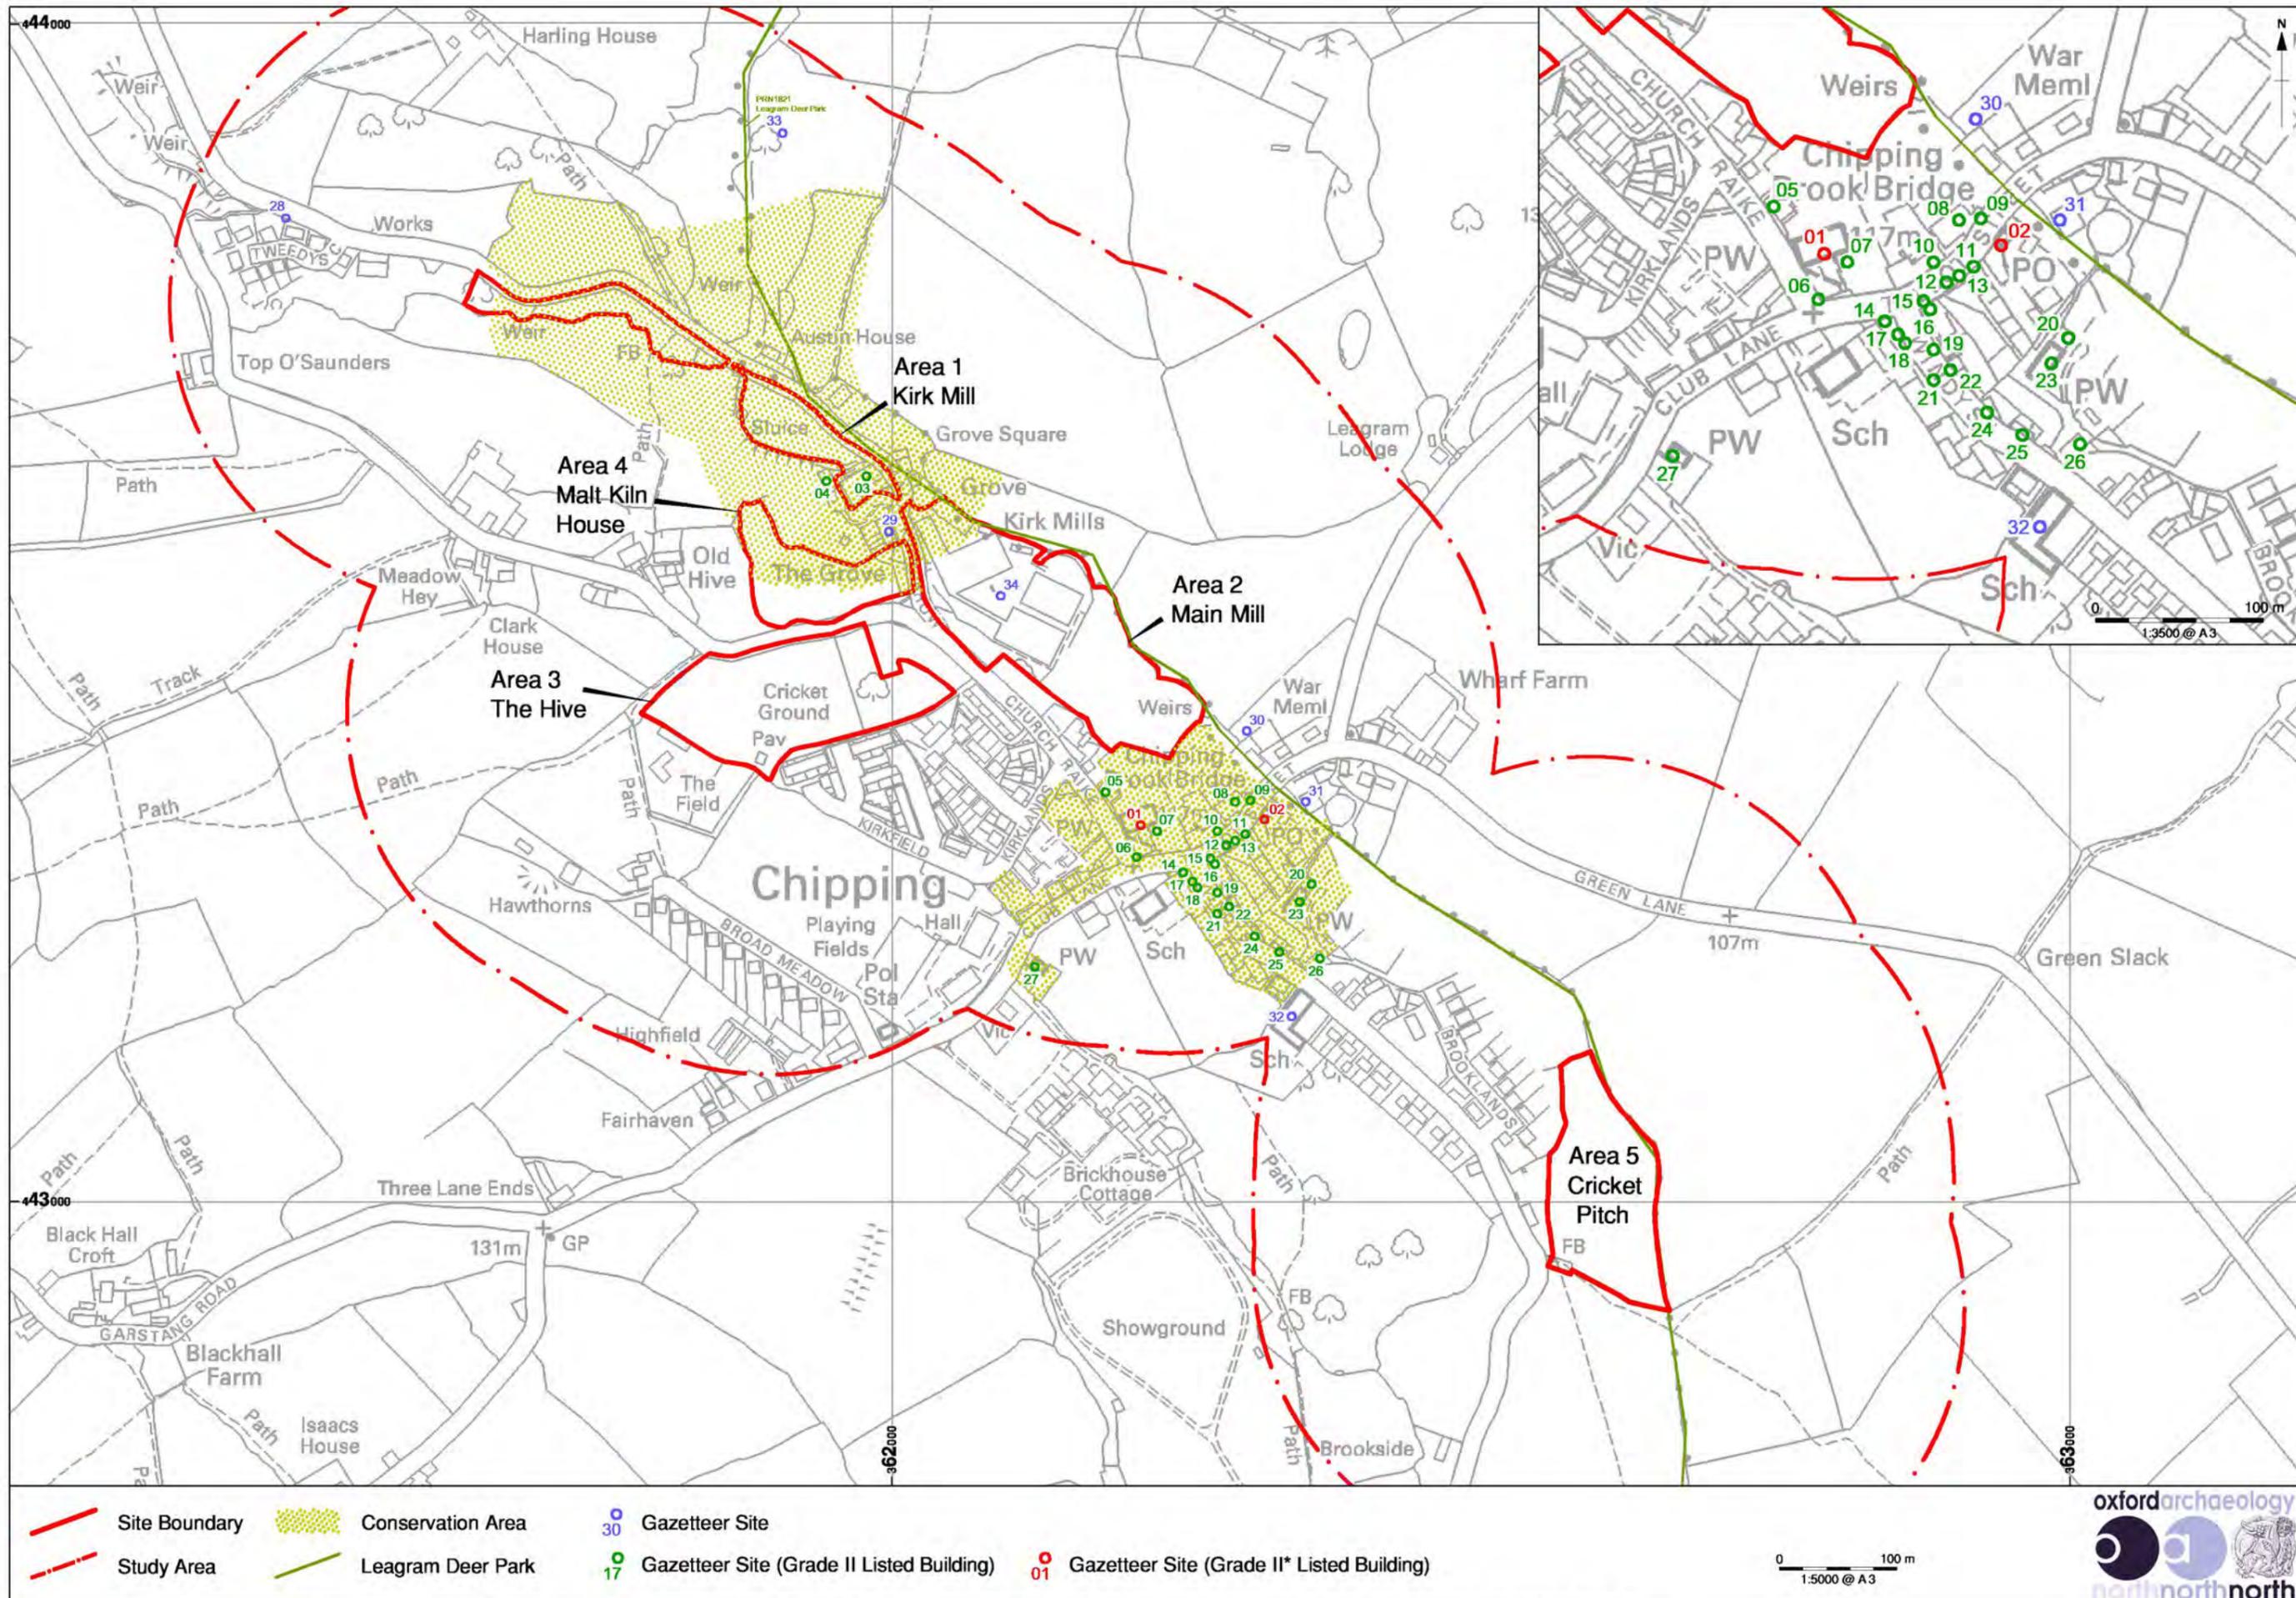
Figure 2: Plan of proposed development areas, showing sites of known archaeological interest
