HERITAGE STATEMENT

**IN SUPPORT OF A PLANNING APPLICATION TO
CONVERT TWO BARNS TO THREE DWELLINGS**

**LITTLE DUDLANDS FARM,
RIMINGTON LANE,
RIMINGTON,
LANCS, BB7 4EA**

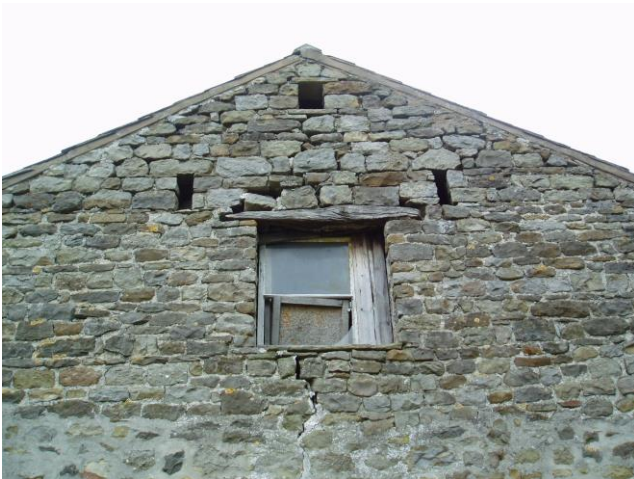
The barns are constructed out of random stone with stone detailing around the openings with evidence of breathing holes in the north barn. Both barns have wagon entrances from the farm yard into the barn. The north barn has a plan square head wagon opening in to a full height storage area. The western gable has breathing holes and an owl hole above a forking hole beneath the ridge. This barn appears to have been constructed in two

Eastern gable north barn

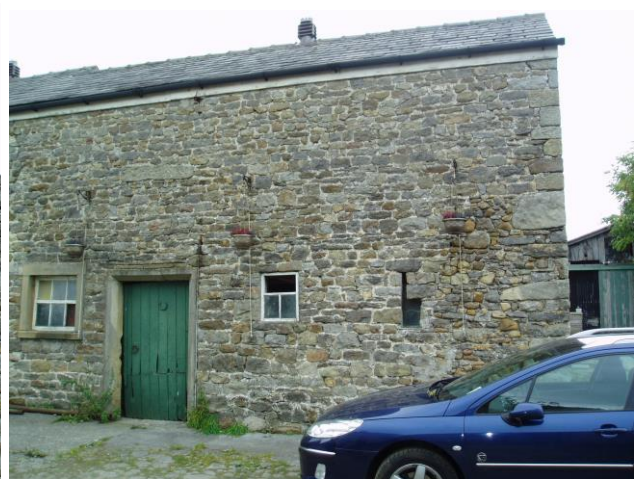
South elevation north barn

demolition of later additions to the barns and the rebuilding of the larger lean-to on the north elevation of the west barn. The removal of the small lean-to brick extension on the south elevation of the north barn will improve the appearance of the building by revealing the original historic fabric.

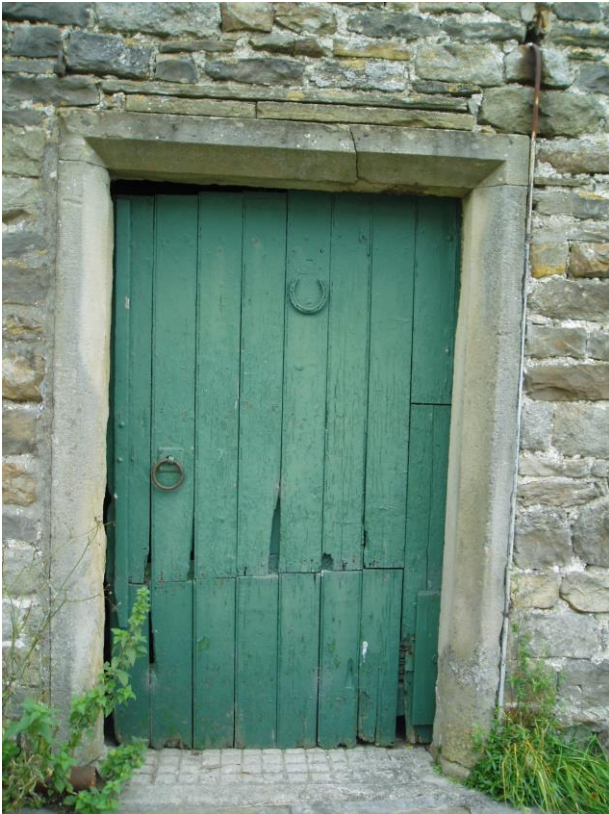
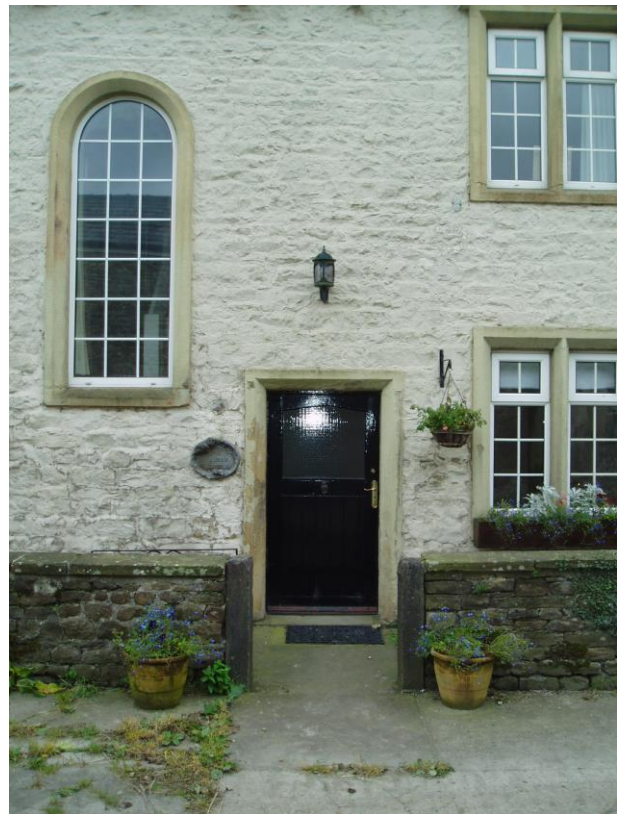
Stable door north barn surround detailing similar to farmhouse door opposite detailing around the farmhouse door opposite. To the right of the stable door are two breathing holes one which has been modified to create small windows. The right hand end

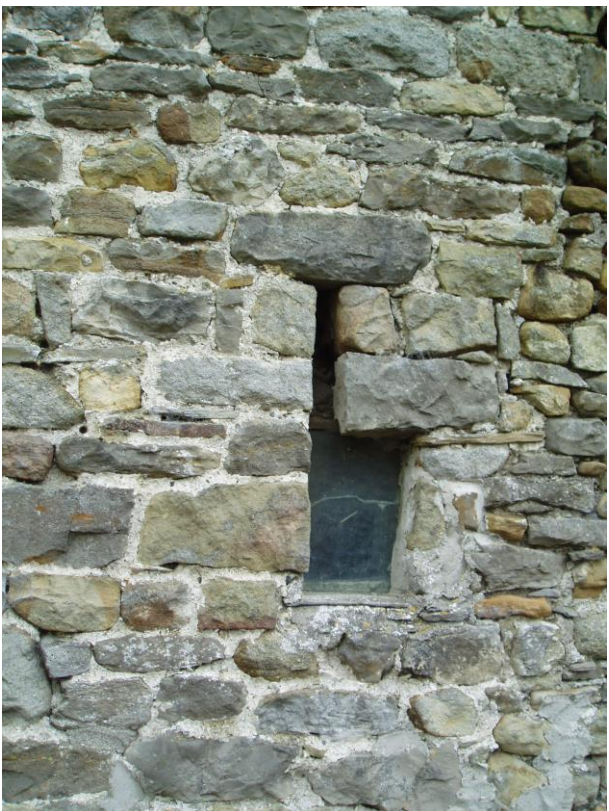
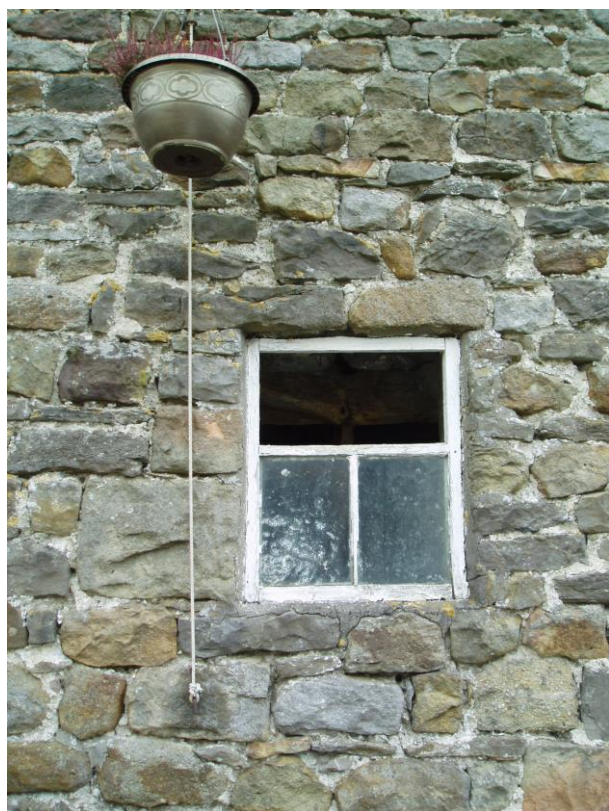
Breathing holes modified to create small windows.

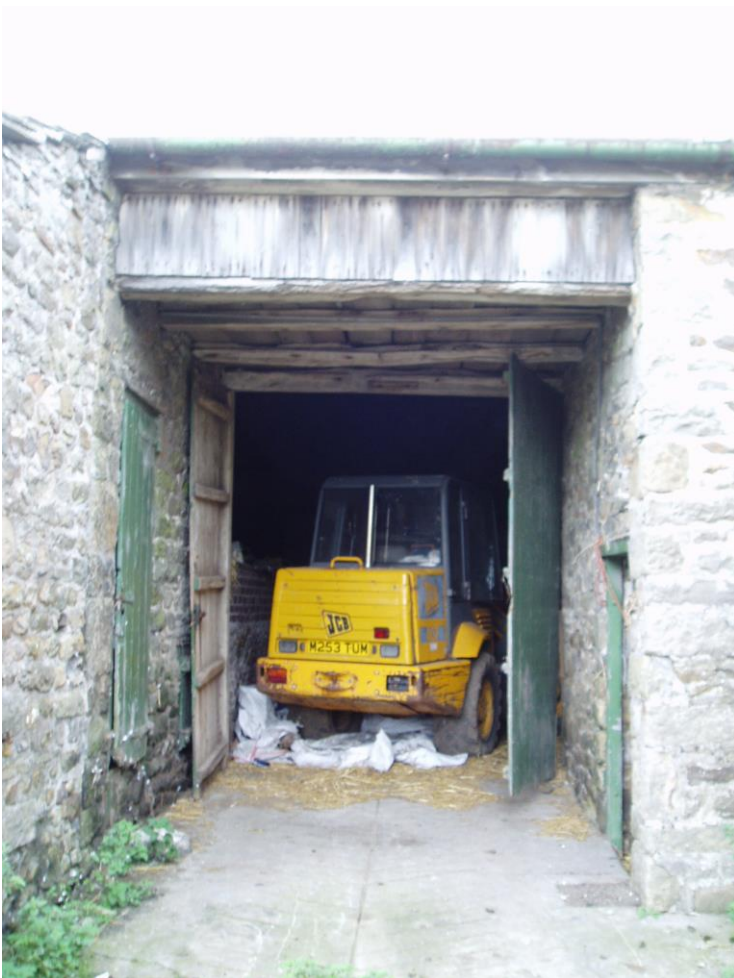
The west barn has wagon entrance in the east elevation into the farm yard with a corresponding door on the western elevation. The east wagon entrance has the barn doors set back beneath a canopy to the right of this entrance is a stable with loft over. To the right is a raised doorway with internal stairs to a harness room and workshop.

West barn wagon entrance

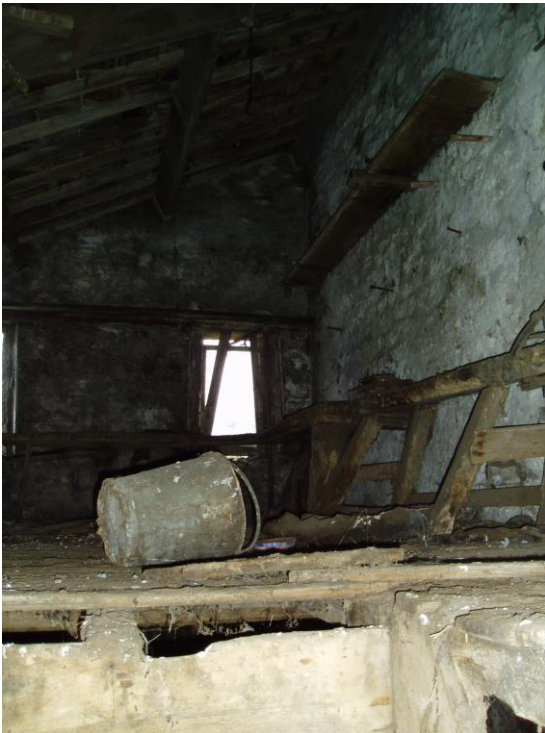
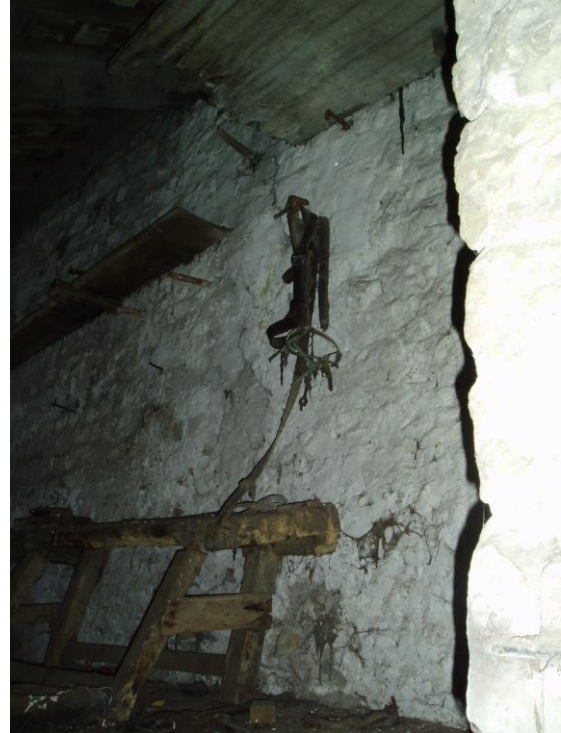
Harness room and workshop

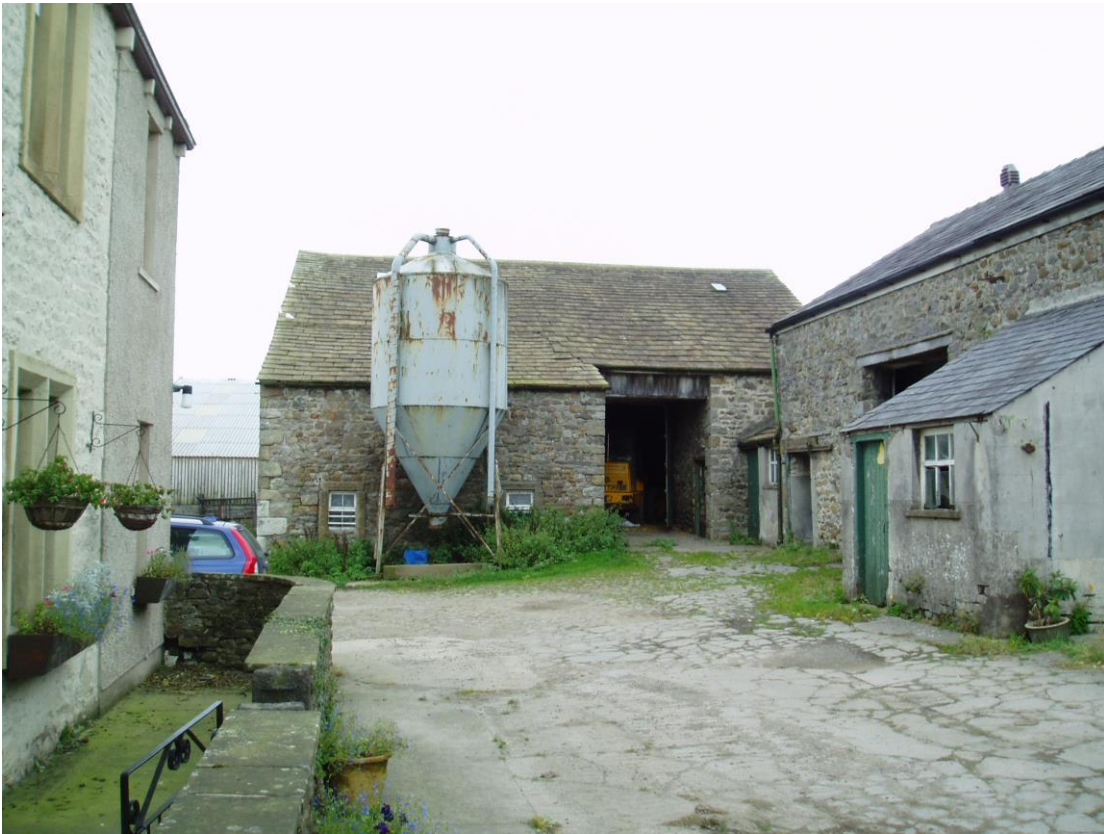
The two barn and the farmhouse stand round a farmyard. This appears to have been originally covered in cobbles. The farmhouse has particularly good stone walls around the garden. At the rear is a low stone wall with flat topped copings. At the front of the farmhouse there is a low stone wall with round coping which dramatically sweeps up at the corners to meet the high stone wall along the gable side garden walls which also forms the back of the domestic outbuildings.

Farmyard facing west

The heritage significance of the building is improved by the reinstatement of the farm yard by the remove of the southern lean to and the domestic garage. The retention and reuse of all the existing openings in the barns, including the wagon entrances, has been the guiding factor in the design of the conversion of the barn using these openings for windows and doors where possible and keeping the introduction of new window openings to a minimum. Any additional alterations by the inclusion of new openings has been kept to a minimum and site to have least impact on the character of the buildings.

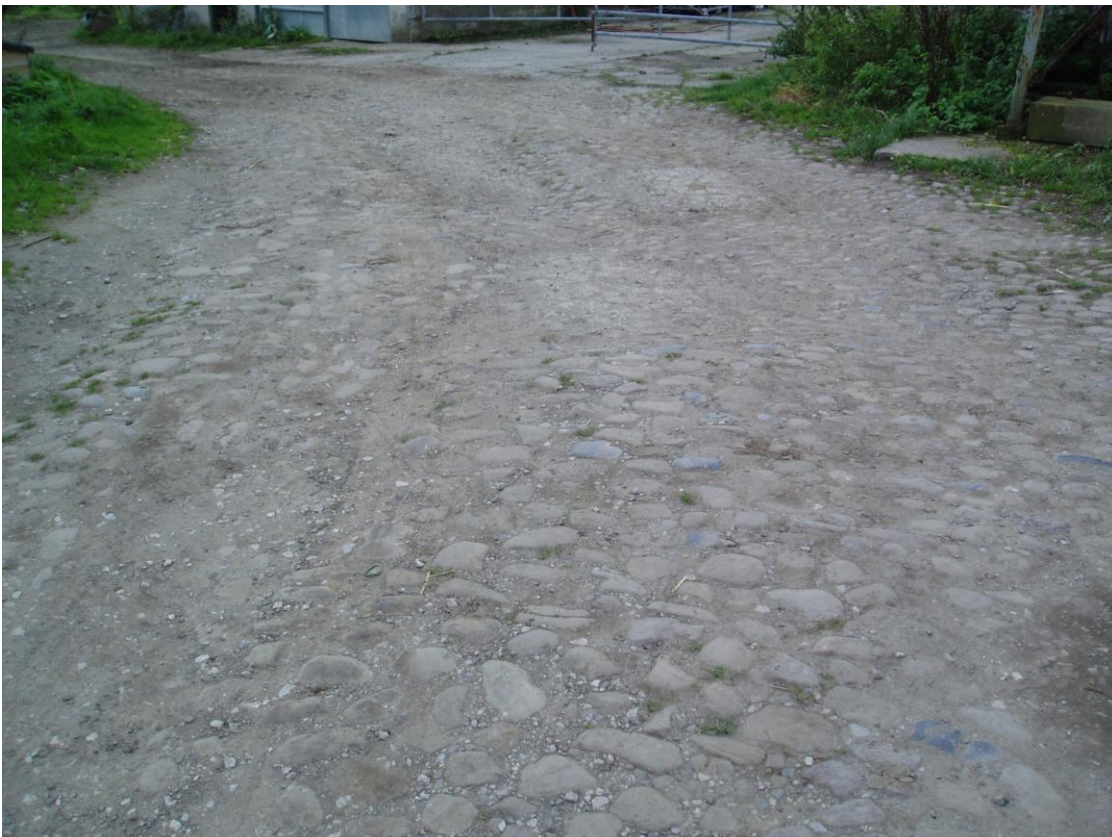
Little Dudlands Farm comprises a farmhouse, a two large detached stone barns, various outbuildings both traditional and modern and a large modern agricultural building. The farmhouse has had a modern two storey extension on the western gable but retains its old outbuildings and garden walls. The front of the farmhouse faces south. The barn to the north of the farmhouse (north barn) faces south and has a wagon entrance into the farm yard. The barn to the west of the farmhouse (west barn) faces east and has a wagon entrance from the farm yard. To the west of these buildings are the majority of the modern farm buildings. To the front of the farmhouse is walled garden area and to the rear a walled flagged area which separates the farmhouse from the farm yard. The farm yard which is surrounded by the farmhouse and the north and west barns has evidenced of

being cobbled with rounded stones. This has been covered and patched with concrete and tarmac.

Cobbled surface of the farm yard

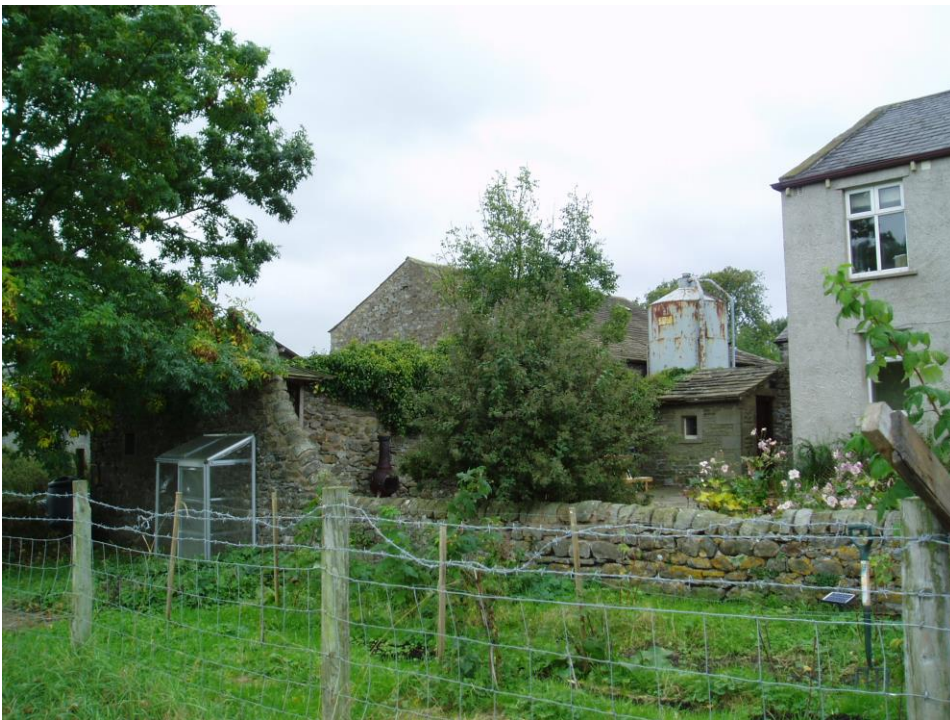
Unusual boundary wall to garden with swept ends.
