Cockshutts Farm Cottage and Farmhouse, School Lane, Simonstone

Heritage Impact Assessment

| Project Ref: | BWH2526-30 |
| Document Ref: | Report No. 2526-30B |

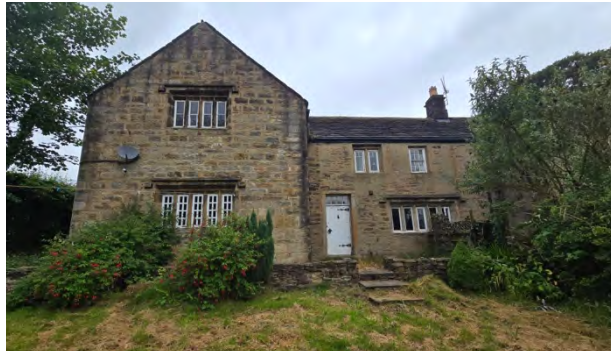
The earliest part of the farmhouse, the central section, has been constructed using coursed slobbered thin sandstone rubble and is topped with a stone slate roof with a chimney in the ridge at the junction of the bays – one at the right gable, and another at the rear corner of the wing. It is noted that the stacks have been rebuilt.

**Figure 2:** Principal south facing elevation of Cockshutts Farmhouse

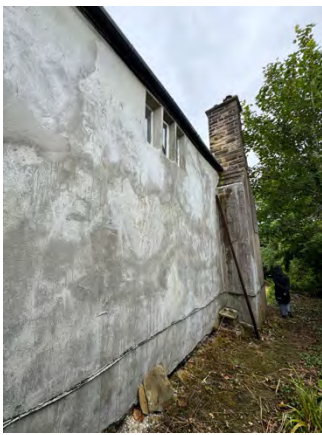
The west facing elevation comprises a subservient side elevation. This elevation, including the external chimney breast has been rendered using inappropriate materials, which is contributing to the prevalence of damp internally. Features of note on this elevation include a five light mullion window at first floor level, the central pane of which is broken, as well as an inserted window at ground floor level.

**Figure 4:** Rendered west facing elevation

It was noted during the site survey that all ground floor rooms are suffering from significant issues relating to damp. It is considered that this has in part been caused by: use of inappropriate render that has been added to the west facing elevation; an area of sloped paving that has been added on the north facing elevation; and lack of adequate ventilation for an appreciable amount of time.

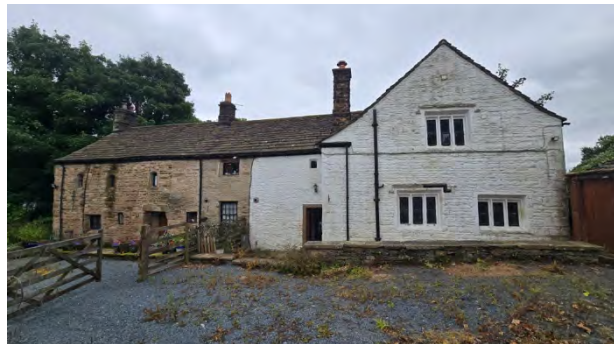
The north facing elevation comprises the rear elevation of the farmhouse. Much like the south facing elevation, the north facing elevation provides views of the earliest part of the farmhouse – the central ‘housebody’ – as well as the gable end of the later projecting cross wing and rear elevation of Cockshutts cottage. Part of the central ‘housebody’, as well as the later projecting cross wing has been painted white. Features of note on this elevation include a doorway at ground floor level, set in a stone surround, above which there is a small picture style window. On the gable end of the projecting cross wing, there are two, three light mullion windows at ground floor level, and one at upper level, the central pane of which is broken. Both sets of windows are feature hood moulds, except the one at ground floor level to the west. It is unclear why this opening is without a hood mould and indeed, why it is slightly ‘dropped’ in comparison to the adjacent eastern opening. It has been suggested that this could be due to historic use of room, or the presence of a former doorway. However, determination of either of these possibilities has largely been precluded by ground treatment which comprises an area of sloped paving. A prominent double line of return quoins to the east of these openings indicate that the projecting cross wing has been extended to the east historically, with the pitch of the roof carried down and a new chimney breast also inserted.

**Figure 3:** Rear elevation

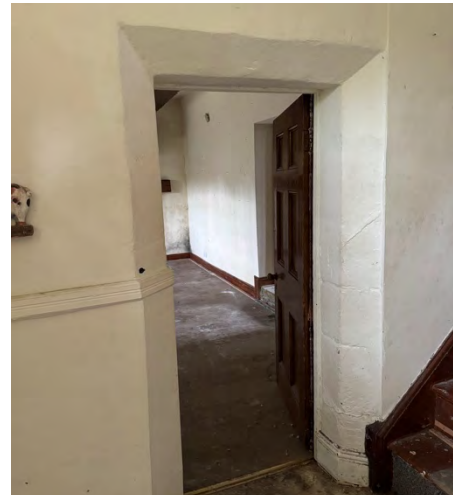
**Figure 10:** View of the chamfered internal doorways on the ground floor

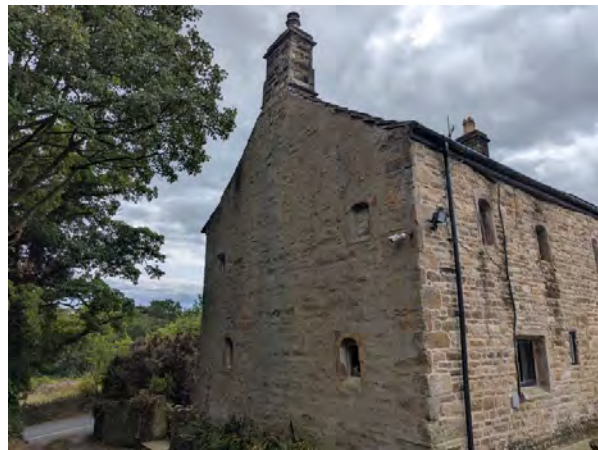
The eastern extension is defined by three deeply chamfered round-headed lights at first-floor level, similar in form to those seen on the other elevations. At ground-floor level, there are two small windows - one with two panes and the other a single fixed light - as well as a wide, shouldered opening leading to a recessed doorway into the through-passage.

Figure 18 View of the east facing elevation

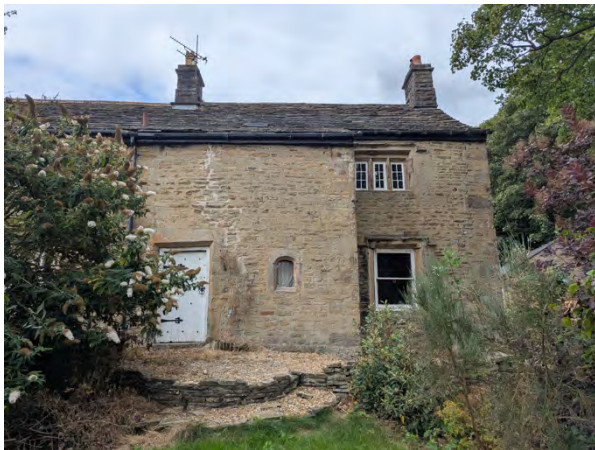
On the central 'housebody', a variety of openings are present, all with black-painted timber frames. At ground-floor level, from right to left, these include: a later sixteen-pane sash window with a black-painted timber frame and replacement header; a small picture-style window, possibly designed to light the area within the firehood; a wide-

shouldered opening to a recessed doorway into the through-passage; another picture-style window; and a larger fixed light. To the left of the wide-shouldered opening, where the picture-style window now sits, there was formerly a doorway providing access into Cockshutts Farm Cottage, though this has since been blocked and replaced by the window. At first-floor level, there are three round-headed lights, alongside a recessed two-light window, now lacking its original mullion.

Figure 19 View of the principal elevation

Alterations are also proposed to all existing windows throughout the Farm Cottage. As previously stated, the existing openings are highly decorative, and feature attractive, recessed cavetto-moulded mullions and hoodmoulds, elements of which have clearly been altered over the years. Although the majority of the existing fenestrations are clearly in serviceable condition, some of the existing frames are in poor condition and contributing to a damp internal environment. Where frames require replacing, these are to be completed using like-for-like in design slim line double glazing units (14mm) in Accoya painted timber. Again, doing so would result in the loss of a small amount of historic fabric, resulting in a minor/moderate negative impact. However, the benefits inherent in improving the buildings overall external envelope as well as its thermal performance should be recognised here.

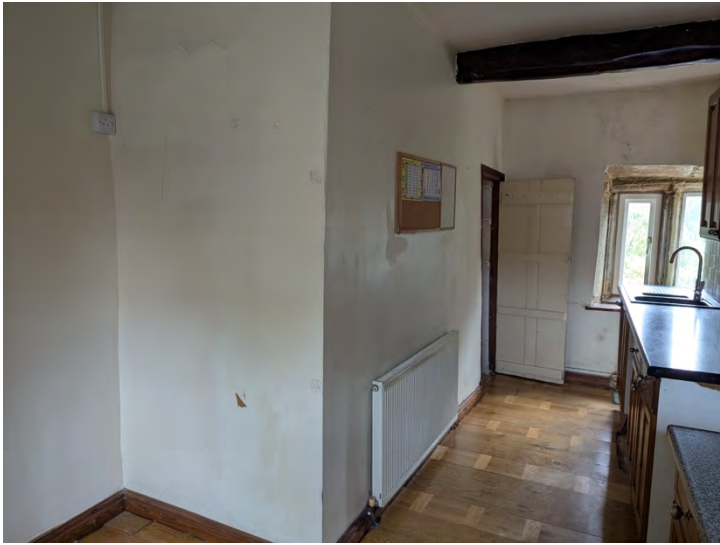
Figure 22 View of the kitchen

The kitchen occupies the eastern end of the central 'housebody', which, as previously noted, formerly comprised the lounge of Cockshutts Farmhouse prior to the internal alterations undertaken in the 2000s. It is considered that the present-day door providing access into the kitchen would originally have served as an external entrance into the housebody, prior to the erection of Cockshutts Farm Cottage, when this wall still formed part of the external elevation. The kitchen is set at a slightly raised level against the north external wall. Two east-west beams supporting the first floor are boxed in, as well as a large axial firehood. The presence of the firehood was identified through light-touch exploratory works carried out under archaeological supervision during the site survey. These works involved the limited careful removal of modern stud partitions and associated plasterwork or paint, with all activity halted once the relevant features had been located. It is recommended that further exploratory investigations, also conducted under archaeological supervision, be undertaken in the future to enhance understanding of the layout and form of the firehood. Such works could be secured by condition, should planning permission be granted.

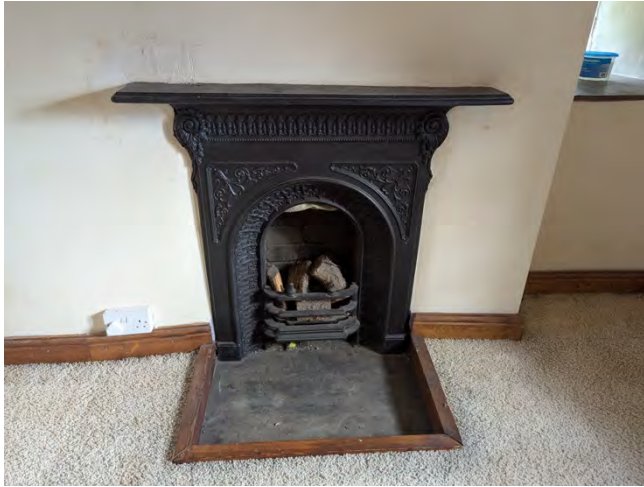
Figure 30 View of the fireplace in the master bedroom

Although the rooms on this floor are relatively plain, with simple decoration such as low skirting, notable surviving features include deep window reveals and an attractive fireplace in the master bedroom. Beyond this, no other elements, including those within the bathrooms, are considered to be of particular historic or architectural interest. During the site survey, it was noted that the ceilings throughout the first floor are very high. It is considered likely that they were inserted at a later date, as the gable walls are plastered within the roof space. Some unevenness in the plaster on the east gable wall suggests possible later rebuilding.

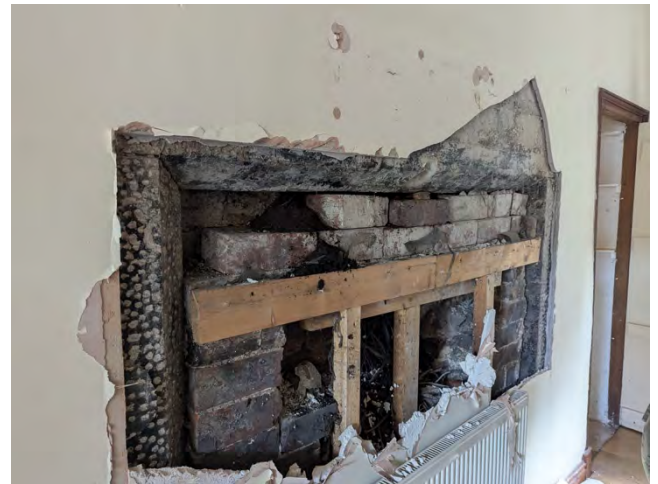
Figure 35 View of the blocked fireplace in the kitchen

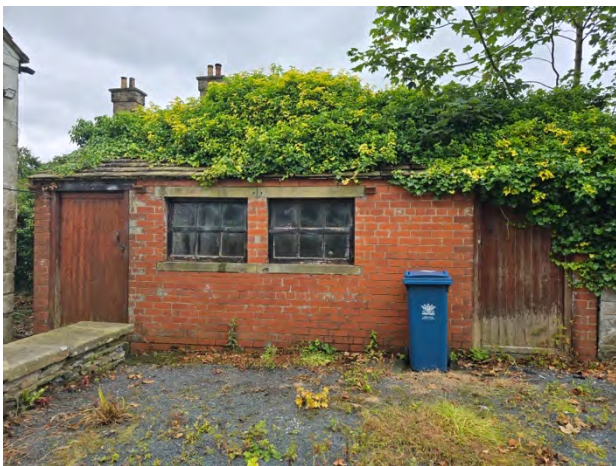
Whilst much of the rest of the structure, including the roof, was obscured by overgrown vegetation during the time of the site survey, other features that were visible and noted as being of interest was a section of stone walling on the north facing gable end. This possibly pertains to the remains of an earlier structure, although it is difficult to prove conclusively. On the south facing gable end, the structure has a bullnosed edge. Given the close proximity of this structure to the farmhouse, it is assumed that this feature was added to reduce potential injuries.

**Figure 39:** Exterior of the brick-built outbuilding

The proposed development seeks to undertake several alterations to the associated landscape, including: clearance of overgrown vegetation; exposure of the existing front patio and pathways, and repair of the existing boundary wall and timber fence dividing the grounds of Cockshutts Farm Cottage and the Farmhouse. The impact of the proposed works on the significance of the affected fabric is considered to be neutral/negligible.

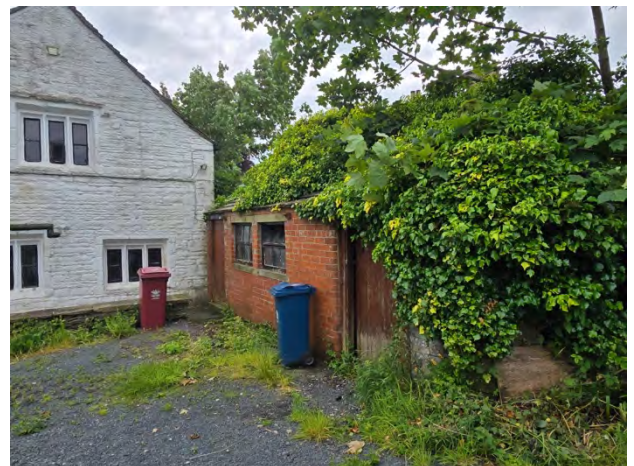
**Figure 38:** Exterior of the brick-built outbuilding

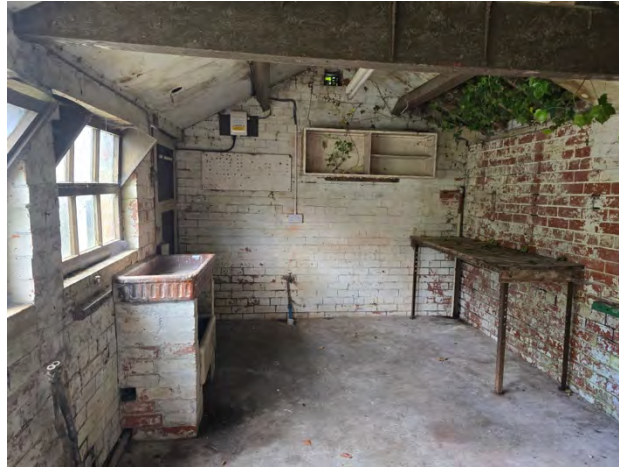
Internally, the brick-built outbuilding comprises a single cell space that is relatively plain, and features machine cut trusses, a concrete floor and walls that have been painted white. A range of features, including a Belfast sink on brick piers, as well as wall mounted storage cupboards evidence the use of this space as an ancillary building. It was noted during the site survey that the structural integrity of the outbuilding is currently being threatened by the overgrown vegetation visible externally.

**Figure 40:** Interior of the brick-built outbuilding
