**25608E/R1**

**February 2011**

**Preliminary Phase 2 Geoenvironmental Assessment at  
Phase 3 Calderstones Park, Whalley BB7 9JT**

**Taylor Wimpey Manchester Limited**

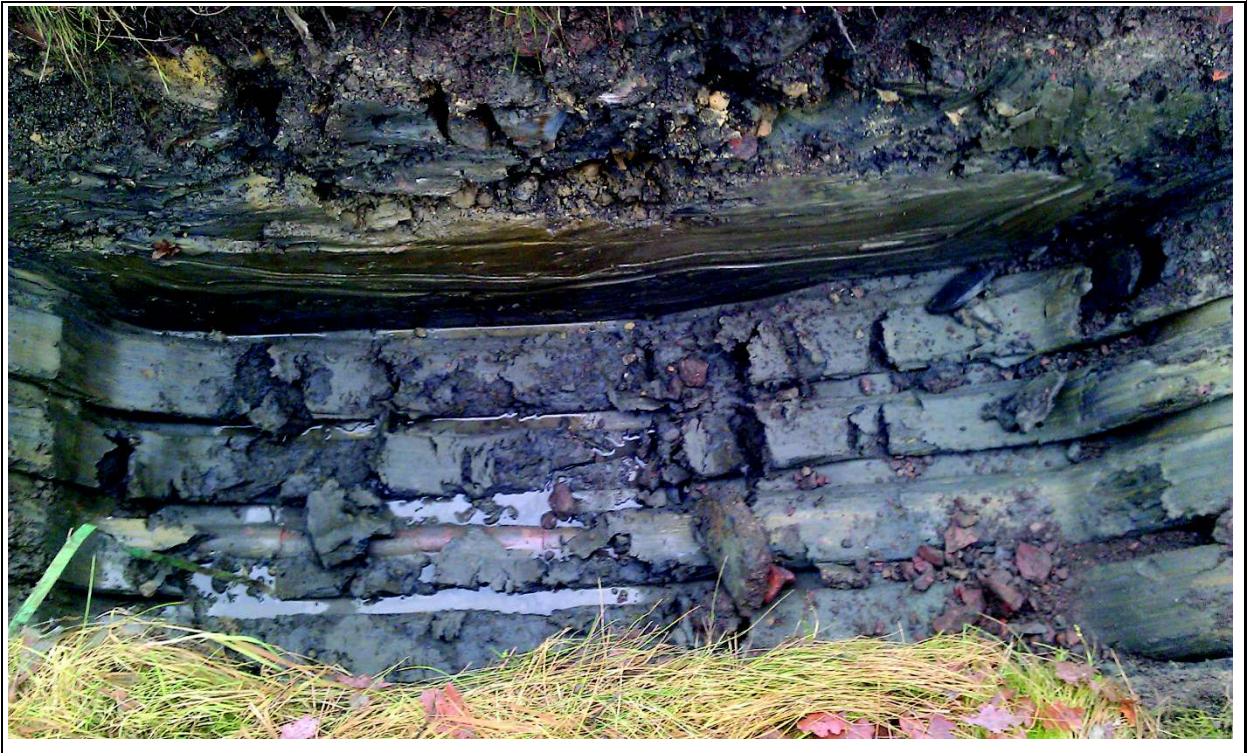
Figure 1 – TP1/SW1

Soakaways were conducted in TP01 and TP02 from ground level to 1.50mbgl and 1.90mbgl respectively in line with BRE Digest 365 – Soakaway design. The permeability tests conducted and calculated permeability soil infiltration rates are shown in appendix E.

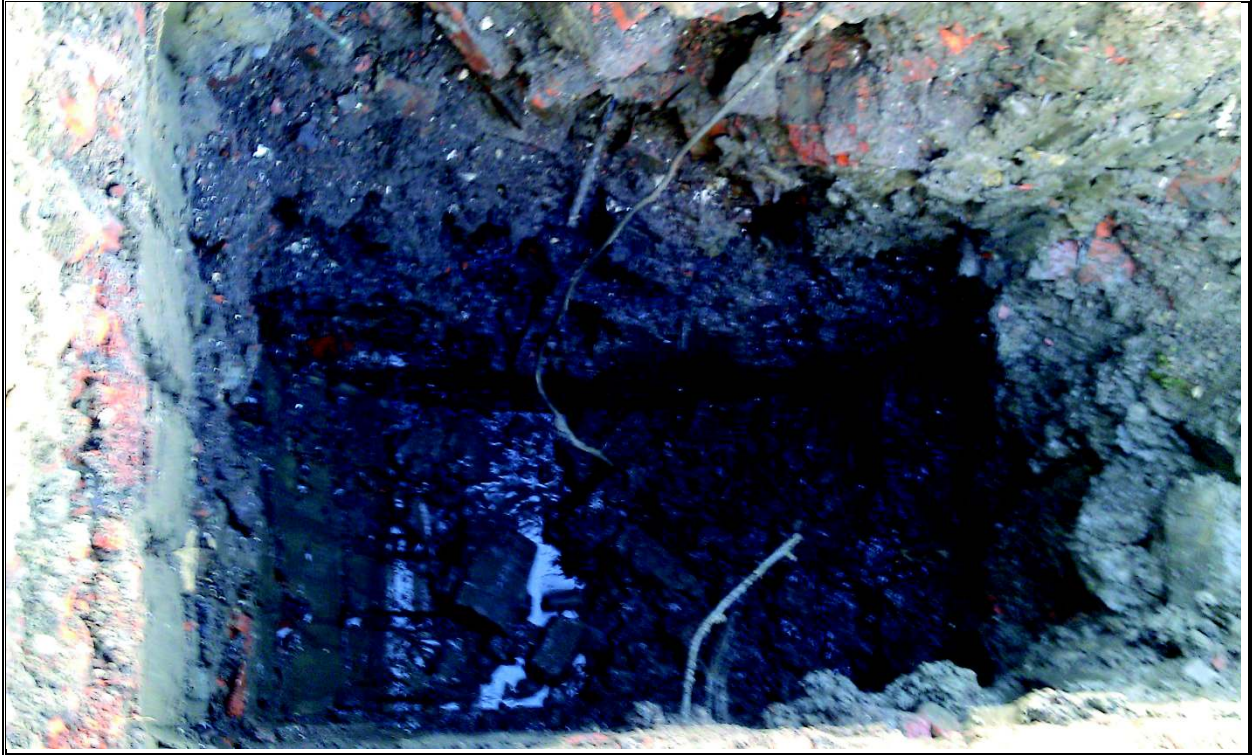
Figure 13 – TP7

Spalling and collapse due to loosely backfilled Made Ground was recorded in TP7 (2.50mbgl), which will require support and consideration during foundations and drainage excavations. Groundwater was encountered during drilling in BH01 at 2.7mbgl and 8.6mbgl within the

superficial deposits. Additionally, groundwater was also encountered during the drilling of WS03 and WS04 at 4.00mbgl and 3.00mbgl respectively. Ingress was noted as generally slow to moderate with the exception of TP07 where ground water was encountered at 2.30m bgl in the made ground and recorded as fast inflowing.
