# Mitton Hall

Mitton, Lancashire

Proposed New Porch and Replacement Conservatory

## Heritage Statement

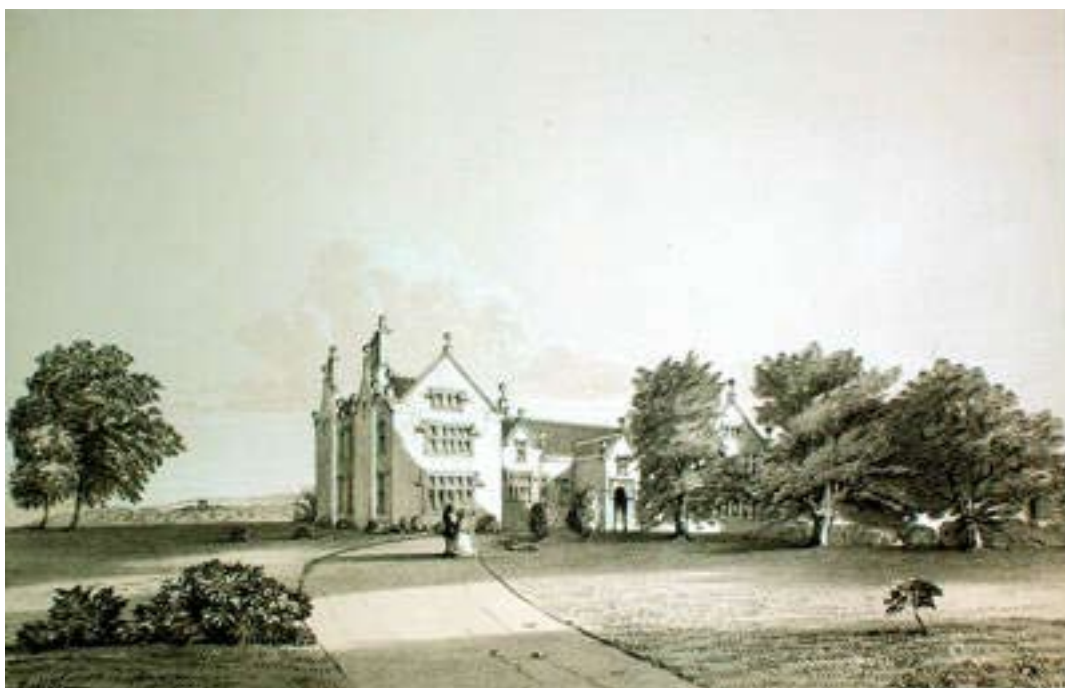
Figure 9. A view of the house shortly after the 1844 alterations. Taken from 'Mansions of England and Wales' by Edward Twycross, published in 1847.

Comparison of John Weld's drawing of 1834 (Figure 4) with Twycross's view published in 1847 (Figure 9) suggests that the exterior of the house was not significantly altered. However, a more detailed examination shows differences in the windows and chimneys depicted in the two views. Although a 20th century cement pebbledash covers the external faces of most of the walls, nearly all the exposed stone dressings appear to date from the 1844 restoration. Where the walling stone is exposed in the south cross-wing, rebuilding of the outer face at least can be seen to have been comprehensive: the stonework shows no evidence of earlier openings and the quoins are 19th century, roughly punched to take a render. The way in which the sandstone window surrounds are set forward of the wall strongly suggests that the whole house had a rendered finish.

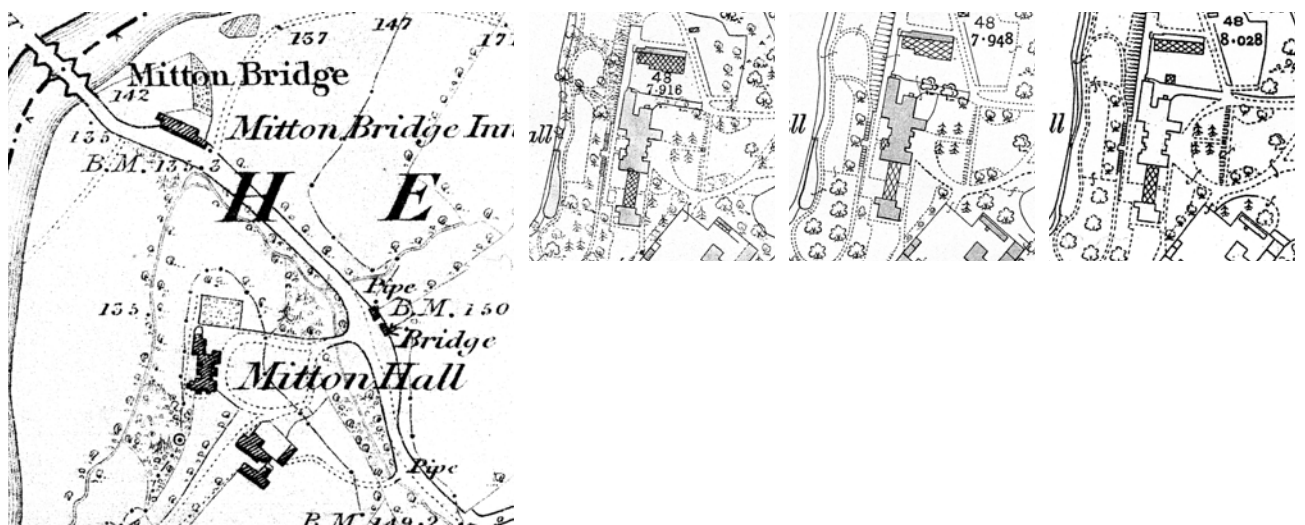
Figure 10. 1848, 1894, 1912 and 1932 Ordnance Survey maps. The recreation block and conservatory can be seen on the three later maps.

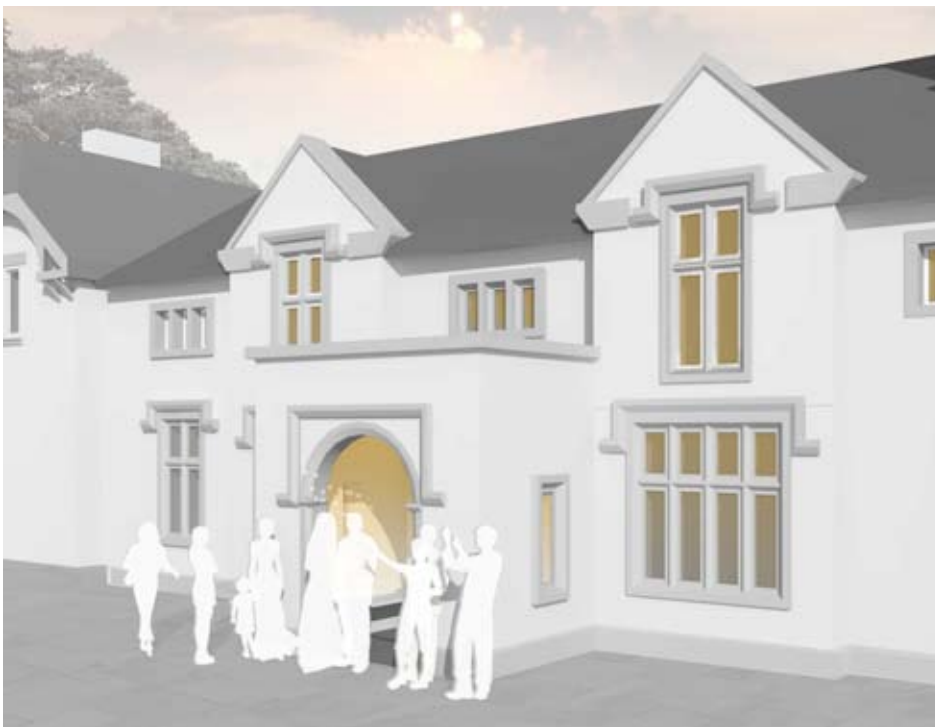
Figure 19. An illustration of the proposed porch, by Stanton Andrews Architects.

The approach taken for the design of the new porch is similar to that taken in the 1980s for the design of the wing. It is in the same 17th century style with roughcast walls and sandstone dressings, but is less elaborate than the porch to the main house, which is two storeys with ball finials to its gable coping. The present doorway (Photograph 2) is set in a shallow projection that extends as far forward as the gabled window projections to each side. Visually it is weak, with its symmetrical placement and the size and importance of the function room inside justifying a more emphatic treatment. In this respect the proposed porch would be an improvement.

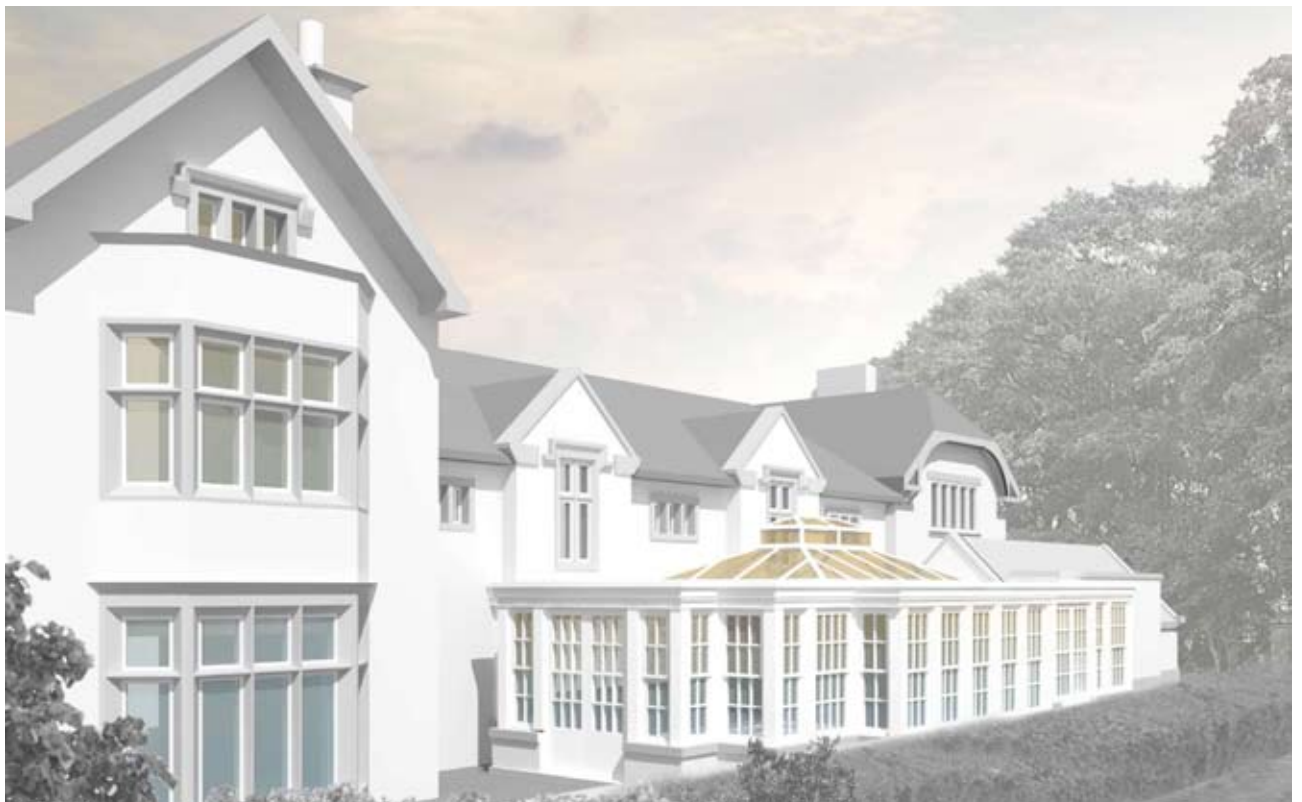
Figure 20. An illustration of the proposed conservatory and kitchen, by Stanton Andrews Architects.

The proposed conservatory would be an improvement, as it would be separated from the cross-wing of the main house and would have a better relationship with the function room wing. The proposed lantern light would interfere less with views from and of the first-floor bedroom windows and would be an attractive feature in its own right. The proposed bay on the entrance axis of the function room, and the continuous ceiling height, would help to integrate the conservatory with the room. The quality of detailing would also be an improvement, with the sill and parapet cornice forming strong horizontal elements and the windows and their glazing having Georgian proportions. The low proportions, simple form and traditional materials used for the proposed replacement kitchen will mean that it too will be an improvement that will not be unduly prominent in distant views or in views from the terrace.

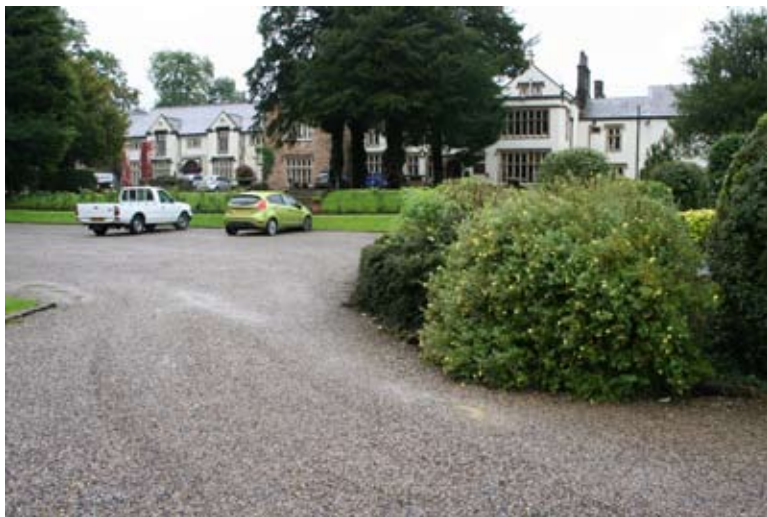
**Photograph 1.** The front of Mitton Hall, viewed from the entrance drive. The original house is near the centre of the photograph, behind trees. The site of the proposed porch is between the two gables of the 1980s function room block, at the left.

The setting of Mitton Hall, with a curving driveway and trees (Photograph 1) means that the whole facade, which stretches from the former recreation block to the south to the north-west service wing, cannot fully be seen from any one position. This means that the main house and the function room wing are seen as separate but linked parts of a long range of buildings, and the existing and proposed porches are unlikely to send out conflicting messages about the location of the main entrance to the complex.

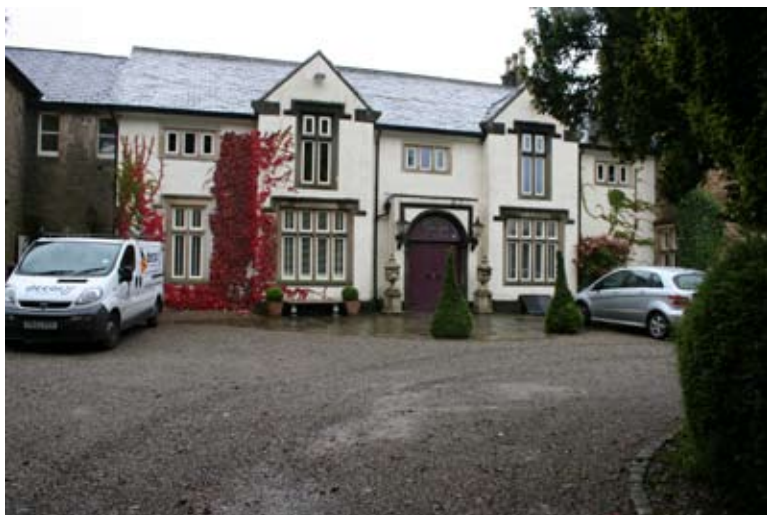
**Photograph 2.** The front of the function room block. The proposed porch would replace the doorway.

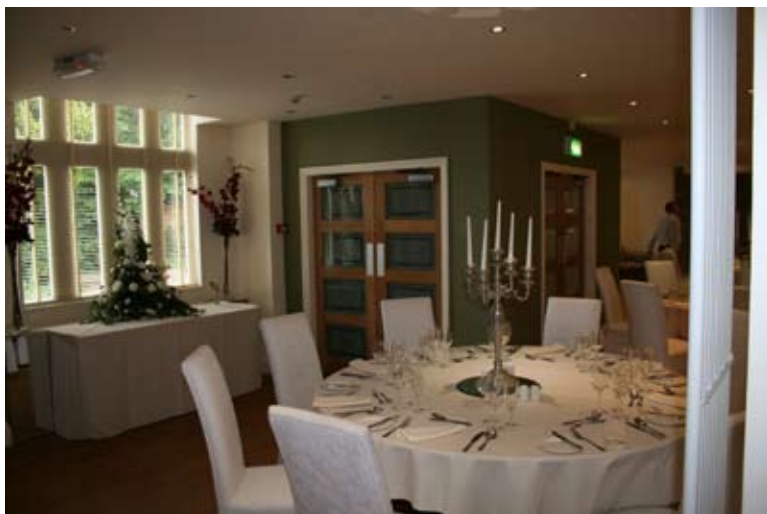
**Photograph 3.** The internal lobby at the entrance to the function room. This would be replaced by the external porch.

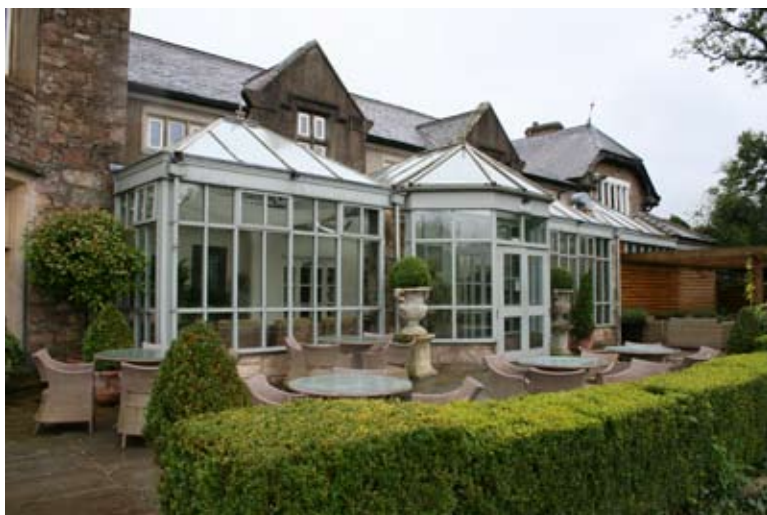
**Photograph 4.** The present conservatory at the rear of the function room block.

The present conservatory dates from the 1980s. Historic photographs (Figures 11 & 14) confirm that the western side of the building, facing the gardens and river, has always been more informal and irregular, but it now includes some elements that detract somewhat from its appearance. These include the 1960s toilet block extension and the conservatory. The latter abuts the corner of the cross-wing of the original house, and obscures views of and out of the mullioned bedroom windows of the 1980s function room block. The proportions of its windows, the top-opening casements, the eaves details and the pyramidal glazed roofs are neither examples of clean modern design nor a good reproduction of an Edwardian or Victorian conservatory.

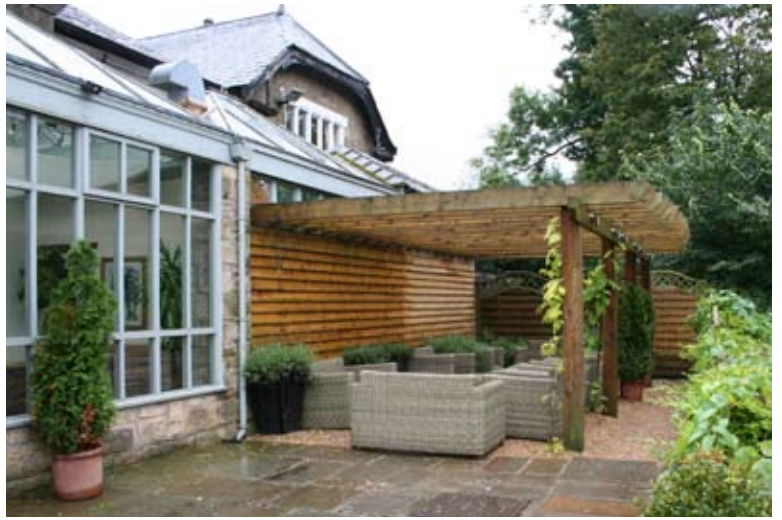
**Photograph 5.** The timber pergola disguises the kitchen behind.

The kitchen serving the function room is currently incorporated into the southern end of the conservatory. Together with the timber pergola, shed and outdoor storage area it has a somewhat untidy appearance and detracts from the setting of the main building when viewed from the southern end of the terrace (Photographs 5 & 6).

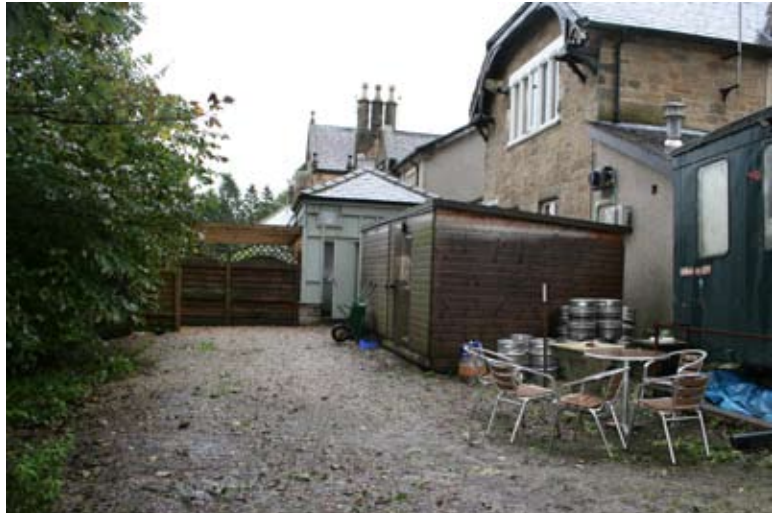
**Photograph 6.** The storage area to the south of the conservatory.
