# Mitton Hall

Mitton, Lancashire

Proposed New Porch and Replacement Conservatory

## Heritage Statement

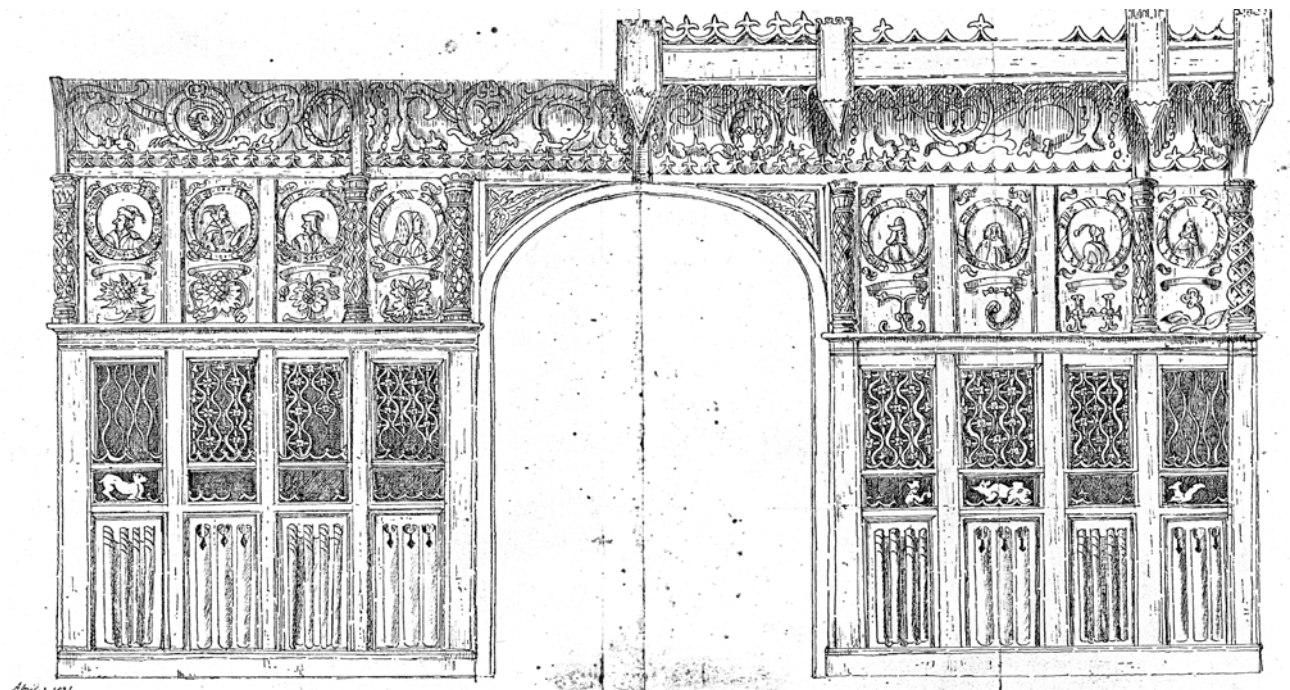
Figure 3. John Weld's drawing, made in 1834, of the 16th century carved screen at the low end of the hall. This appears to have been removed from the house in the early 1980s.

The cross-wing at this end of the building has been drastically altered, but the survival of the wall dividing it from the hall and its general proportions suggest that it is possible that some timbers from the medieval frame may survive, embedded in the later walls or incorporated in the floors and ceilings. Some of the panelling that remains in the hall, and possible the stone fireplace uncovered in 1874, may be 16th century. The intricately carved screen illustrated by John Weld (Figure 3) seems to have been of this period. We understand that this disappeared from the house as recently as the early 1980s. If this is the case its whereabouts should be investigated, as it is a significant loss.

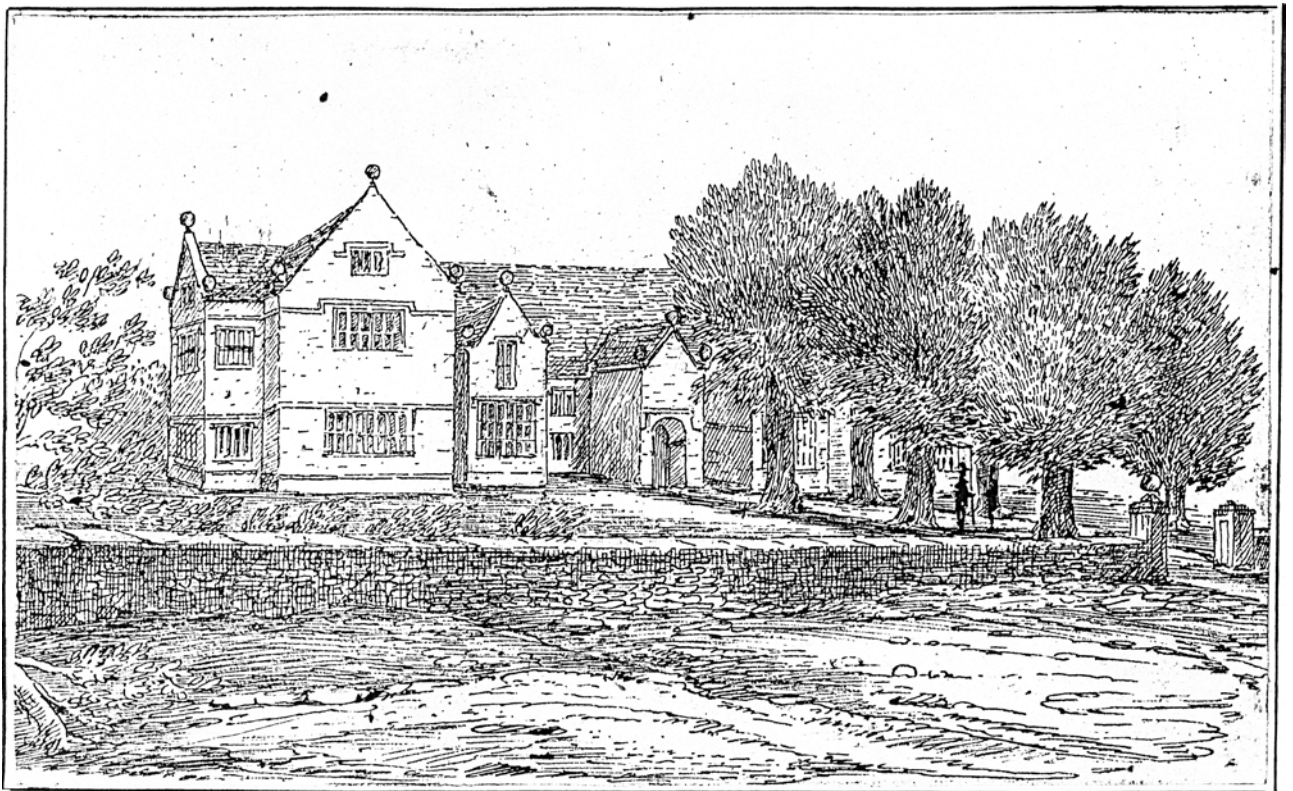
*Little Milton Hall.*

Figure 4. John Weld's drawing of the front of the house in 1834.

We are fortunate that there are several early 19th century accounts and illustrations of the house before the 1844 restoration, and these suggest that the front of the building and the hall had not been significantly altered since around 1600. The drawing made by John Weld in 1834 (Figure 4) shows an H-plan house with mullioned and transomed windows, of similar general appearance to the house surviving today. The plan in Whitaker's History of Whalley (Figure 7) also pre-dates the restoration. It shows a bay window on the south side of the south cross-wing, visible in the Weld drawing, and additional rooms on the north side of the north cross-wing, including a porch. These rooms were replaced by larger service wings in 1844 and the wings were significantly altered several times in the 20th century. A moulded archway survives and was probably the outer doorway of the porch: its arch is moulded on both sides and there is no rebate or hinges for a door.

Comparison of John Weld's drawing of 1834 (Figure 4) with Twycross's view published in 1847 (Figure 9) suggests that the exterior of the house was not significantly altered. However, a more detailed examination shows differences in the windows and chimneys depicted in the two views. Although a 20th century cement pebbledash covers the external faces of most of the walls, nearly all the exposed stone dressings appear to date from the 1844 restoration. Where the walling stone is exposed in the south cross-wing, rebuilding of the outer face at least can be seen to have been comprehensive: the stonework shows no evidence of earlier openings and the quoins are 19th century, roughly punched to take a render. The way in which the sandstone window surrounds are set forward of the wall strongly suggests that the whole house had a rendered finish.

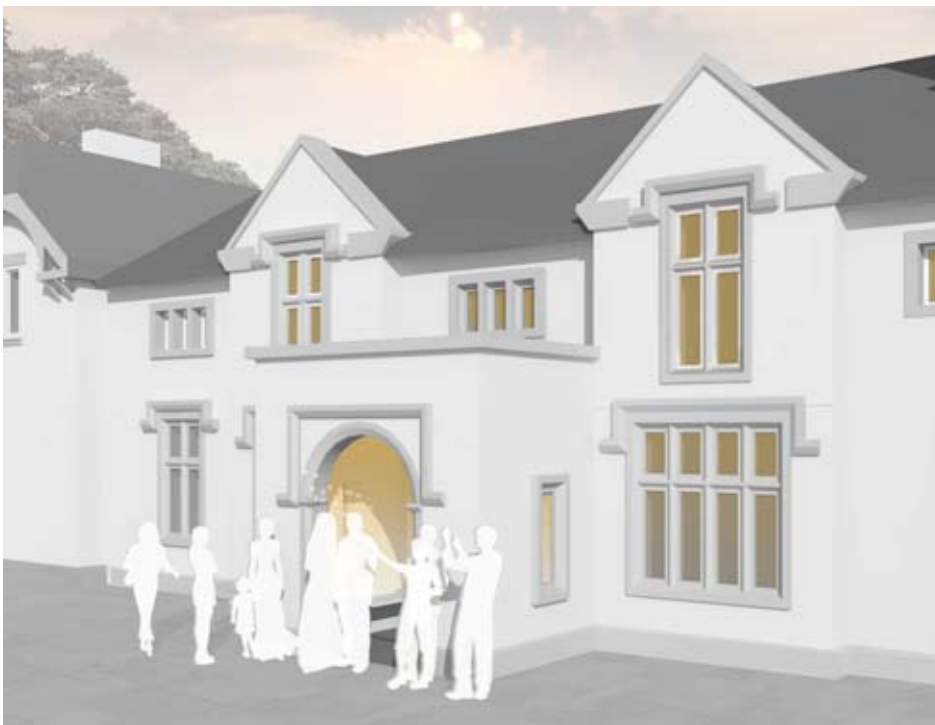
Figure 19. An illustration of the proposed porch, by Stanton Andrews Architects.

The approach taken for the design of the new porch is similar to that taken in the 1980s for the design of the wing. It is in the same 17th century style with roughcast walls and sandstone dressings, but is less elaborate than the porch to the main house, which is two storeys with ball finials to its gable coping. The present doorway (Photograph 2) is set in a shallow projection that extends as far forward as the gabled window projections to each side. Visually it is weak, with its symmetrical placement and the size and importance of the function room inside justifying a more emphatic treatment. In this respect the proposed porch would be an improvement.

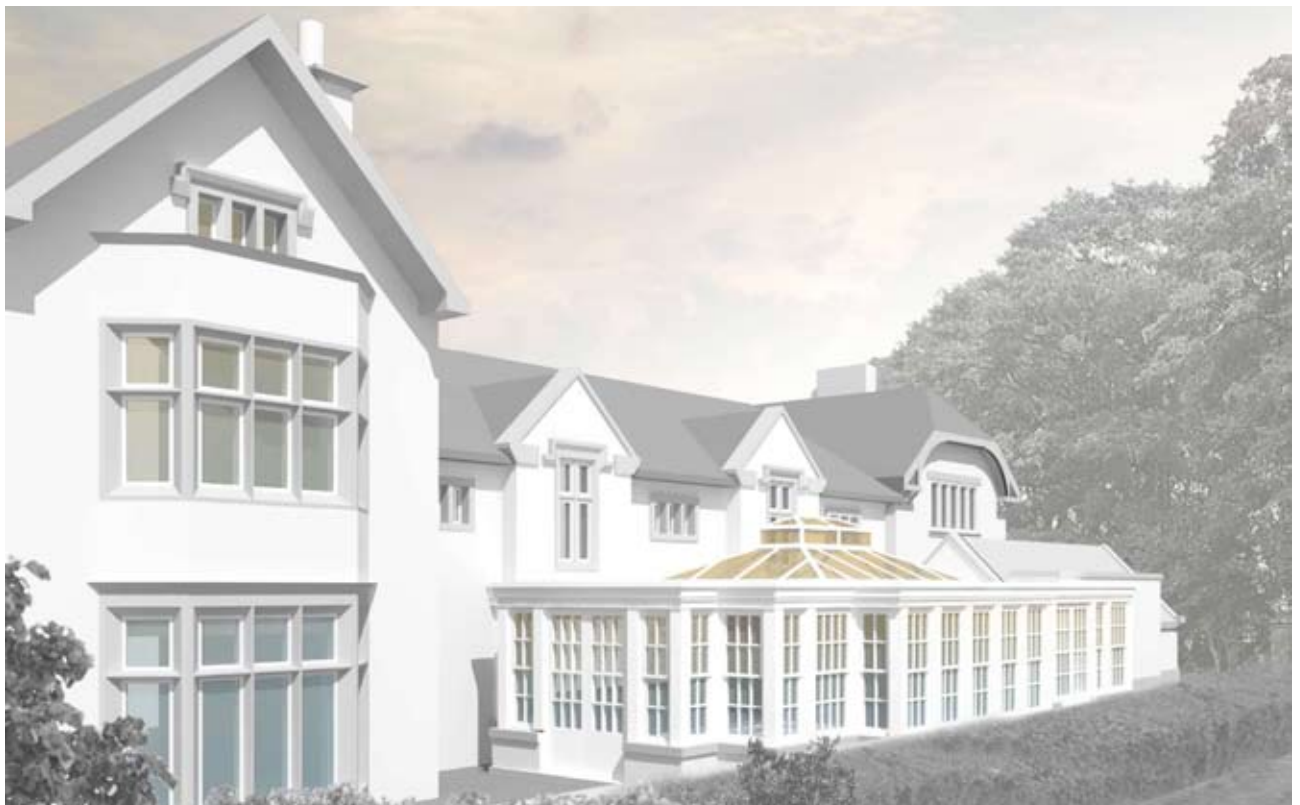
Figure 20. An illustration of the proposed conservatory and kitchen, by Stanton Andrews Architects.

The proposed conservatory would be an improvement, as it would be separated from the cross-wing of the main house and would have a better relationship with the function room wing. The proposed lantern light would interfere less with views from and of the first-floor bedroom windows and would be an attractive feature in its own right. The proposed bay on the entrance axis of the function room, and the continuous ceiling height, would help to integrate the conservatory with the room. The quality of detailing would also be an improvement, with the sill and parapet cornice forming strong horizontal elements and the windows and their glazing having Georgian proportions. The low proportions, simple form and traditional materials used for the proposed replacement kitchen will mean that it too will be an improvement that will not be unduly prominent in distant views or in views from the terrace.
