**Highfield, Snodworth Road, Langho, Blackburn**

**Bats: Building Inspection & Surveys**

**Simply Ecology Limited**

**November 2018  
(Updated May 2019)**

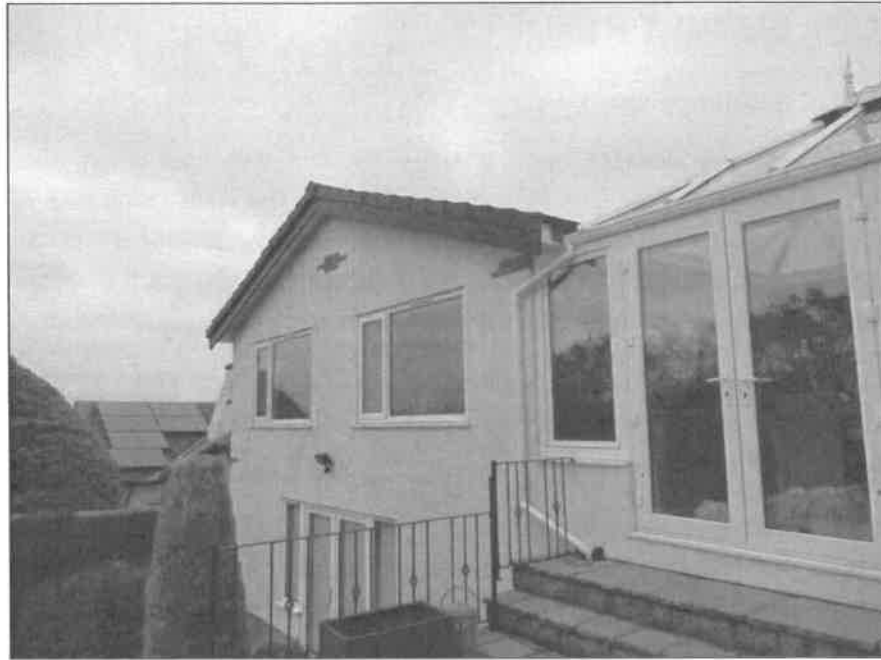
*Plate 2: The rear of the building comprised of a conservatory and white stucco plaster.*

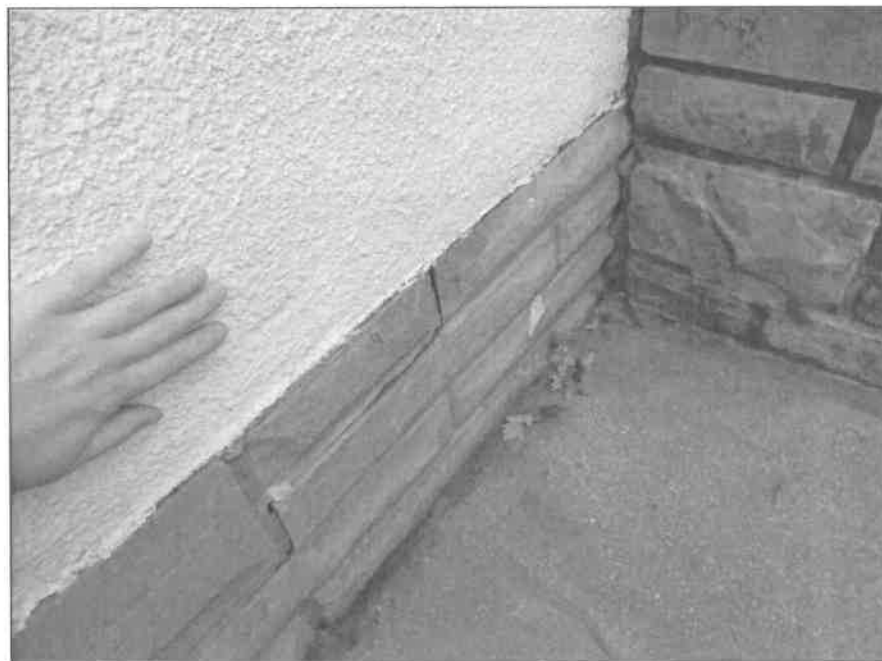
*Plate 3: The white stucco walls would have been an ideal surface for bat droppings to adhere to, however despite a thorough inspection no evidence was found.*

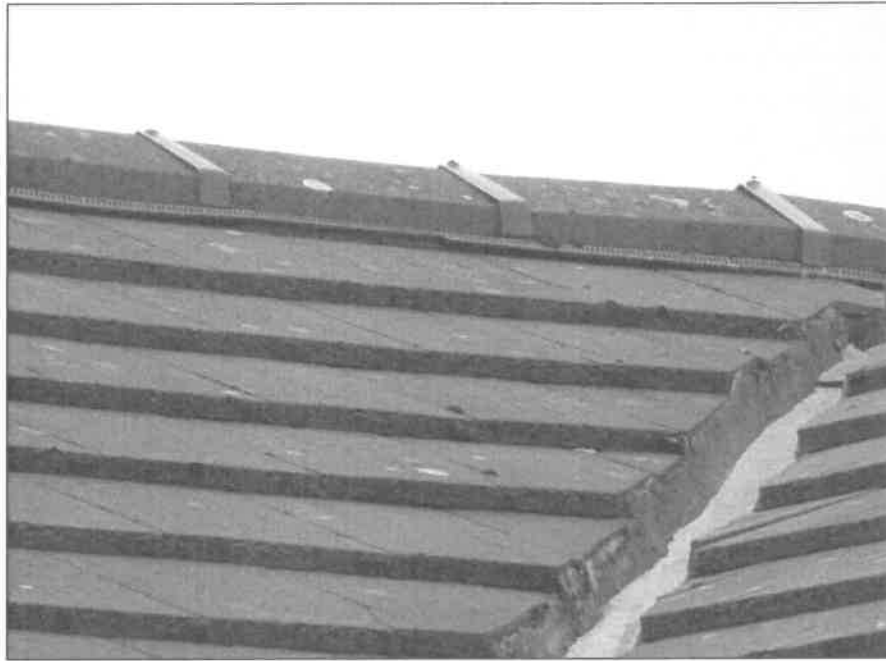
*Plate 8: The plastic roof ventilation was lifted along the ridge tiles at the southern end of the property.*

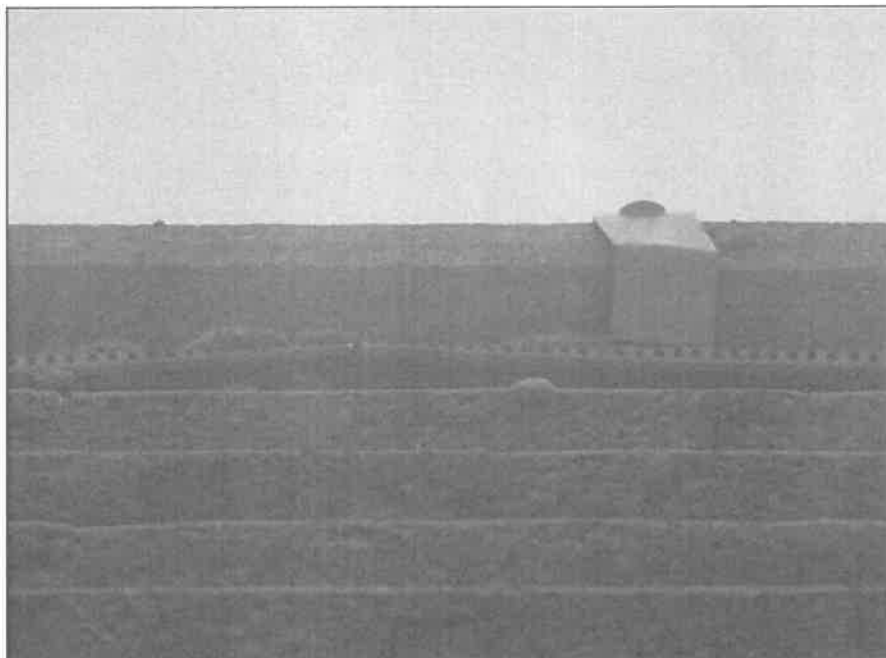
*Plate 9: In places the ventilation was lifted enough for bats to easily gain access into the loft space.*

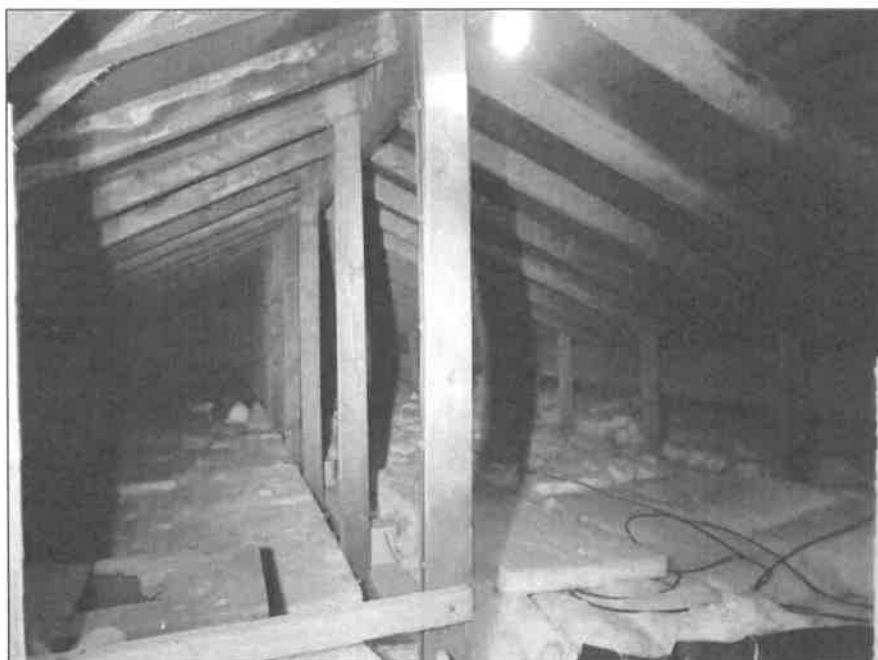
- 3.2.1 An internal inspection was also carried out to look for signs of roosting bats, such as droppings or prey remains. The loft void was a dark and warm space, which was well insulated and fully accessible throughout (see Plate 10).
- 3.2.2 In the southern area of the loft void, a gap between the timber ridge beam and roofing membrane was present along almost the entire roof (see Plate 11). Within this gap, the

*Plate 10: The loft void was warm, dark and well insulated.*

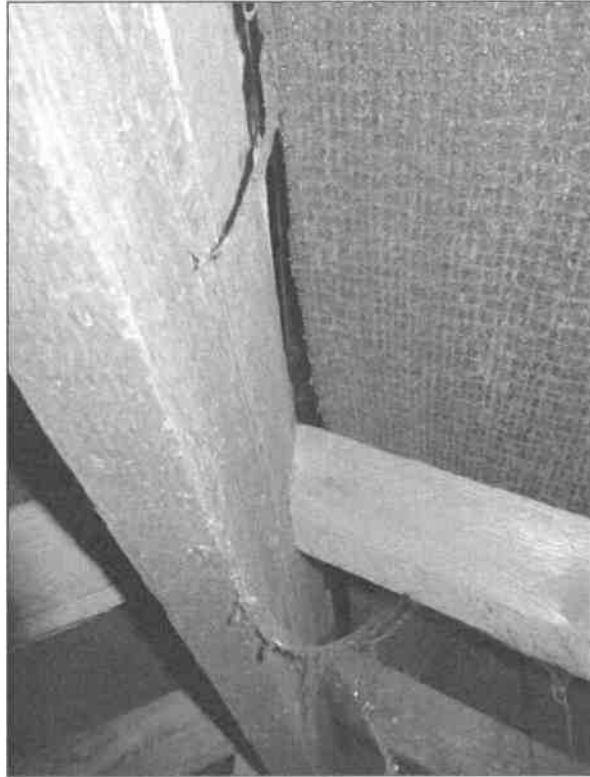
*Plate 11: In the southern aspect of the house, there was a substantial gap between the roofing membrane and the ridge beam, sufficient for bats to use.*

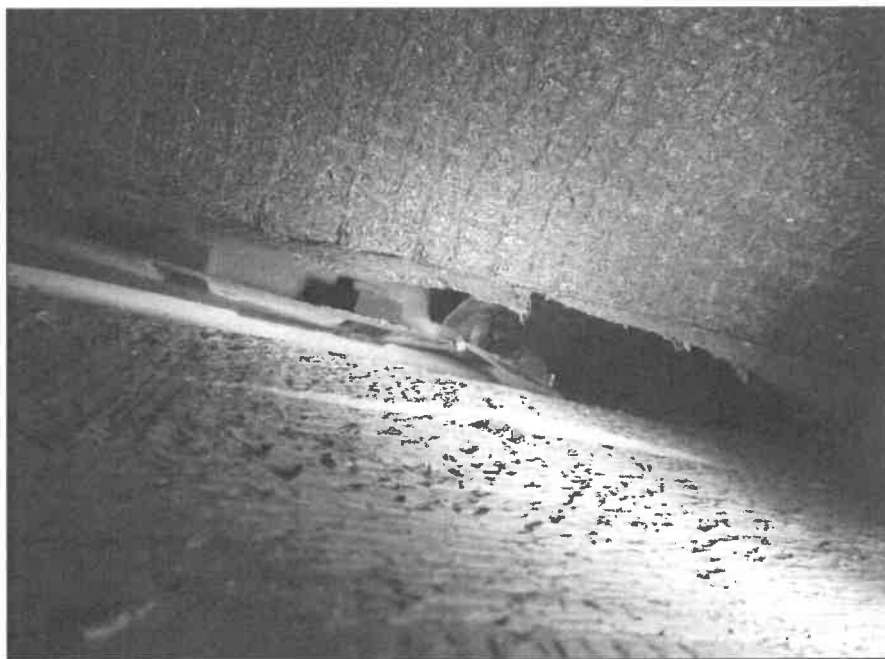
exterior lifted plastic roof vent was visible (see Plate 12). Directly beneath these gaps along the ridge beam were clusters of bat droppings, which were located throughout both the southern and eastern aspects of the loft (see Plate 13). Potential scratch marks were also visible upon the timber ridge beam, which was largely clear of cobwebs (see Plate 14).

*Plate 12: Within the gap, the plastic roof vent was visible.*

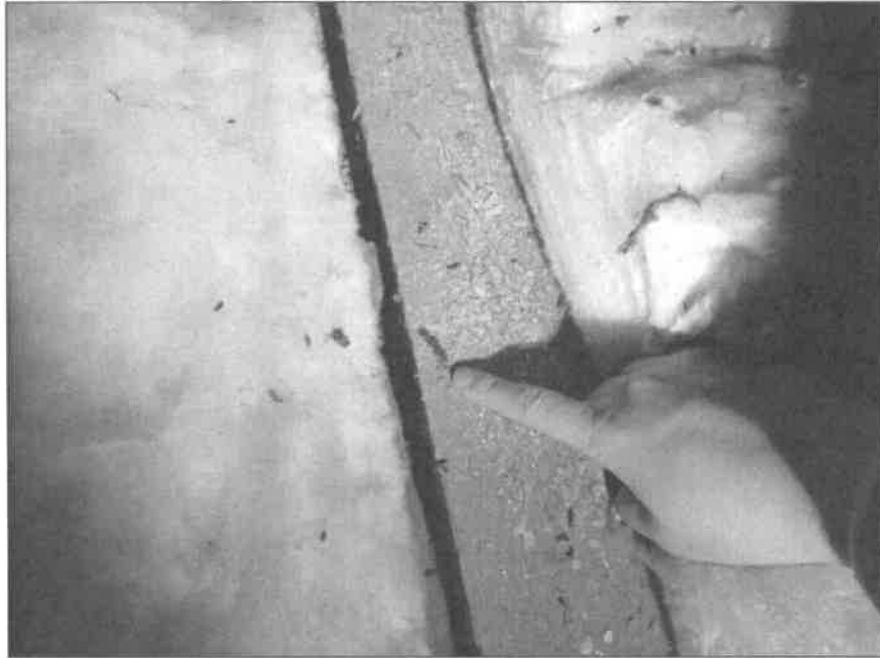
*Plate 13: Directly beneath the ridge beam a number of droppings were identified throughout both the southern and eastern aspects of the loft void.*

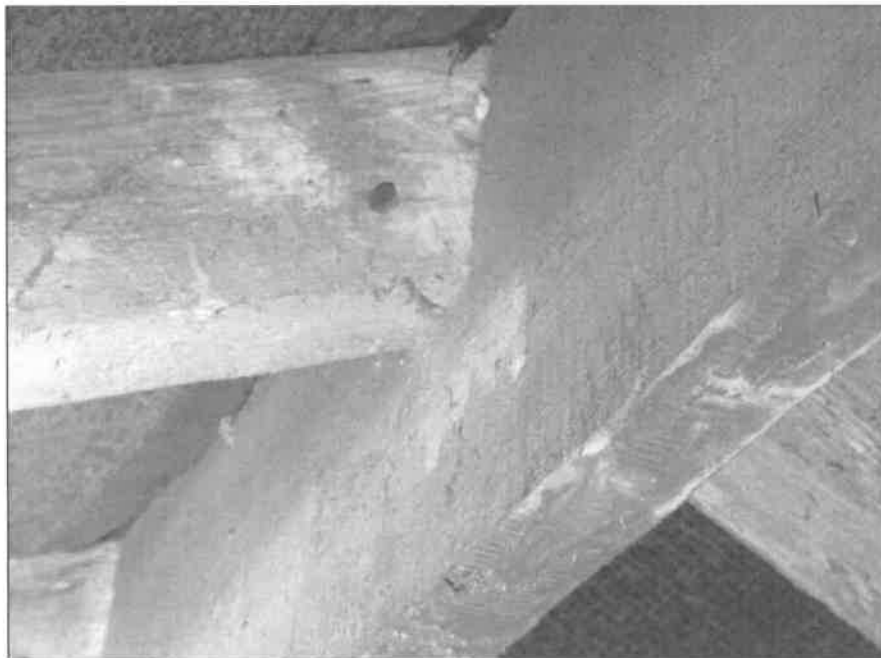
*Plate 14: Absence of cobwebs and possible scratch marks were also apparent upon the ridge beam, suggesting roosting bats.*

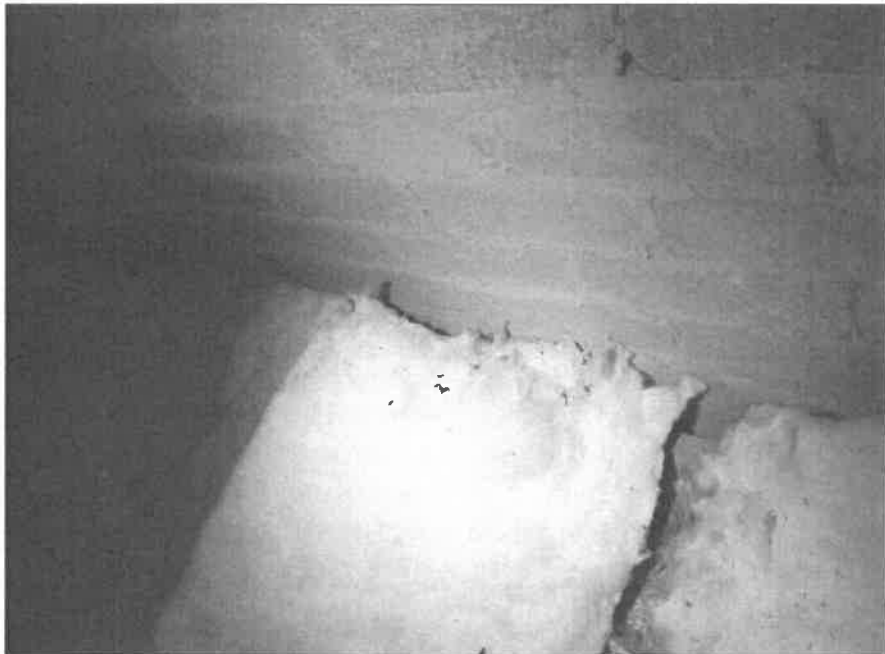
*Plate 16: Droppings at the foot of the gable wall suggested bats were using this feature.*

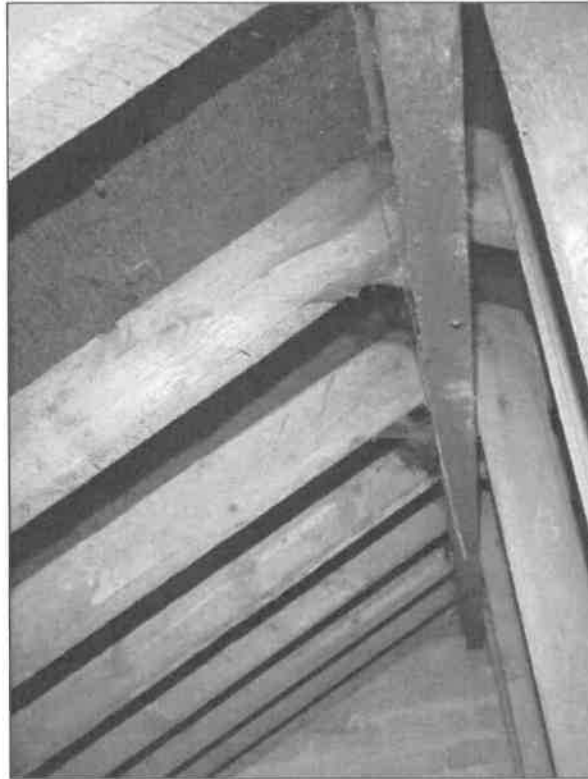
- 3.2.4 The northern aspect of the loft was also inspected. However no droppings or other signs of bats were found in this area, which had significantly more cobwebs (see Plate 17). It is envisaged that bats are not using this aspect of the roof void, although the proposed extension to the property is going to significantly impact the southern area of the roof, where it is thought that bats are potentially roosting.

*Plate 17: The northern aspect of the loft lacked any bat droppings and contained a greater number of cobwebs, suggesting bats were not using this area of the loft void.*

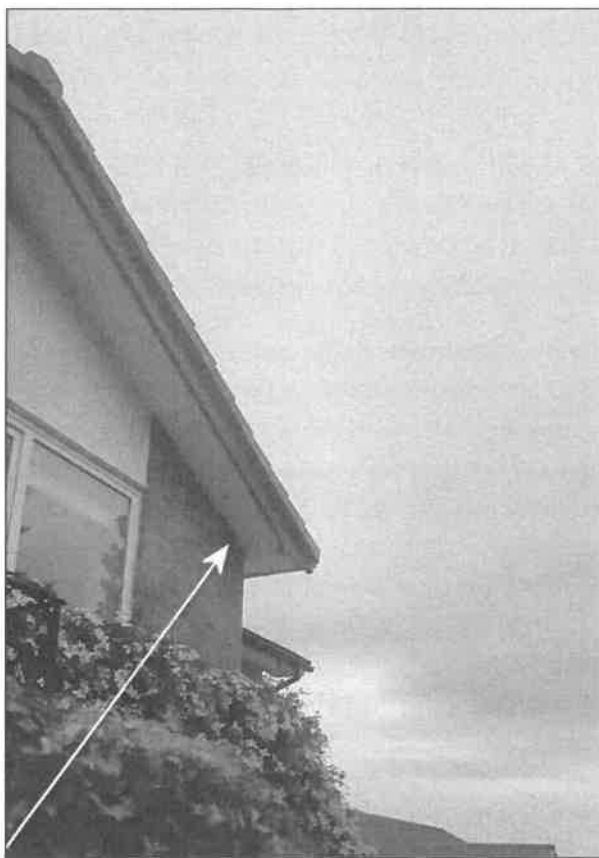
- 3.3.3 At 04:35 a single common pipistrelle (*Pipistrellus pipistrellus*) was observed making a couple of pre-entry landings on the wall at the front of the property. The bat was observed alighting and entering its roost at 04:37 in the soffit at the front of the house (See Plates 18 and 19). No other bats entered any roosts on the building. The overall pattern of activity changed 20 minutes before sunrise, when all activity at the house ceased and final bats were observed moving away along the tree tops to the front of the property.

*Plate 18: Location of bat roost at the front of the house.*

- *It is advised* that no Natural England licence or mitigation is necessary in this instance as no subsequent impact upon any bat roost is predicted. Although a roost for a single bat was present at the front of the house, this conclusion was reached due to the lack of any likely impact upon the known bat roost. **Reason:** This advice is in full compliance with: Section 9 (1 & 4) of The Wildlife & Countryside Act 1981 (as amended), Part 3 (41; 1 & 2) of The Conservation of Habitats and Species Regulations 2017 and Section 15 of the National Planning Policy Framework.
