Arboricultural Constraints Appraisal

**Land Rear of Black Horse Pub, Pimlico
Road, Clitheroe, Lancashire, BB7 4PZ**

June 2020

Project No.: BTC2000

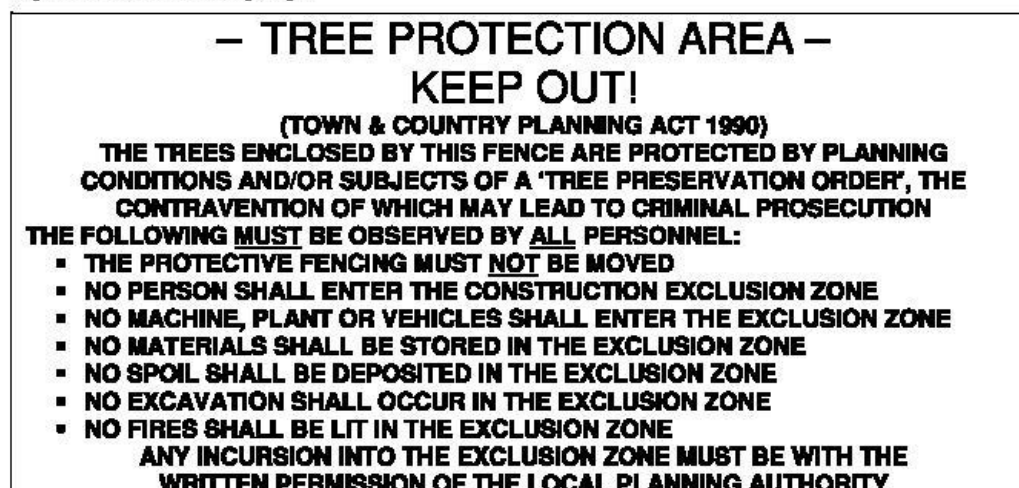
Figure 1: CEZ Warning Sign

6. No fixing shall be made to any tree and all possible precautions shall be taken to prevent damage to tree roots when locating posts.
7. A 600mm x 300mm warning sign reading "TREE PROTECTION AREA KEEP OUT" (see Figure 1, below) shall be fixed to every 10.0 metre length of protective fencing.

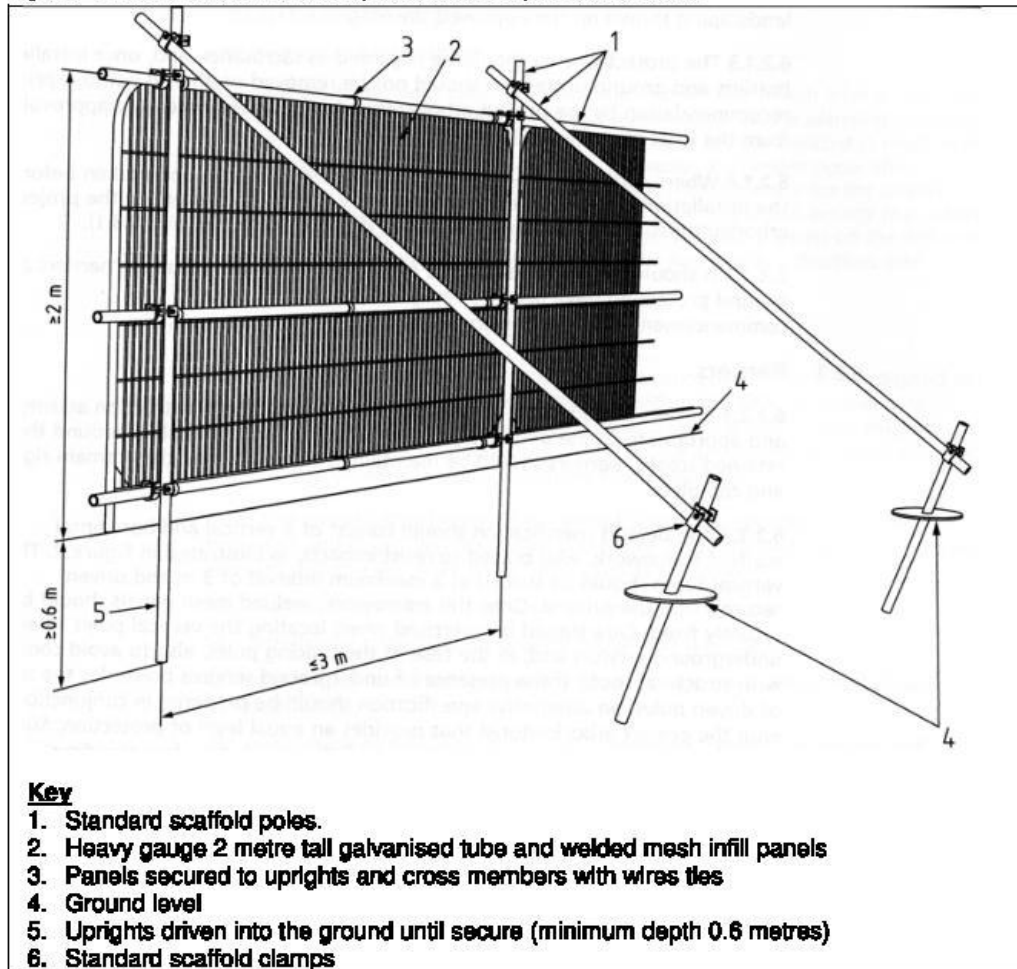
Figure 2: BS5837:2012 Default specification for protective barrier

1. Temporary protective fencing panels shall be weldmesh "Heras" panels of at least 2.0 metres in height.
2. The panels shall butt together and be securely fixed to a scaffold framework, as per 3 to 5 below.

3. The scaffold framework shall comprise of upright poles of at least 3.0 metres in length driven no less than 0.6 metres into the ground at maximum 3.0 metre centres with horizontal and diagonal poles fixed to the uprights, as per 4 to 5 below.

4. The two horizontal rail poles shall be attached to the uprights at heights of 0.6 and 1.8 metres with 3 no. clamps to each joint.
5. The diagonal scaffold pole struts be clamped to the top rail of the scaffold framework at a 45° angle and extend back into the CEZ and clamped to a 0.7 metre length of scaffold tube that shall be driven no less than 0.5m into the ground.

1. be retained in place throughout the development process, as specified in the 'Temporary Protective Fencing Construction' section below and detailed in BS5837:2012 Figure 2 (overleaf);

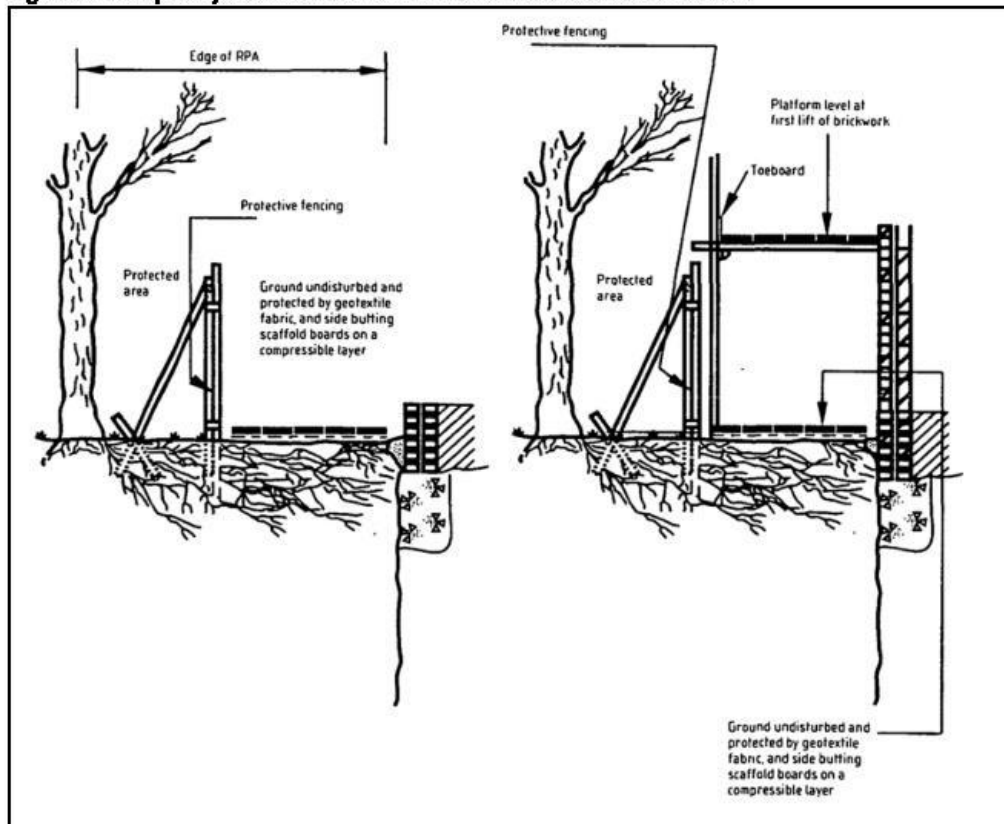
Figure 3: Temporary Ground Protection – Recommended Construction

1. Any necessary Temporary Ground Protection areas shall conform to Figure 3, below, unless otherwise agreed with the LPA.
2. The Ground Protection Area shall be left undisturbed and covered by a semi-permeable geotextile membrane which shall, in turn, be covered by a compressible layer consisting of a material such as woodchip.
3. Side-butting scaffold boards shall then be fitted to cover the Ground Protection Area.
4. On completion of installation, and prior to any demolition or construction works, site preparation, excavation or delivery of plant and materials, the Consulting Arboriculturist or the LPA Tree Officer, as agreed, shall inspect the Temporary Ground Protection.
5. The Temporary Ground Protection shall remain in place until completion of the project and only removed following receipt of written permission from the LPA.

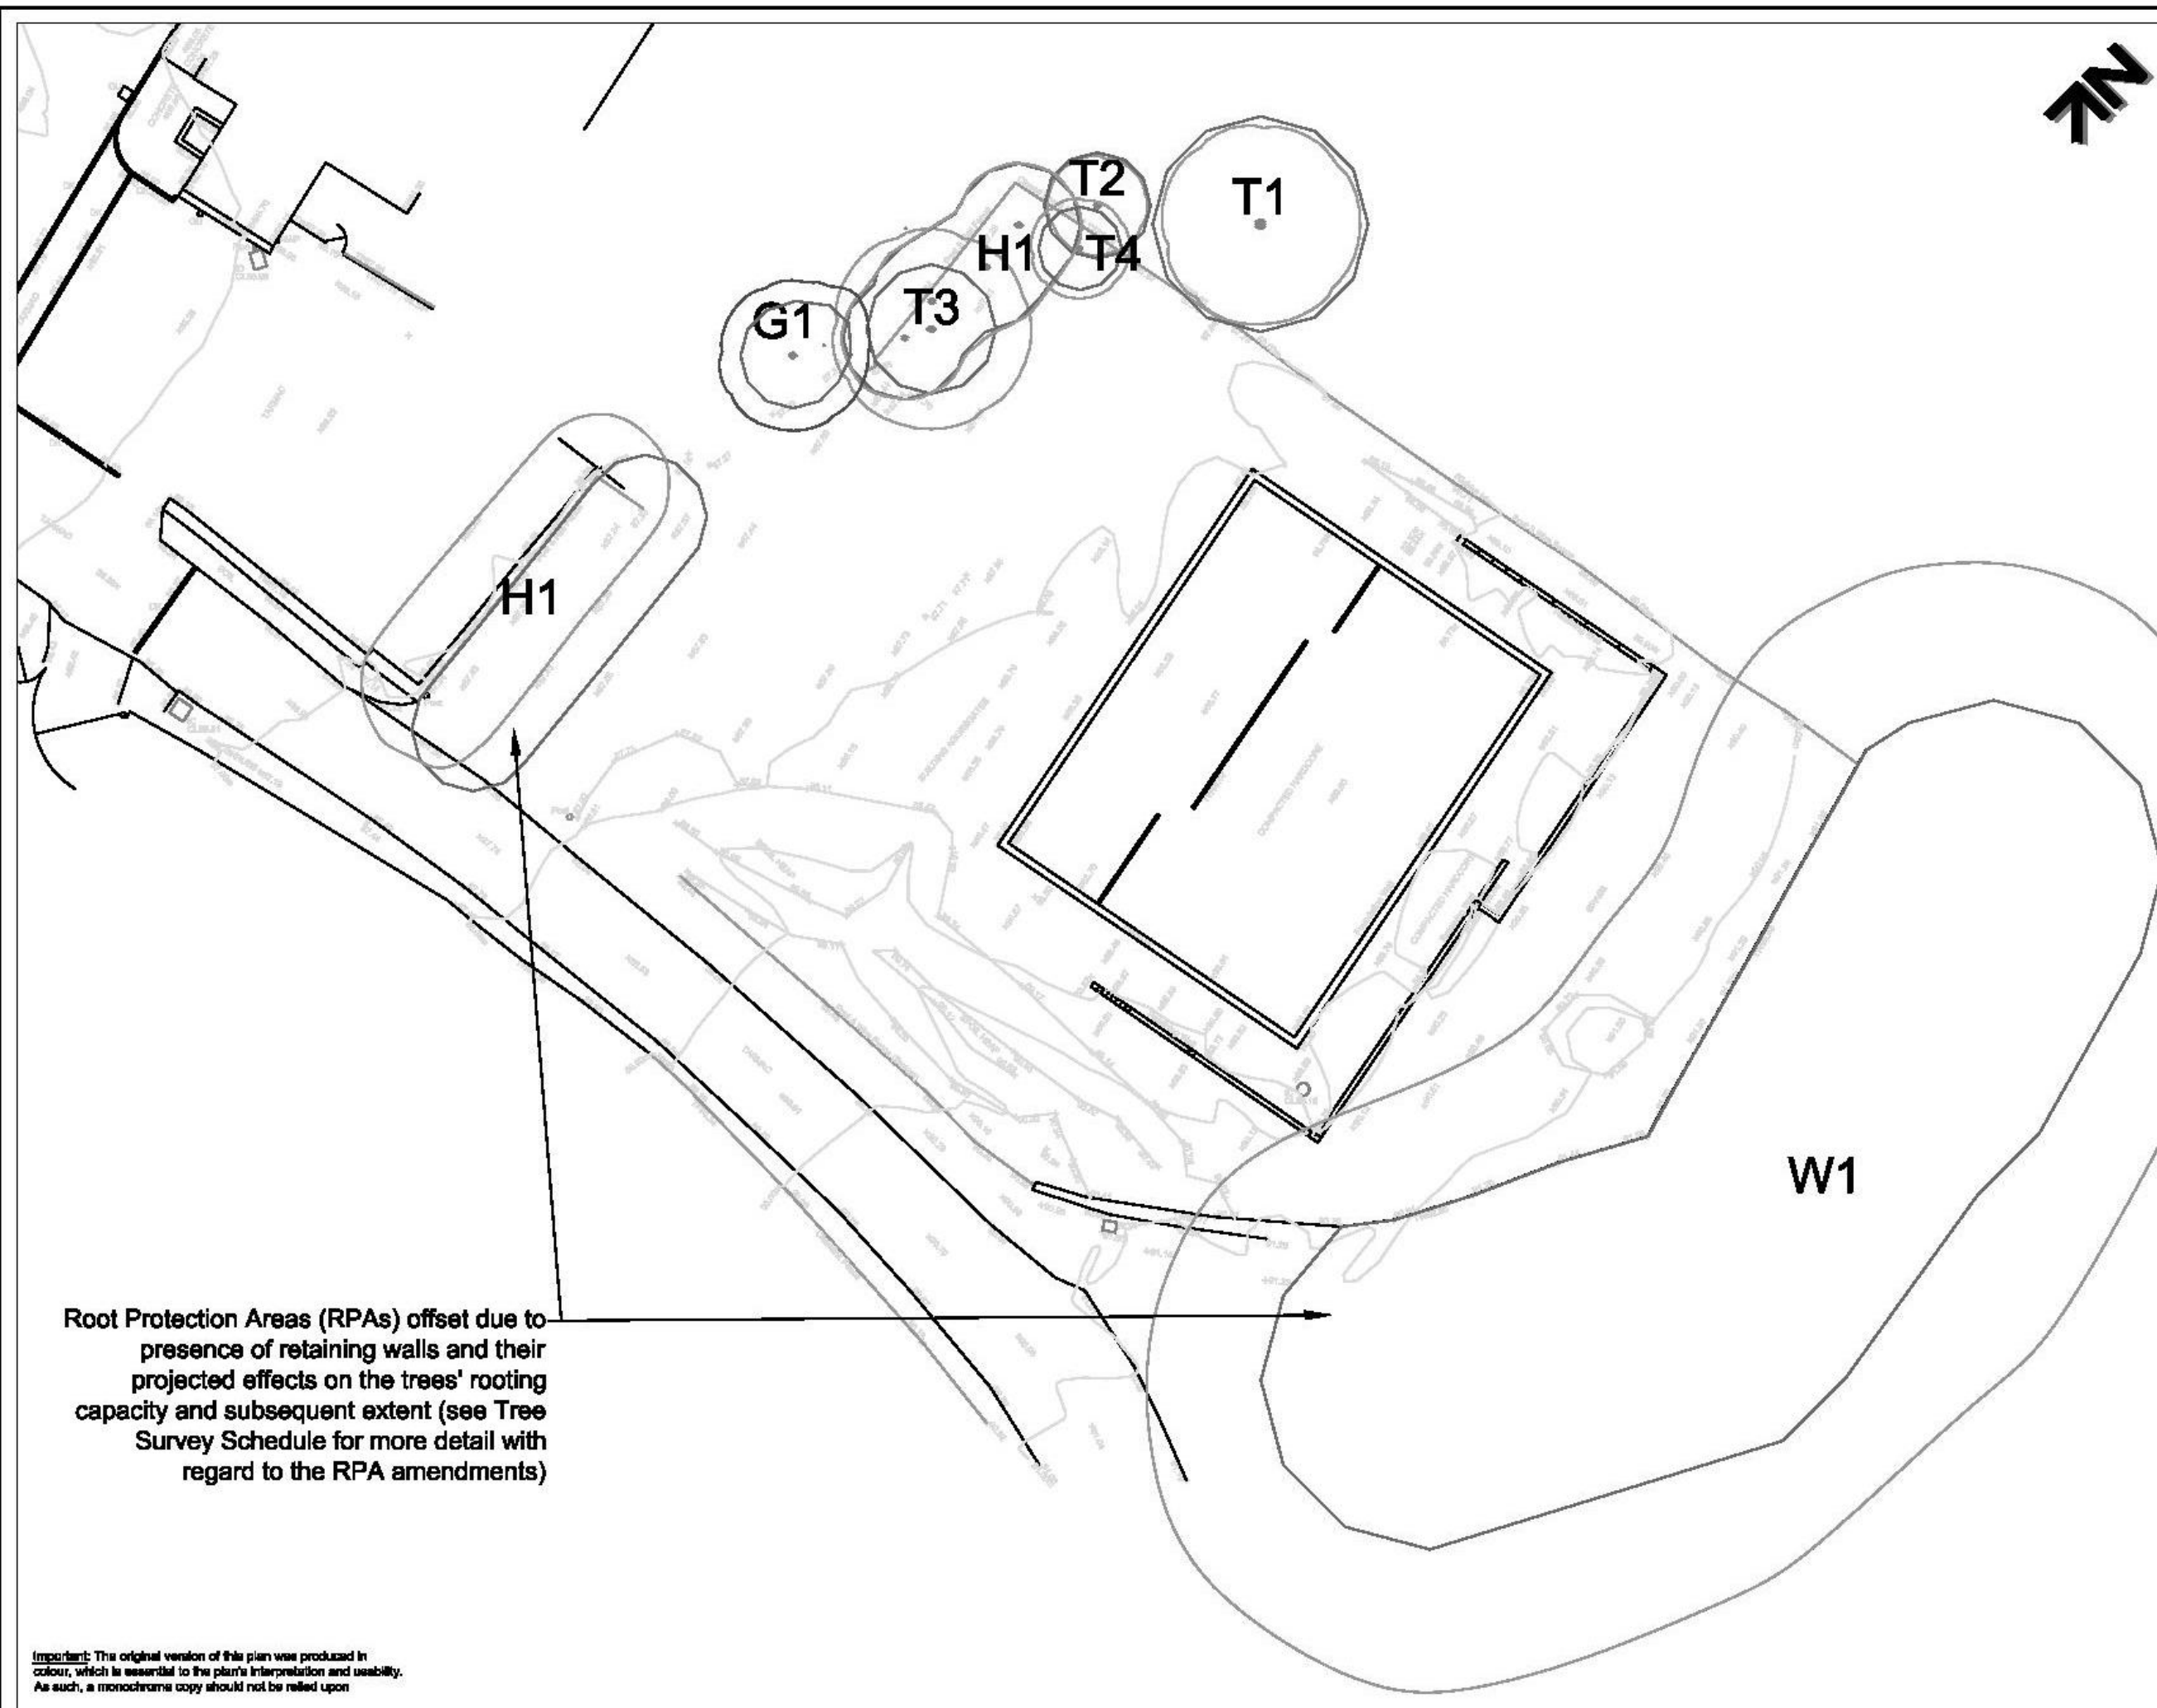
Title:
TREE CONSTRAINTS PLAN
In Relation to Proposed Residential Development

Note: Only the stem locations of the individual trees T3 and the north section of hedge H1 were included on the topographical survey based plan provided. The locations and extents of all other trees, groups, hedges and woodlands were subsequently plotted by the arboricultural surveyor at the time of the survey using GPS siting and, where possible, measurement from existing land features. As such, the plotted locations of these trees cannot therefore be considered to be wholly accurate

- RPAs**
Areas of Ground Around Trees that Should be Protected Throughout Development Works with Protective Fencing to form a Construction Exclusion Zone - see Temporary Protective Fencing Specification
