**Bat Survey Report and Method Statement  
European Protected Species (Bats)**

**Mill Race Cottage,  
Dilworth Bottoms,  
Ribchester,  
PR3 3ZB**

**04.10.2022**

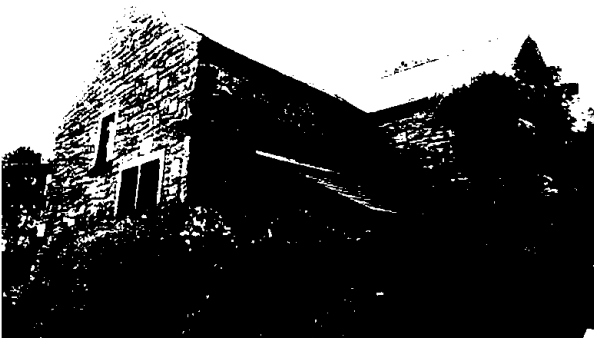
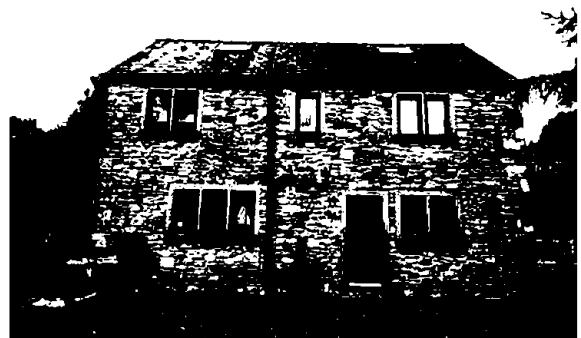
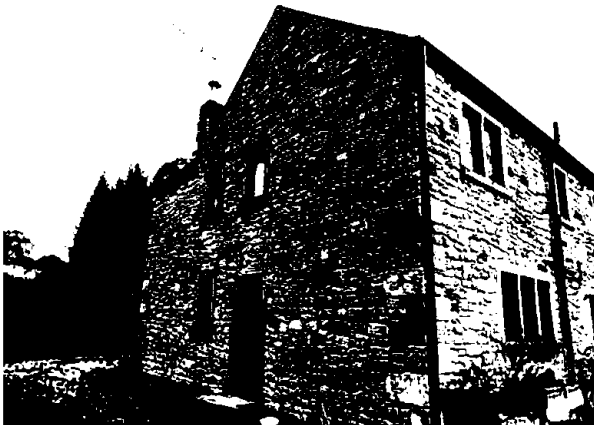
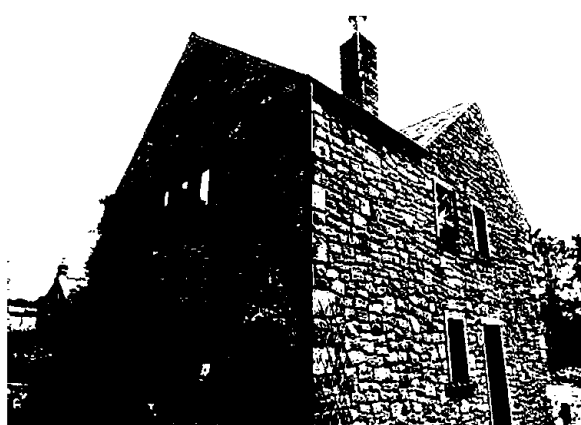
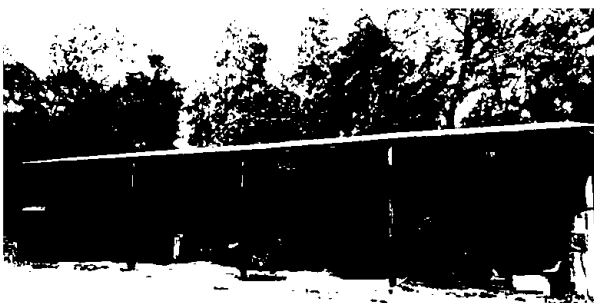
The property consists of a detached modern stone built two storey house with a double pitch and valley slate roof, a single storey porch is present to the frontage. The property has a open fronted portal style corrugated metal and block outbuilding present to the west of the main house. External walls are generally well pointed with no obvious cracks, gaps or crevices suitable for roosting bats.

Roof slates are close fitting with no obvious missing, lifted or slipped slates present. Ridge tiles are pointed and well sealed. Some gaps were present behind fascia boarding.

The main house was assessed as offering low bat roost potential, the portal style outbuilding offers negligible potential due to a lack of cavities or crevices.

Roof tiles should be removed by hand and under supervision where necessary.

Fascia boards should be removed with care by hand and under supervision where necessary.
