**BAT SURVEY AT -**

Land off Slaidburn road  
Newton in Bowland  
Clitheroe

DATE AND TIME OF VISIT  
21<sup>st</sup> Sept 2021

REFERENCE NO. 6510

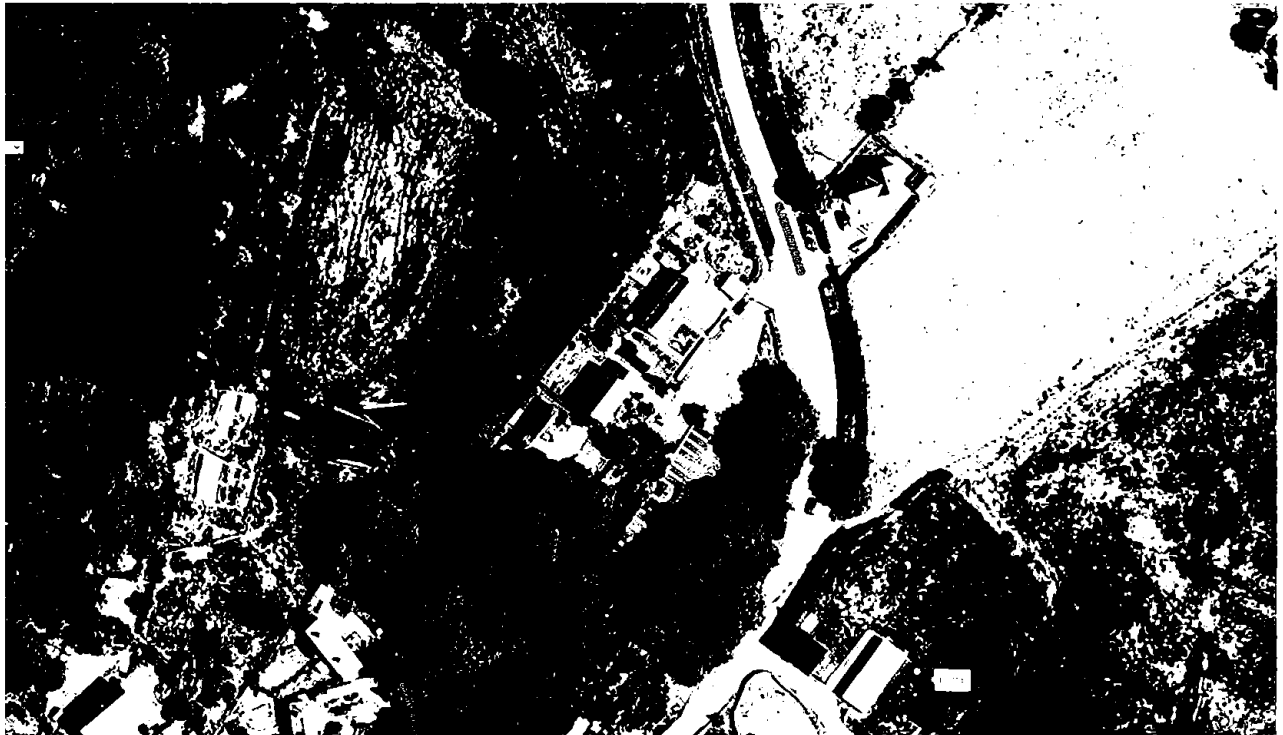
The site has been used as a workplace and is mainly hard standing with some grassed areas, although the site is surrounded by mature trees m

The site itself does not provide roost or forage potential but the immediate surroundings do provide optimal forage and roost potential.

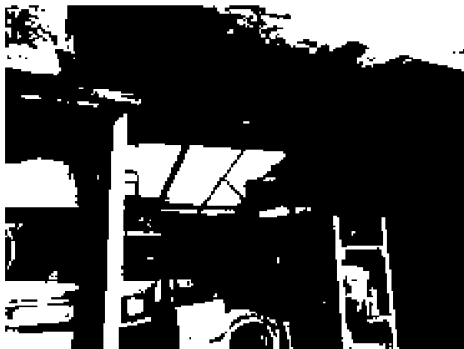
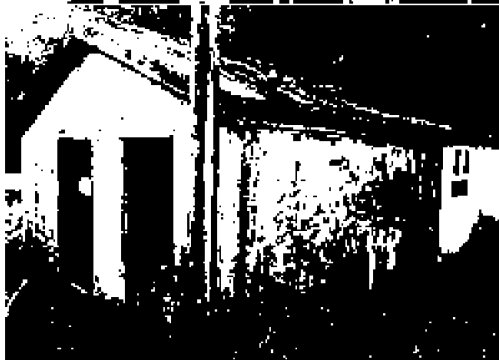
The walls are concrete block some sections having a render finish . The open timber section has OSB board sheets fixed to a timber frame, the timbers and sheets appear relatively new.

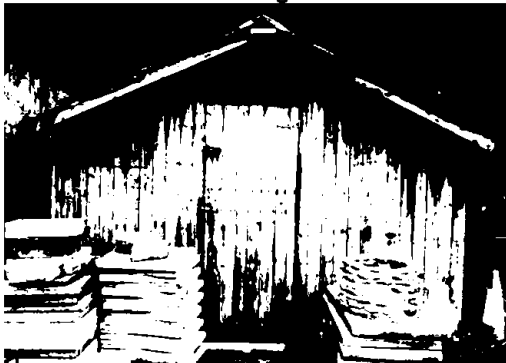
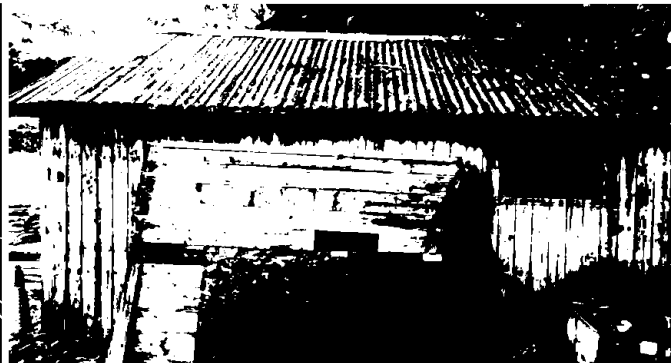
Timber vertical boarding fixed over a timber frame.

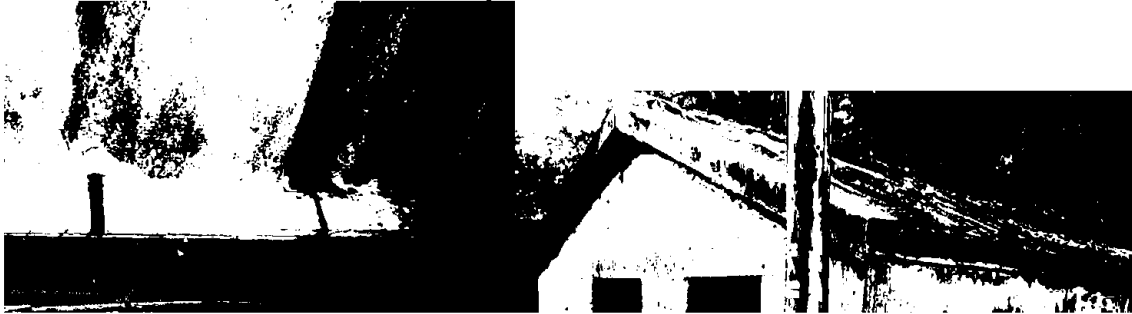
Whilst the fibre cement sheet has significant moss coverage the sheets are all in tact and tight fitting. The trims to the gables and ridge are in good condition and tight fitting. The corrugations are pointed at the eaves (see below) There are no access points in this roof. The ad hoc shelter is open bats can freely enter.

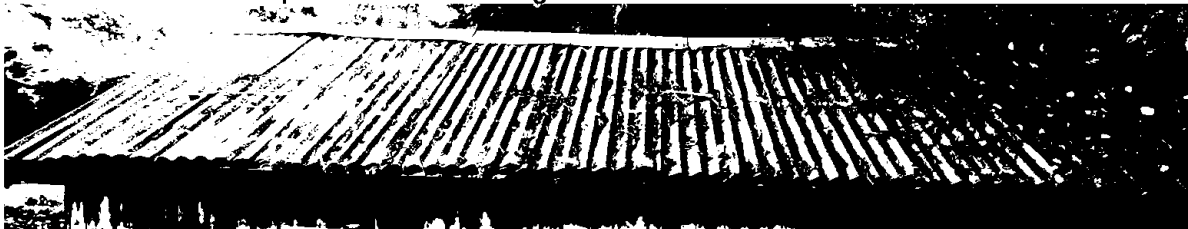
The metal sheet finish and metal ridge trim are old and slightly rusty but are still intact and tight fitting. However Bat access is possible via the corrugations at the eaves abutment.

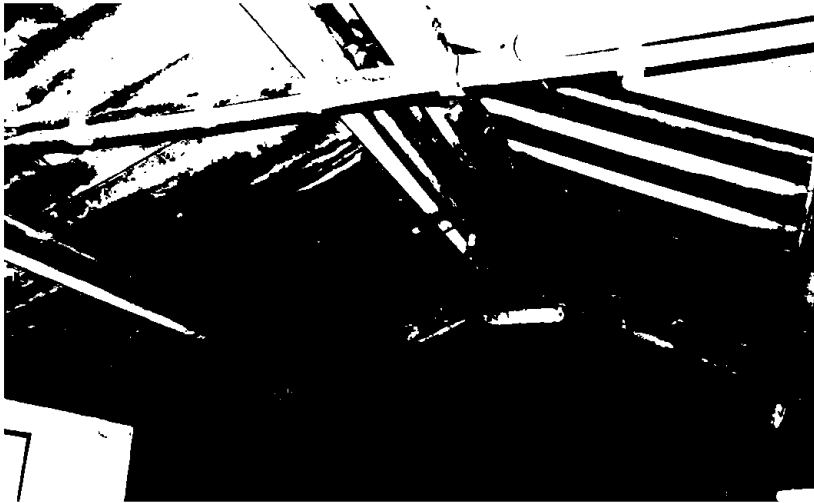
There is no enclosed roof space in the workshop The concrete roof structure is fully visible as is the under side of the sheet roof covering. The structure provides sub optimal roost potential.

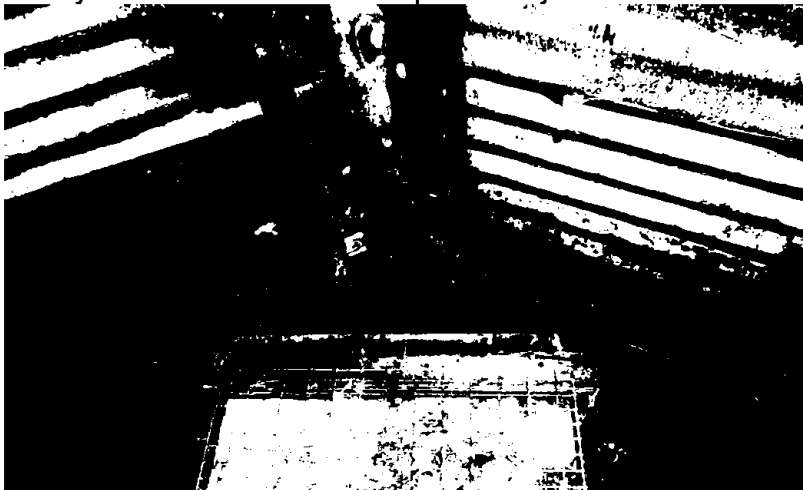
The roof structure of the shed was fully visible. Metal angle truss with timber purlins and sheets directly over. The structure did not provide any roost habitat for bats
