**Ecological Consultants
Environmental and Rural Chartered Surveyors**

**BAT SURVEY AT
Knott Gate Farmhouse**

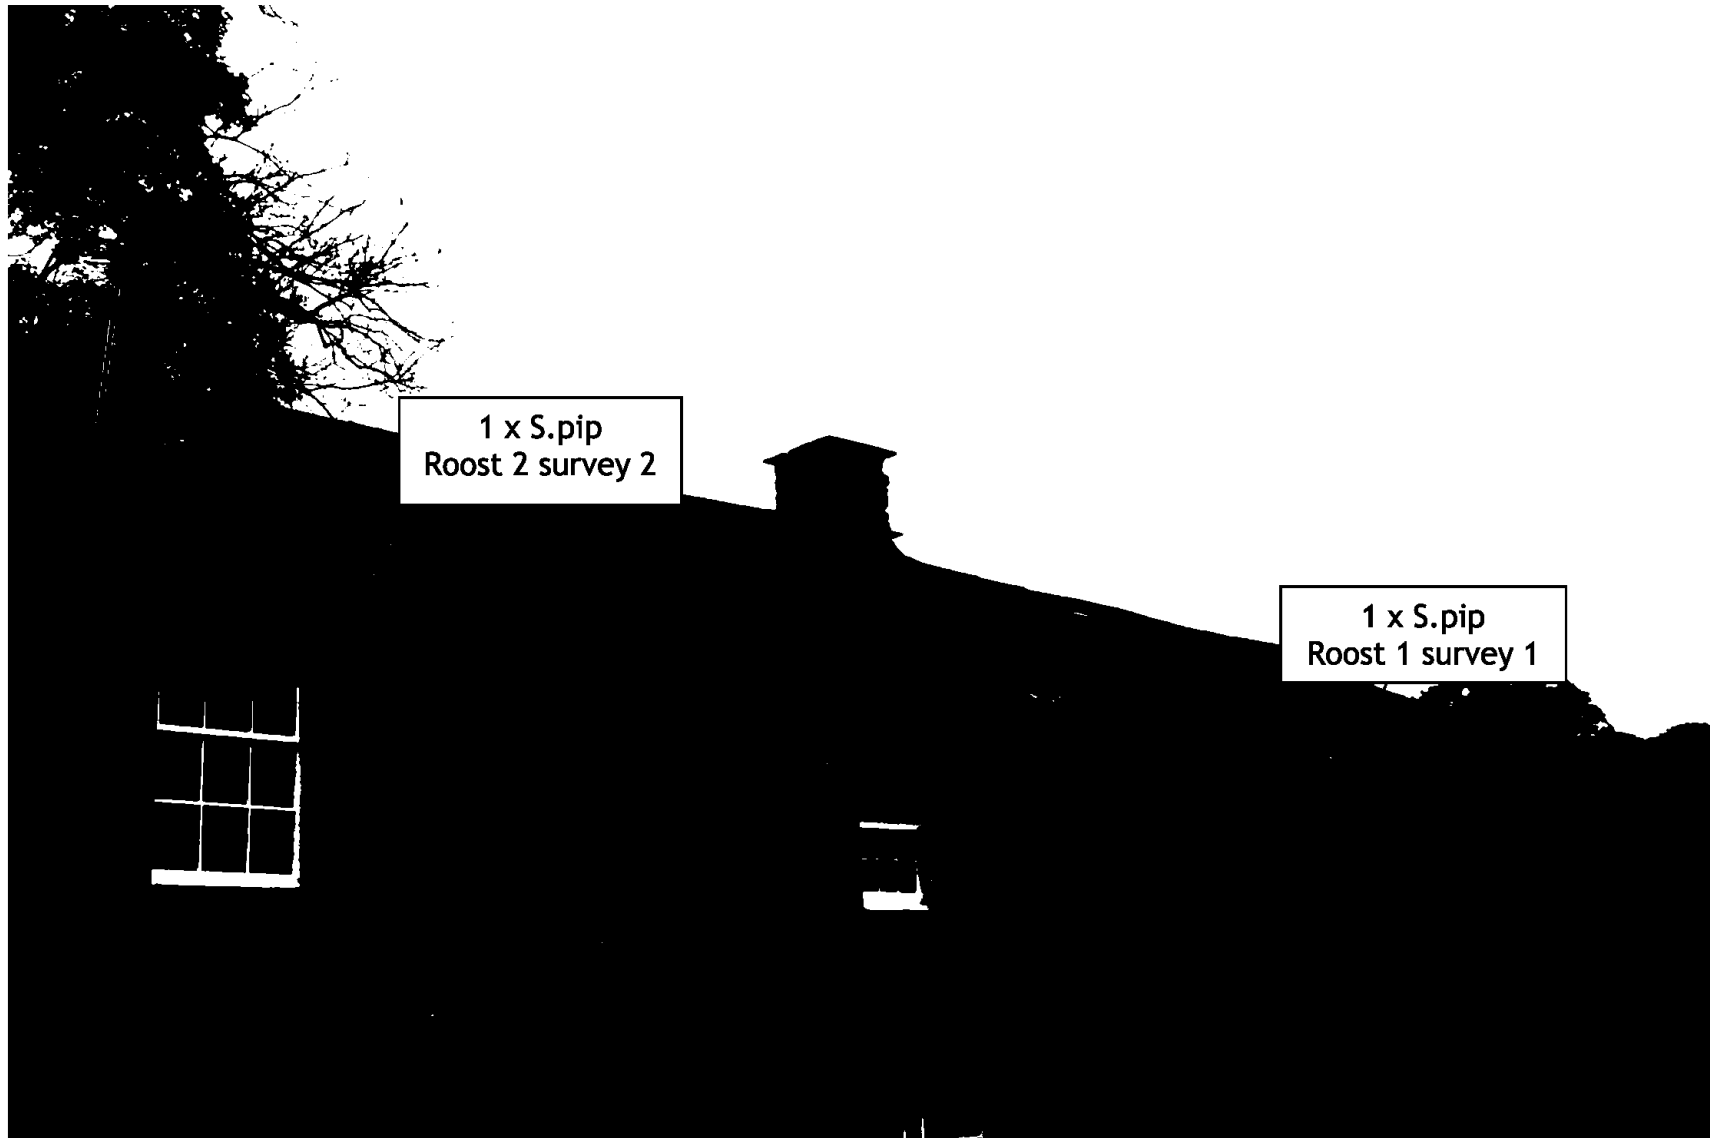
Figure 7- Roost locations

There was current evidence of two Soprano Pipistrelle (*Pipistrellus pygmaeus*) bats roosting found at the site during the survey.

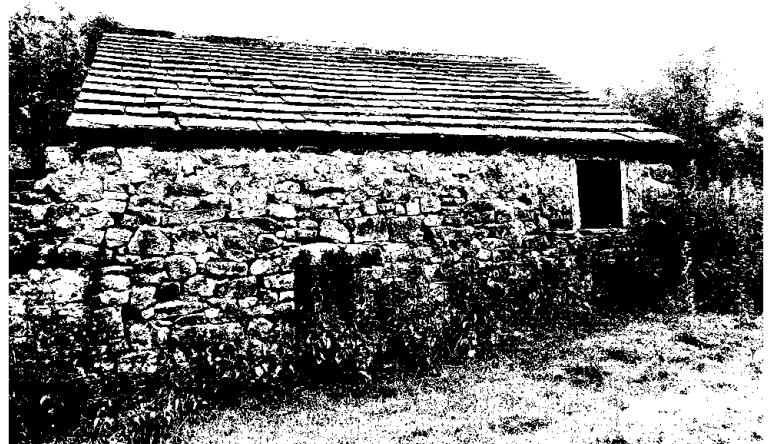
The walls of the detached store are also stone but low to the ground, being single storey. Shallow gaps were noted in them but no evidence of use by bats was apparent.

The store has well sealed walls and a stone slate roof. It is a small building which could be fully inspected during the daytime surveys
