ARBORICULTURAL IMPLICATIONS ASSESSMENT

PROPOSED DEVELOPMENT

**HILLSIDE
MOOR LANE
WISWELL**

Ref: TRE/HML/Rev A

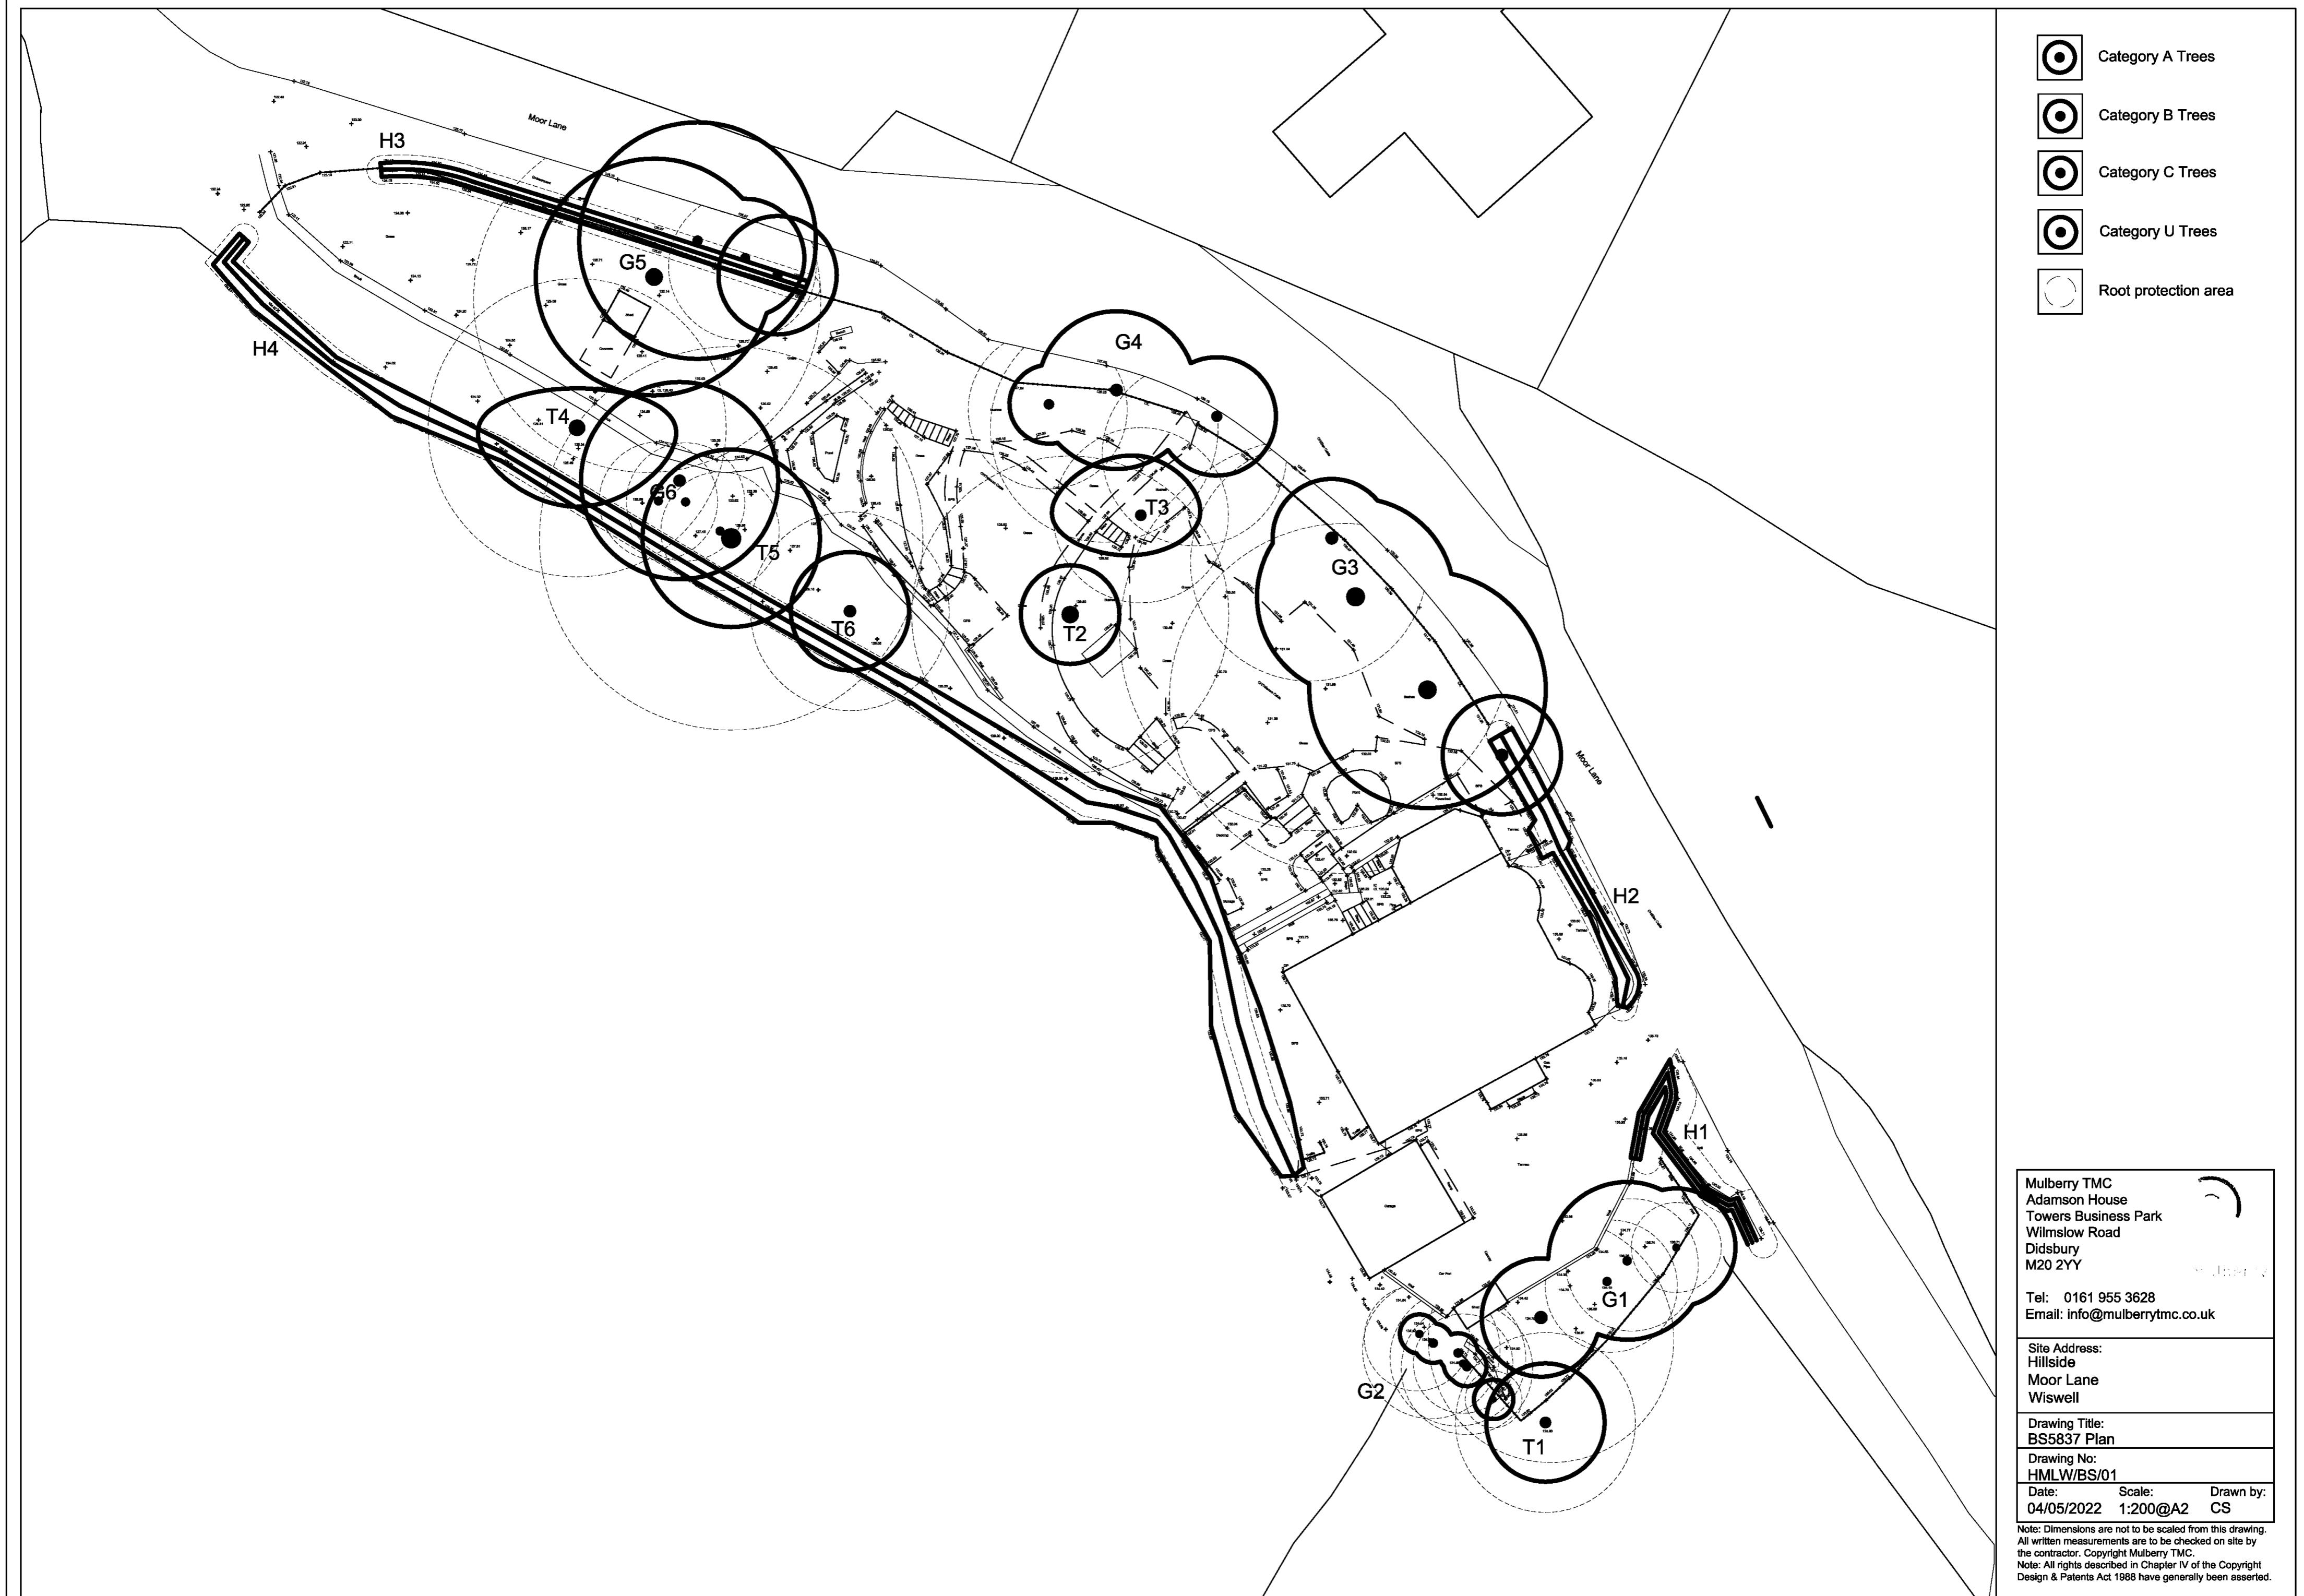
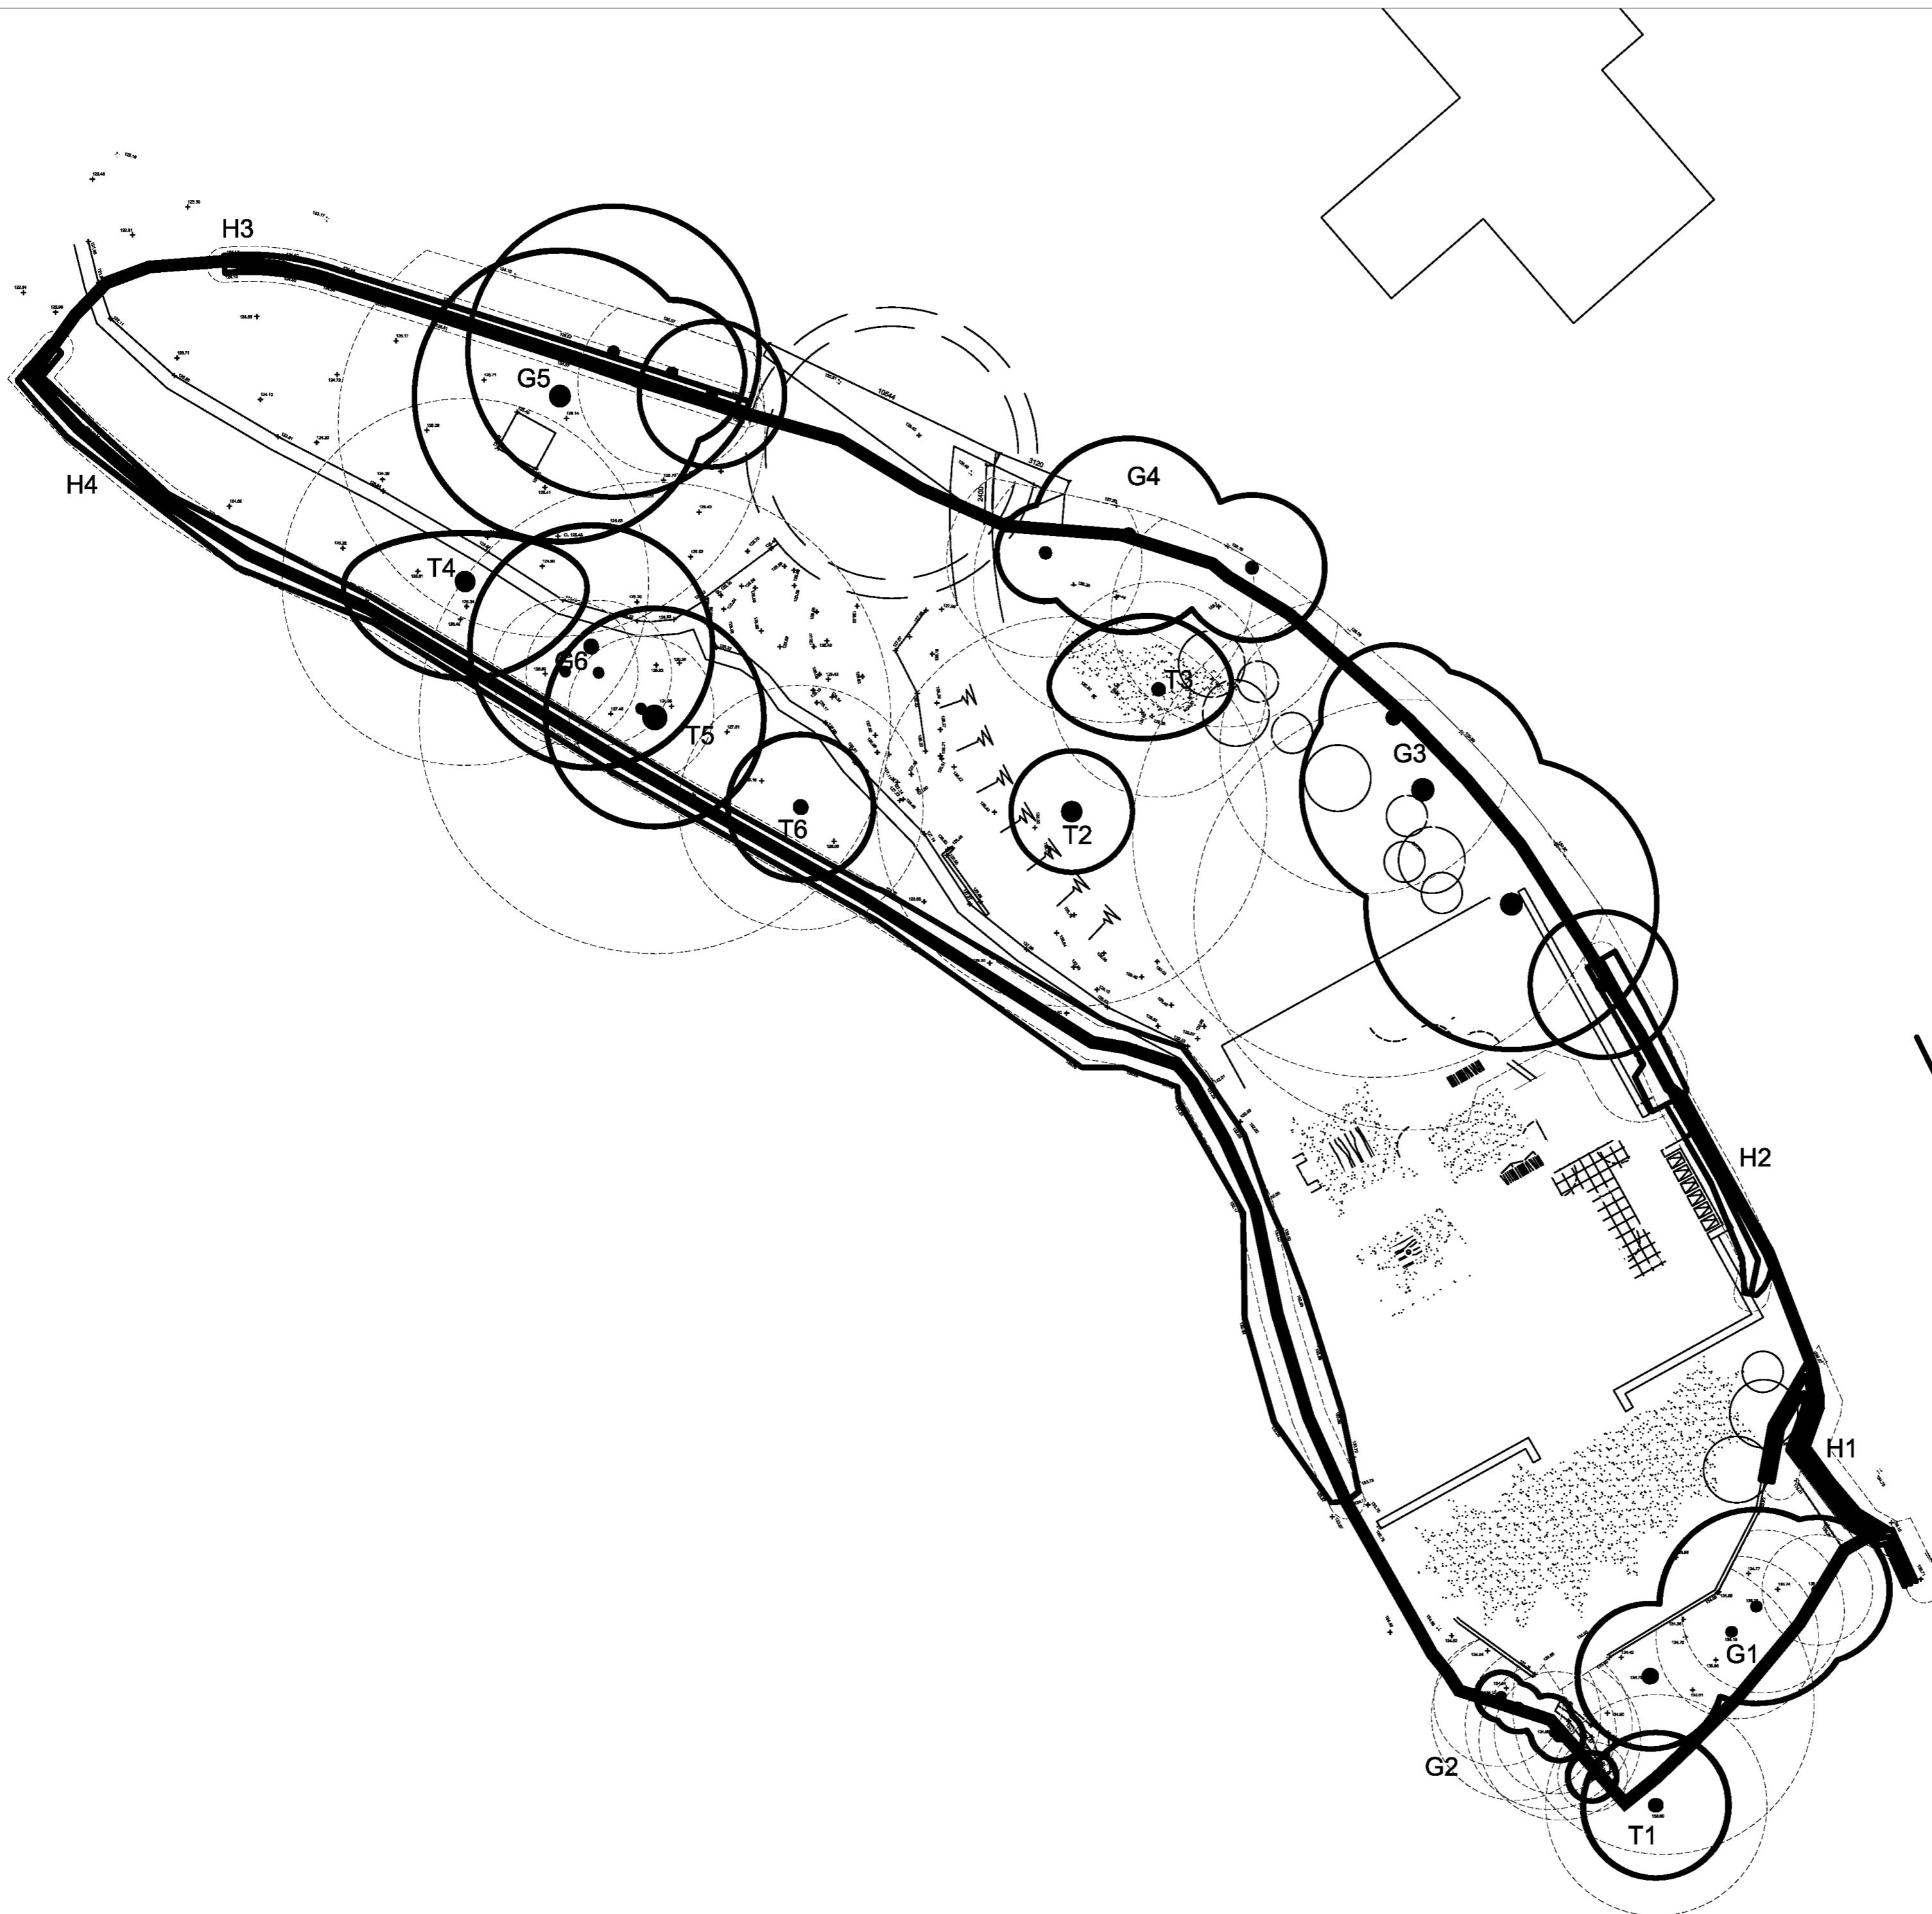
Drawing Title:
 AIS Plan

- 3.1 Due to the proposed development and its associated infrastructure there are a number of locations where the proposals are in close proximity to the trees surveyed. The Site Layout Plan within appendix three identifies the trees in relation to the proposed development.
- 3.2 In order to fully assess the impact of the proposals an Impact Table has been created detailing each tree, which shows the proximity of the associated works to the tree.
- 3.3 This can then be assessed in accordance with BS 5837:2012 to determine whether the development will have a detrimental impact on the health of each tree. Once this has been determined remedial measures can be detailed to reduce the impact the proposals will have on the treescape.

Tree No.	Root Protection Area identified in Table 2 of BS 5837:2012	Distance to Proposed Hard Standing (m)	Distance to Proposed Development (m)	Can the Tree/s be Successfully Retained
T1	65m ²	N/A	N/A	Yes
T2	Fell Due to Development			
T3	62m ²	1.50	16.10	No
T4	180m ²	12.70	38.50	Yes
T5	297m ²	8.50	28.40	Yes as outlined in section 5.0
T6	80m ²	8.50	21.50	Yes
G1	76m ²	N/A	N/A	Yes
G2	33m ²	N/A	N/A	Yes
G3	Fell Due to Development			
G4	Fell Due to Development			
G5	209m ²	3.70	37.70	Yes as outlined in section 5.0
G6	80m ²	8.70	31.60	Yes
H1	2m ²	N/A	N/A	Yes
H2	2m ²	1.40	4.50	Yes
H3	2m ²	0.80	35.10	Yes
H4	2m ²	2.60	1.70	Yes

Trees to be retained		Trees to be removed	
	With No Impact	With detailed construction	Due to Condition	Due to Development
Tree No.	T1, T4, T5, T6, G1, G2, G5, G6, H1, H2, H3 & H4	N/A	N/A	T2, T3, G3 & G4

5.1.1 The impact table below shows the proposed car parking having a minor encroachment into the root protection area of T5 & G5. It is felt that due to the species, condition and limited extent of encroachment the proposal will not have a detrimental impact on the safe useful life expectancy of these trees.
