Hillside, Moor Lane, Wiswell

Bat Scoping Survey Report

11th April 2022

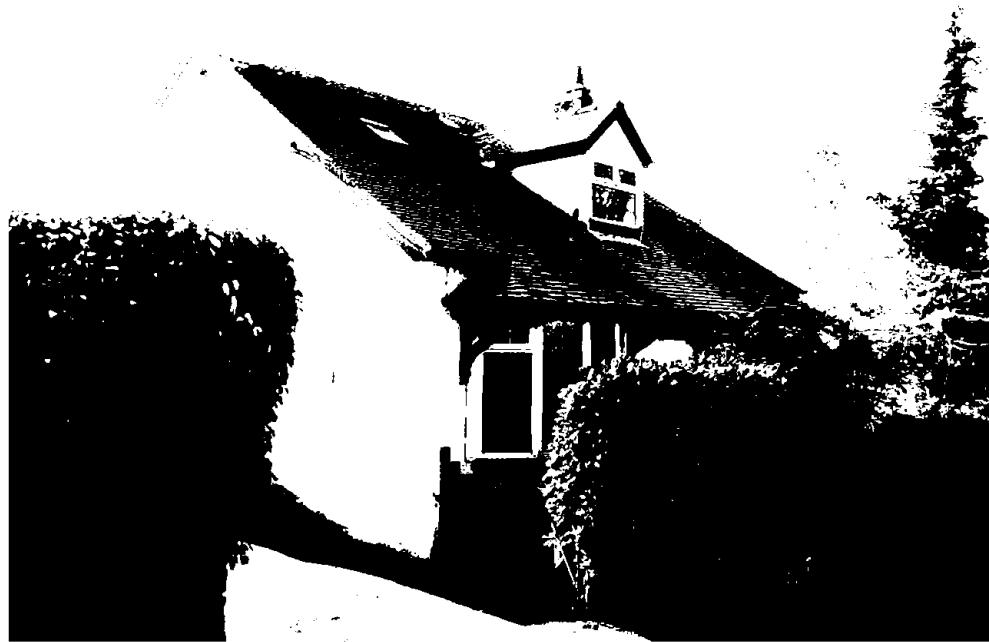
The house has a pitched roof clad in ceramic rosemary tiles. The house has three gable faces, facing north, west and south. There is a dormer window at the building's east face. The external brickwork of the house has been rendered in white pebble dashing.

The dormer window, at the buildings east face, also offers potential bat roosting habitat between overlapping tiles running along the pitched dormer roof.

Photograph 1- South and east face of house

In order to further assess the potential bat roosting features identified, at least one dusk or dawn bat activity survey should be carried out during the peak bat survey season (between late May and the end of August). It is recommended that two surveyors are used to assess the buildings. Recommended surveyor locations are shown on figure 2 in the Appendix.

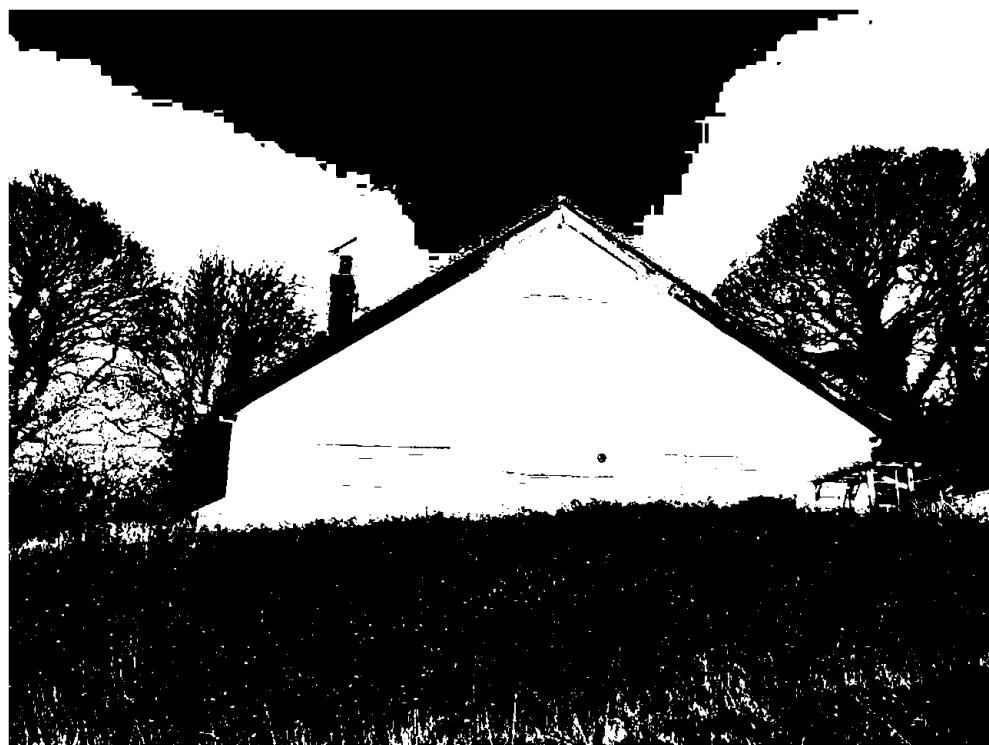
Some limited potential bat roosting habitat was identified at each face of the house. The verge mortar at the gables appears intact and well-sealed, however there are occasional narrow gaps present between the overlapping rosemary tiles at each gable face. These features offer potential roosting habitat for individual or low numbers of bats.

Photograph 2- West face of house

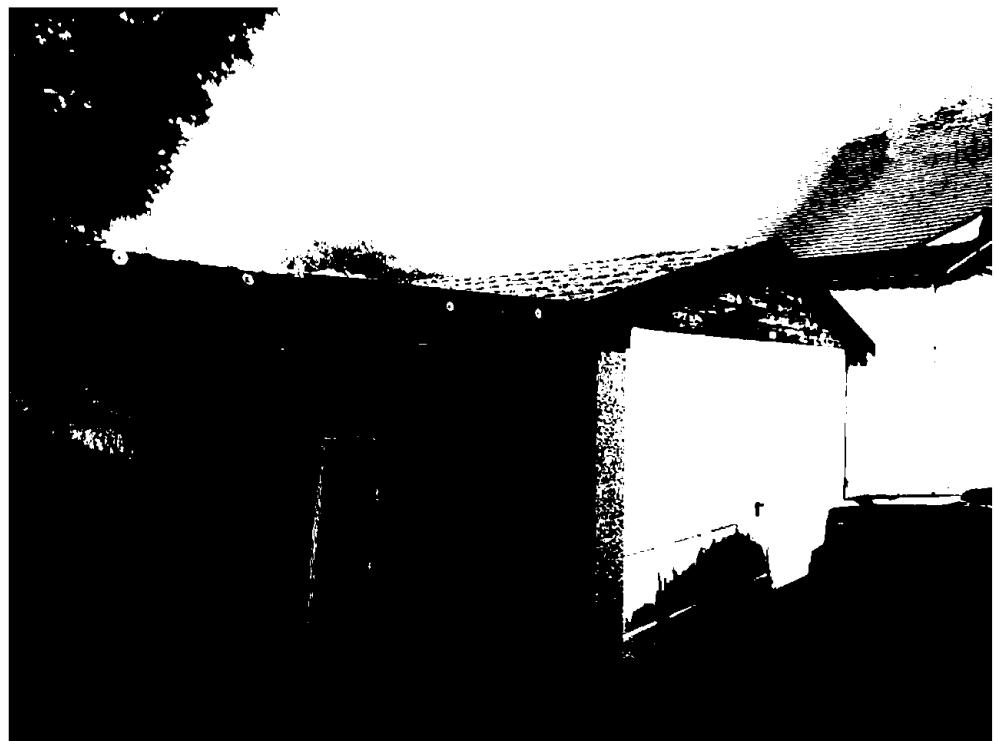
The detached garage building (Building 2) is constructed of rendered concrete panels and has a shallow pitched roof clad in tightly fitted, interlocking concrete tiles. The garage has tight fascia boarding running beneath the gables. No obvious potential bat roosting habitat was identified.

Based upon the external inspection, the garage is considered to offer a 'negligible' bat roosting potential.

Photograph 3- Garage building

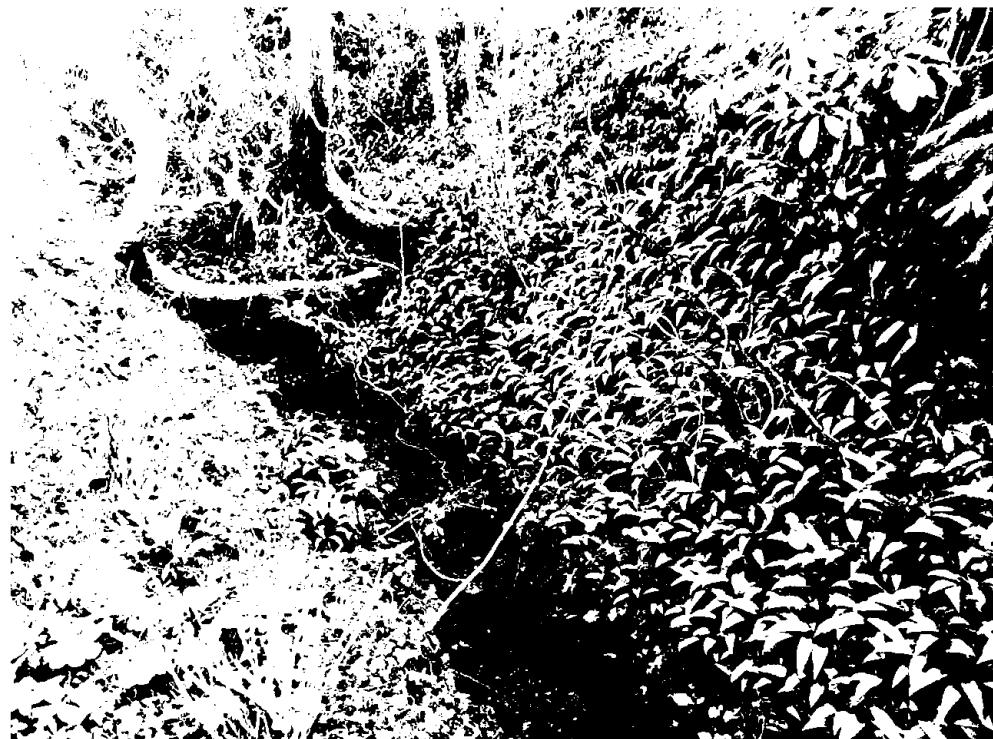
A narrow watercourse runs along the western boundary of the site with a further channel joining this watercourse from the east of the site.

The stone channel is approximately 1 m wide with a low water flow. Much of the channel is dry with water collected in shallow pools less than 10 cm deep. The bank between the hedge and the channel on the site western boundary supports a carpet of wild garlic and ivy.

Photograph 7- Small stream/drain that flows through garden

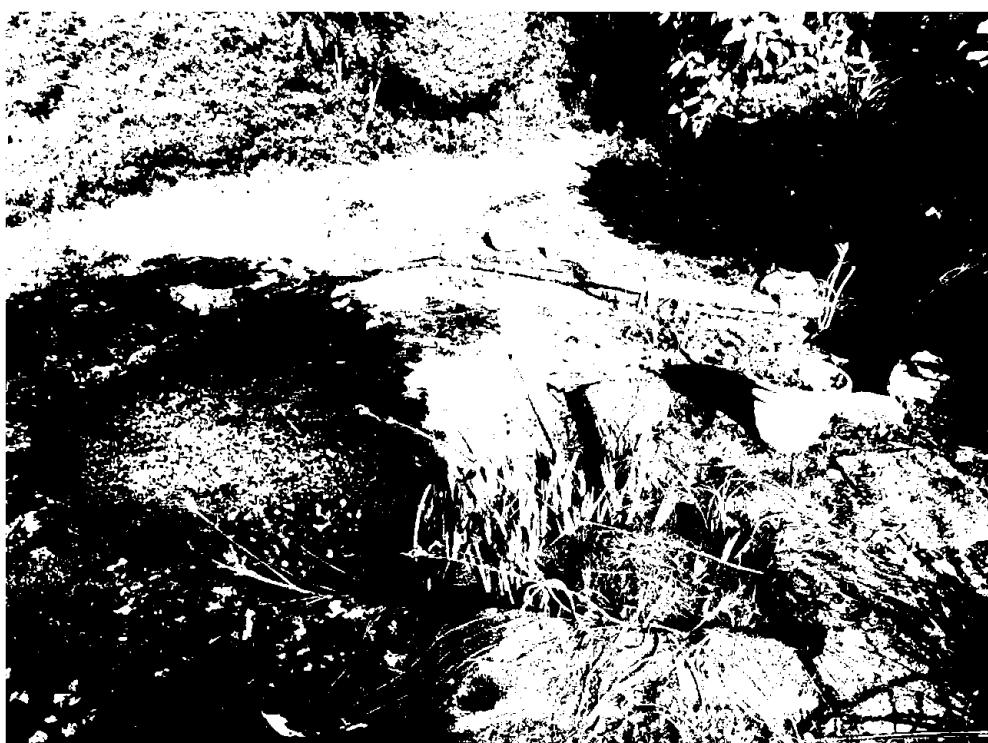
Pond 2 is located on the top garden terrace (Target Note 4), this pond is also contained within a patio area. The pond measures approximately 10 m² in area and supports Canadian pondweed, marsh marigold and yellow iris with a covering of duckweed. Frogspawn was also observed to be present within this pond.

Photograph 10- Pond at Target Note 4
