# **Preliminary Bat Roost Assessment Report**

**Outbuildings at Land adjacent to Miles Hill,  
Moor Lane,  
Billington,  
BB7 9JH**

**13.03.2023**

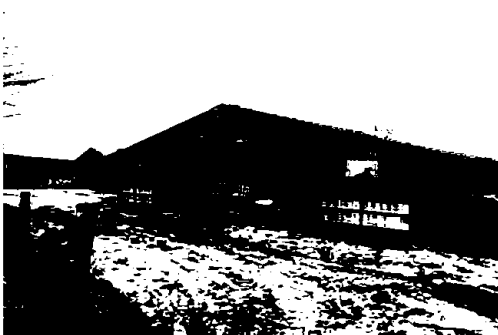
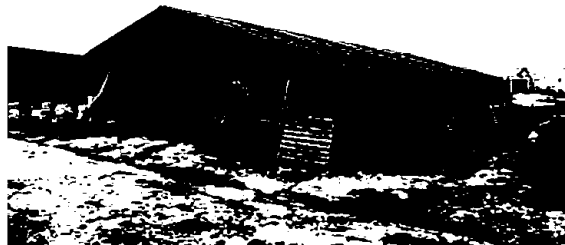
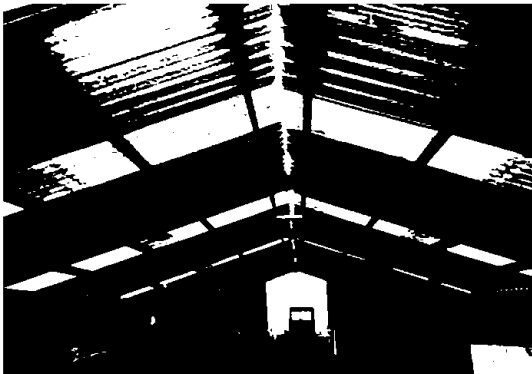
The property consists of three portal style agricultural outbuildings, two with double pitched corrugated fibreboard roof, and an open fronted outbuilding with single pitched corrugated fibreboard roof.

The buildings have single skin timber sides and roof panels are unlined with ridge panels exposed to the interior.

The outbuildings can be considered to offer negligible bat roost potential.

The buildings are single skin construction with no cracks, gaps, cavities or crevices suitable for roosting bats and were assessed as offering negligible roosting potential.

No evidence (in the form of scattered droppings, urine splashing, feeding remains or grease marking) to suggest use by bats was recorded.
