**Bat Survey Report and Method Statement
European Protected Species (Bats)**

**4 Commons Lane,
Balderstone,
BB2 7LP.**

17.05.2023

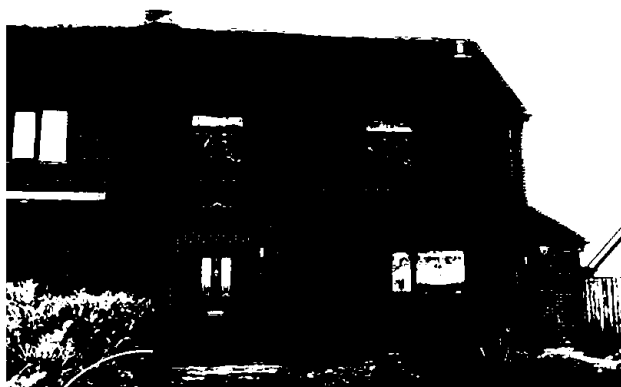
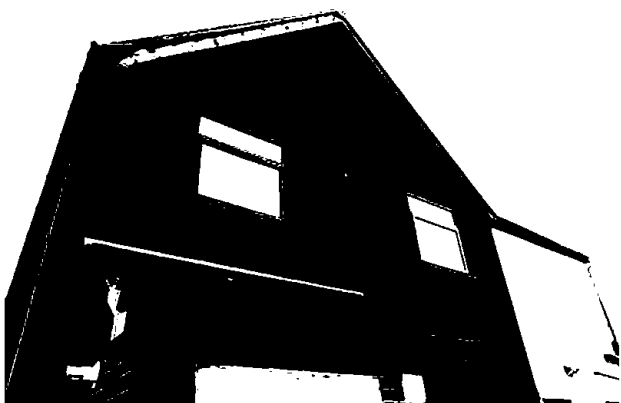
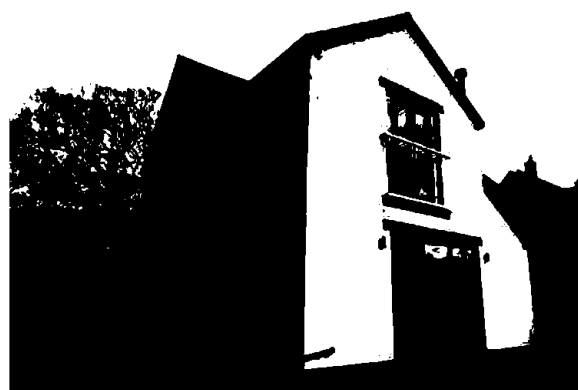
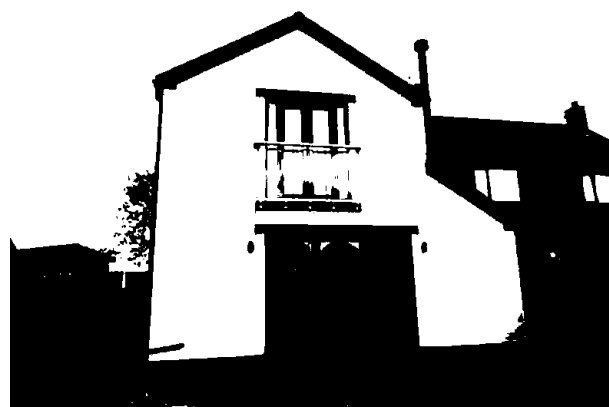
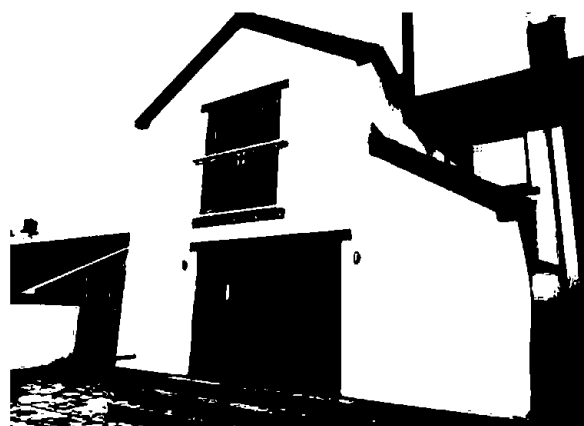
The property consists of a semi detached two storey brick built house with double pitched tiled roof a modern two storey extension is present to the rear.

The property has well pointed external walls and gable ends, the extension features rendered and painted walls.

Roof tiles are close fitting with no slipped, missing or lifted tiles and the ridge is well pointed.

The building was assessed as offering a negligible to low level of bat roost potential.

No physical evidence, in the form of concentrated or scattered droppings, urine splashing, feeding remains or grease staining, was observed during a visual check of the building.
