**BAT SURVEY AT -
BROAD OAKS
NORTHCOTE ROAD
LANGHO**

**DATE AND TIME OF VISIT
14th April 2023 9.00am**

REFERENCE NO. 6870

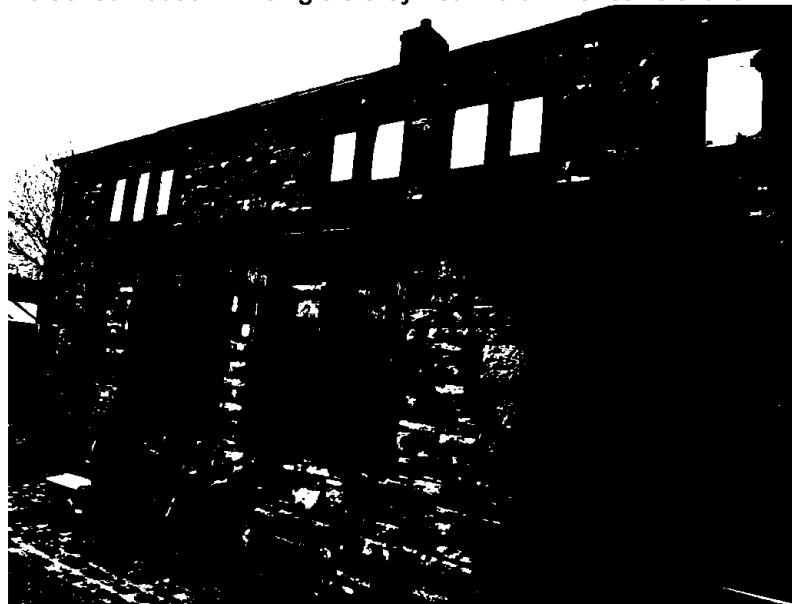
Detached house with single storey Lean to on the rear elevation.

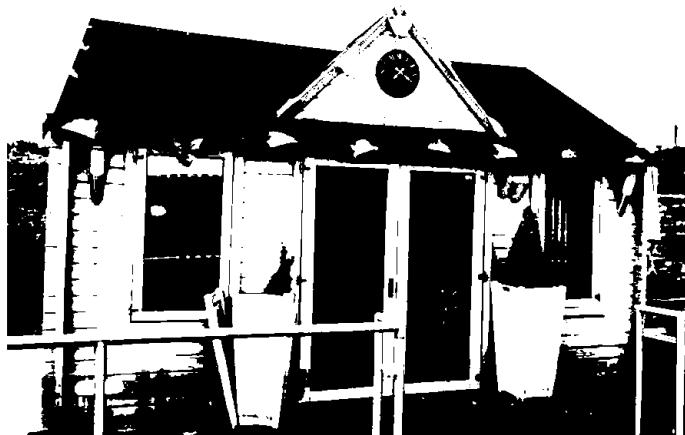
Detached summer house in the garden.

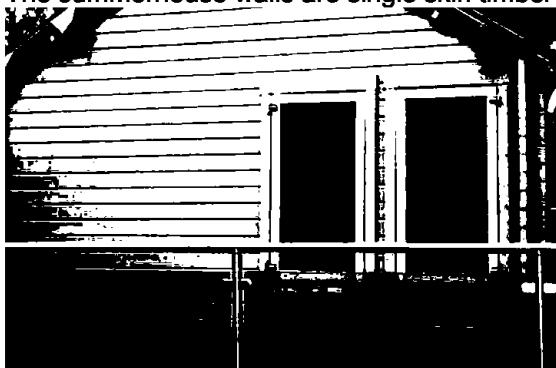
The summerhouse walls are single skin timber boarding

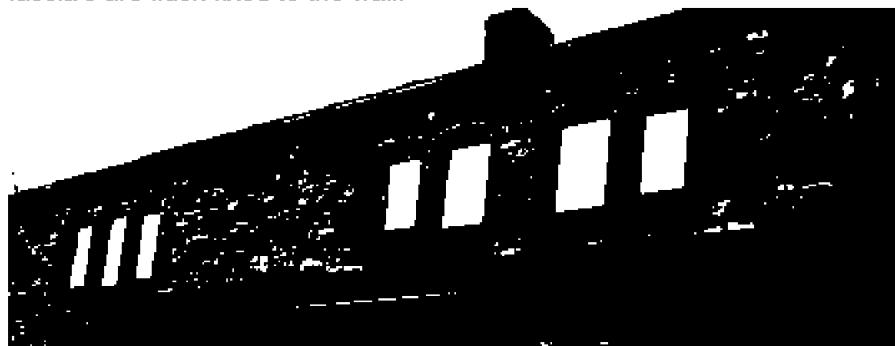
The lean to roof has a grey slate finish with pointed verges and flashed to the main house wall. UPVC fascia's are flush fixed to the wall.

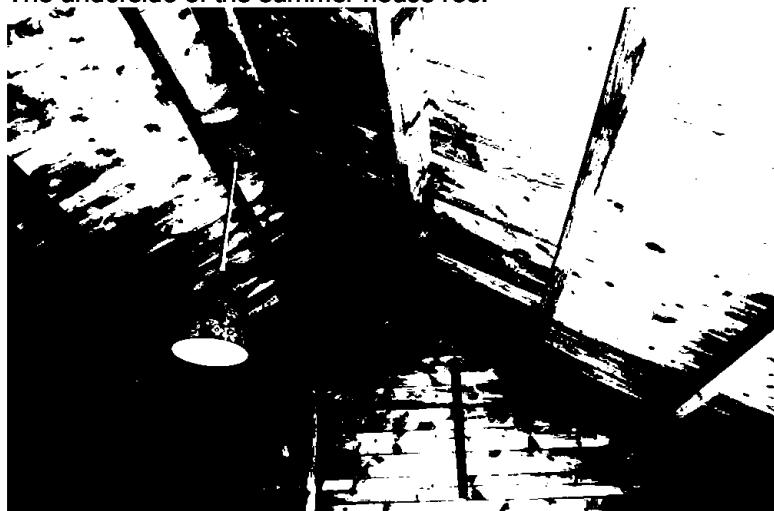
The underside of the summer house roof

The Summerhouse roof has timber purlins with single skin timber boarding over. In excellent condition and did not provide any potential roost habitat for bats.

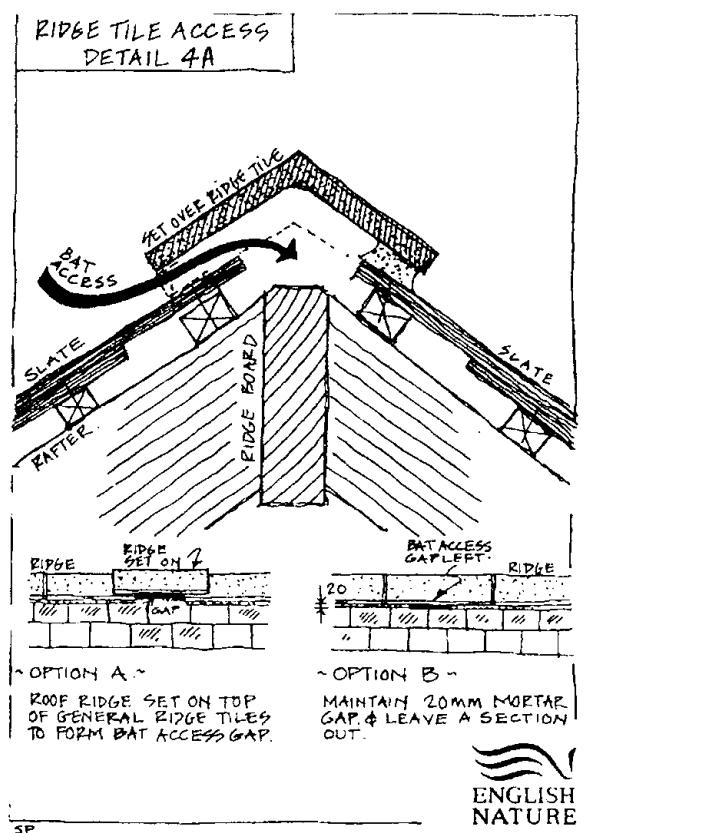
Ridge access tile Detail 4A (below)

RECOMMENDED BY NATURAL ENGLAND: either raised ridge tiles providing 15 – 20mm gaps or leaving access gaps under tiles to enable bats to enter the space beneath the ridge tiles

Pipistrelles and long-eared bats will enter roofs via narrow gaps under the ridge tiles; additional benefits are provided when small gaps are provided through the roofing felt or sarking membrane thus enabling bats to enter any retained roof voids.

PROVIDE 2 NO RIDGE ACCESS TILES ALONG THE ROOF RIDGE.

SPACE RIDGE ACCESS SLATES EVENLY ALONG LENGTH OF ROOF.
