PROJECT: 2630 CHIPPING HOUSING
REPORT: 501 ARBORICULTURAL SURVEY

PREPARED BY TPM LANDSCAPE LTD

Chipping Homes Ltd

Date: October 2016

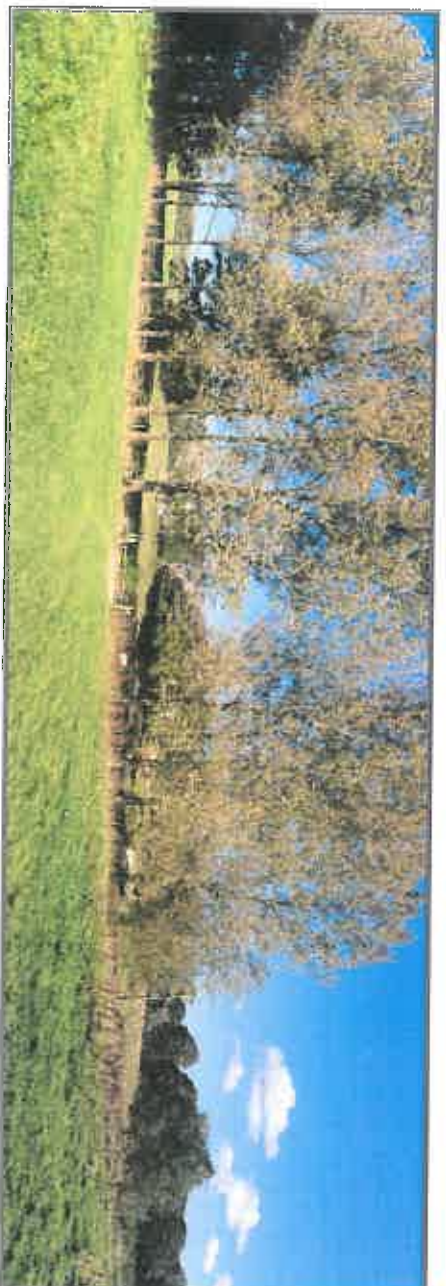
- Along the eastern boundary of the site are a line of black poplar assessed as C1 and noted as having limited value within a residential setting.
- A hedgerow follows the Church Raika boundary to the north containing principally hawthorn and elder but with some other native species. A section of this hedgerow will be lost to enable access into the site.

G11 Black Poplar group on western boundary

No trees have been assessed as requiring immediate removal due to poor health or health and safety concerns. The Black Poplars at the western boundary of the site were noted as not being well suited to a residential environment in the longer term.

The G11 groups of black poplar at the western boundary of the site have been highlighted as potentially causing problems through limb loss in the future.

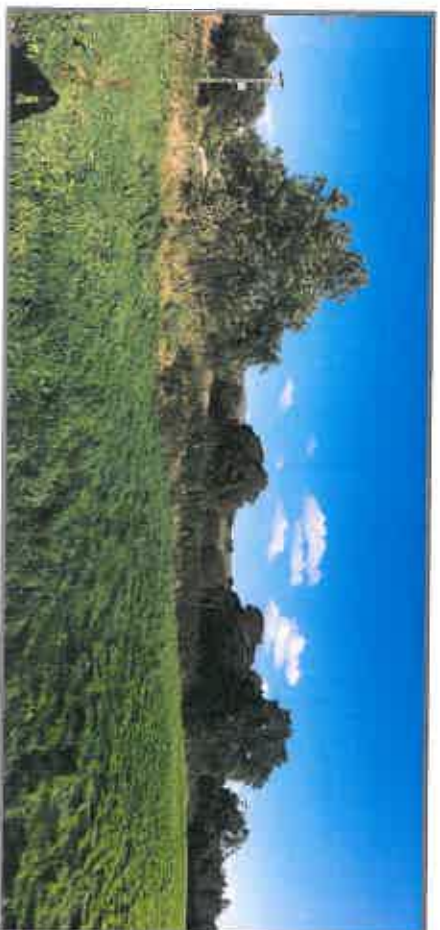
Northern boundary and H8 with T7 in the foreground

Boundary vegetation is retained around the whole of the site other than for a small section of the northern boundary hedgerow H8. Although not replaced the design proposals include for the introduction of a stone retaining wall around this entrance providing an appropriate boundary treatment in place of the hedge.

Location of Hard Surface / Tree Interface	Potential Methodology to limit impacts on trees
H8, T7, G4	Potential clash with level changes to facilitate access entrance

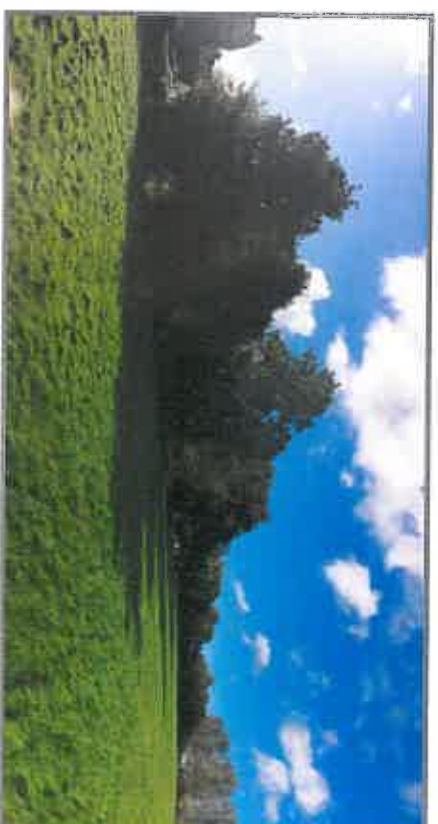
- Elsewhere intermittent individual trees lie along the southern boundary of generally good quality being assessed as B2.

Southern Boundary groups

Properties along the southern boundary of the site will experience some shading from retained mature trees and hedgerow along this boundary. This will extend over back garden areas with only T9 likely to cause some shading of the properties themselves.

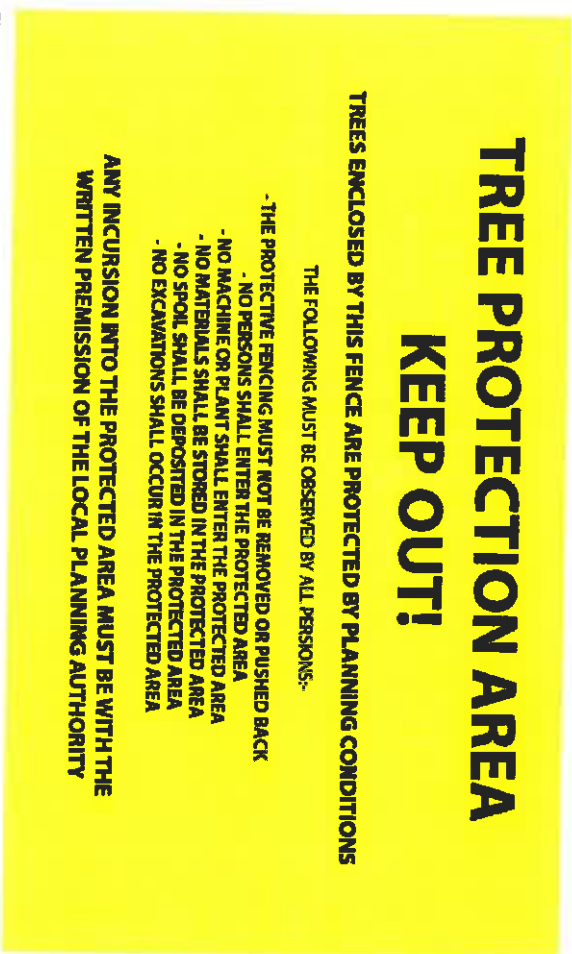
Figure 3 - example signage

This method statement has been produced from current guidelines BS 5837:2012 Trees in relation to Design, Demolition and Construction - Recommendations. All trees as shown to be retained on the approved plan should be protected by a tree protection fence before any materials or machinery are brought onto the site, and before any demolition, development or stripping of topsoil commences. Please refer to drawing 2530-102 for location of fencing and Figures 1 + 2 in Section 9.0 for the specification of the Tree Protection Fence. All-weather notices should be attached to the barrier with words such as: "TREE PROTECTION AREA KEEP OUT", please refer to Figure 4 in Section 9.0 for an example of signage.

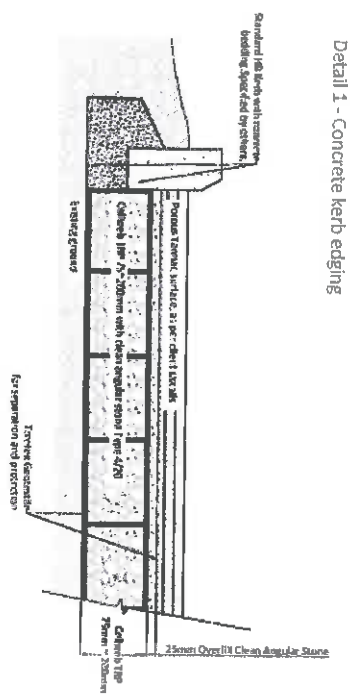
Detail 1 - Concrete kerb edging

Note: Subbase could be required depending on the existing ground conditions and the type of traffic on the surface.

Figure 5 - No-Dig Construction Details over RPA

Areas of proposed surfacing over the RPA should be carried out to a 'No Dig' construction method in line with detailed construction details from an engineer. Geotextiles and porous surfaces to be used. Surfacing should be constructed over existing levels to avoid excavations within the main body of the RPA.
