Project:
HIGHER LICKHURST
FARMHOUSE
CHIPPING

Title:
PROPOSED CRACK
REPAIR DETAILS.

Project No:	Drawing No:	Issue:
4138	01	A

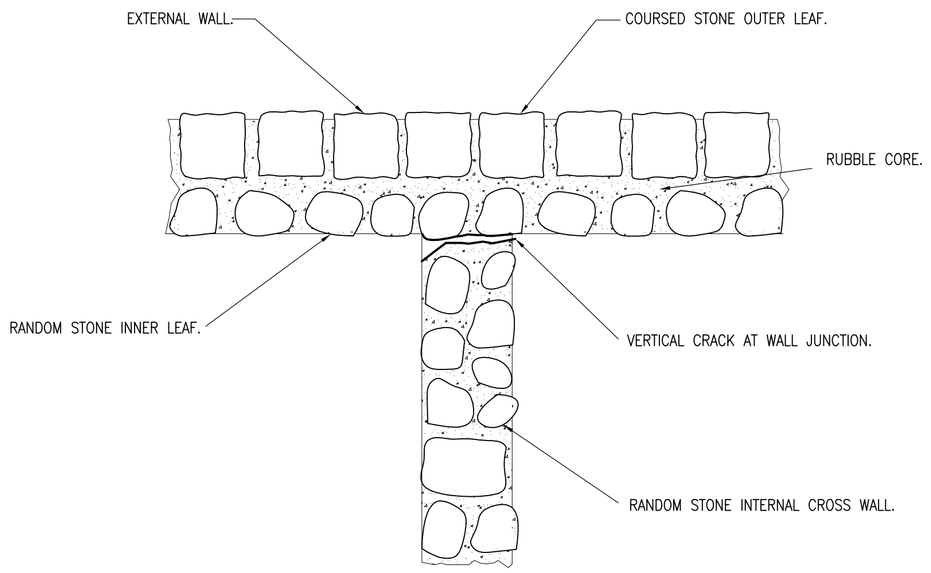
PLAN SHOWING POSITION OF EXISTING CRACK.

DETAIL 1.
REPAIRS TO UNBONDED WALL SECTIONS

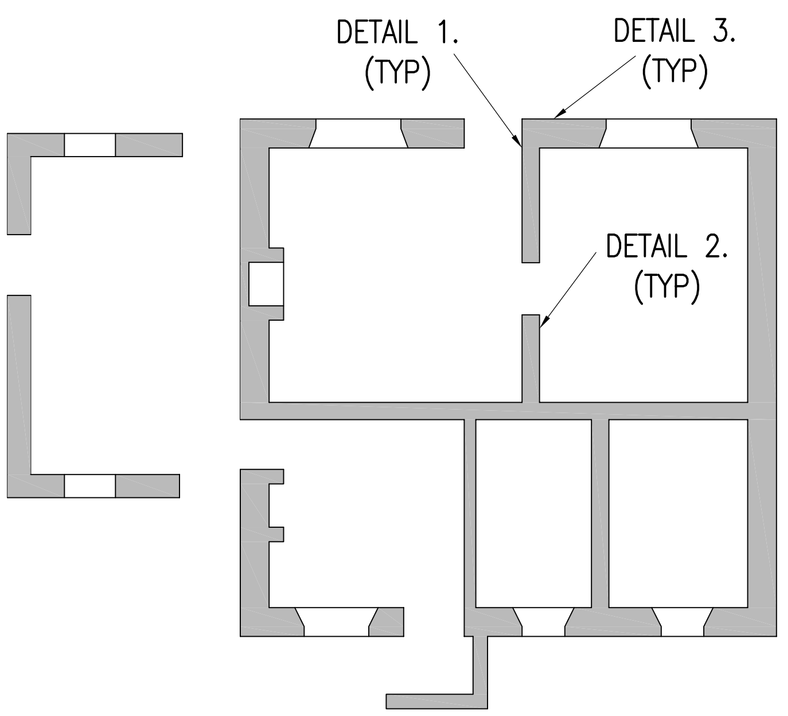
GROUND FLOOR PLAN OF FARMHOUSE.
(SHOWING TYPICAL CRACK LOCATIONS).

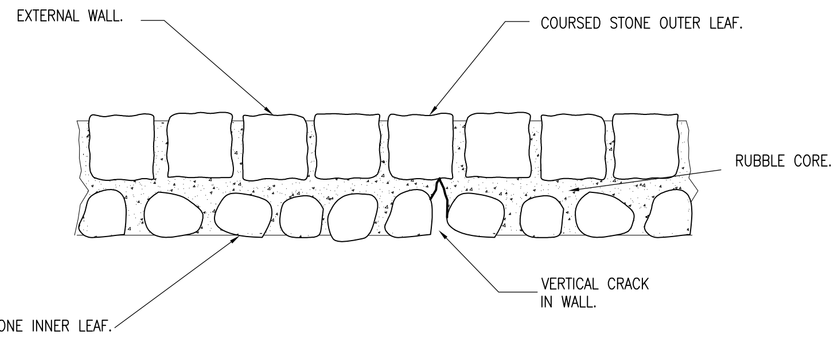
PLAN SHOWING EXISTING CRACK.

DETAIL 2.
REPAIRS TO VERTICAL CRACKS TO INTERNAL/INSIDE FACES OF EXTERNAL WALLS

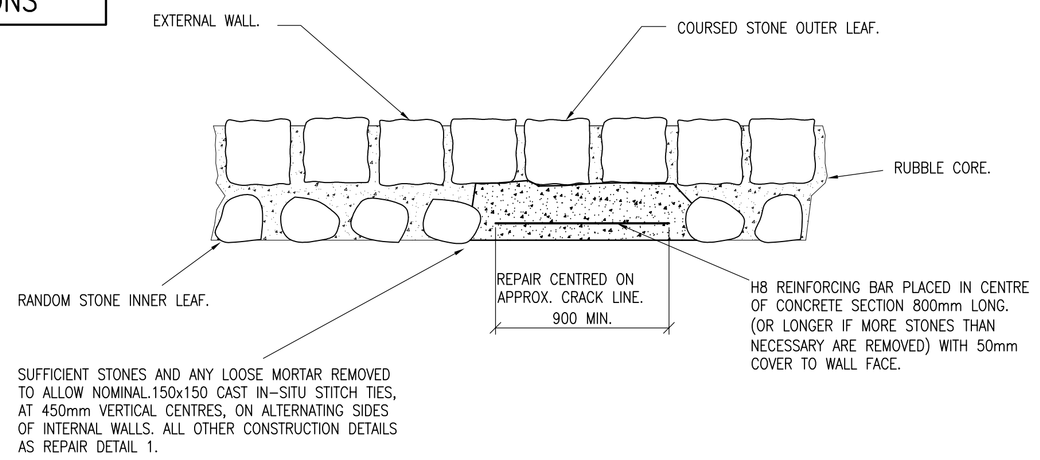
PLAN SHOWING EXISTING CRACK.

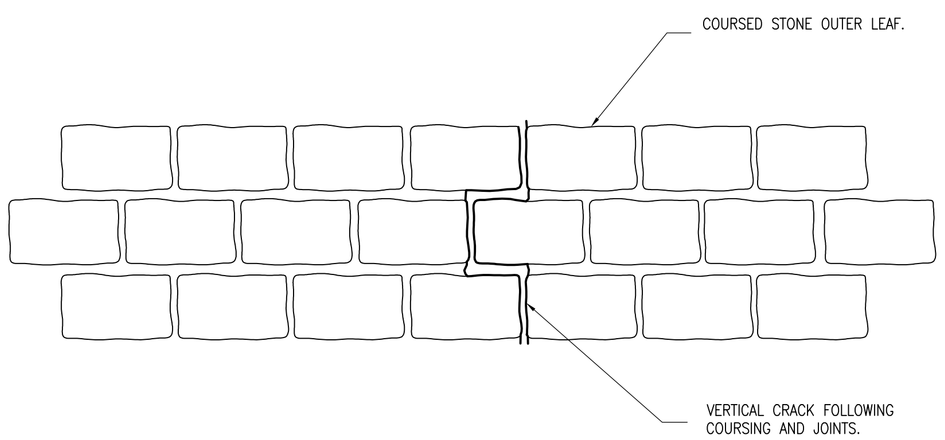
ELEVATION ON EXISTING EXTERNAL WALL CRACK.

DETAIL 3.
REPAIRS TO VERTICAL CRACKS IN OUTER STONE LEAF OF EXTERIOR WALLS.
