Proposed residential development
Land east of Chipping Lane
Longridge, Preston

Ground Investigation Report
(Phase 1)

Proposed residential development
Phase 1
Land East of Chipping Lane
Longridge
Preston
PR3 2NA

GROUND INVESTIGATION REPORT

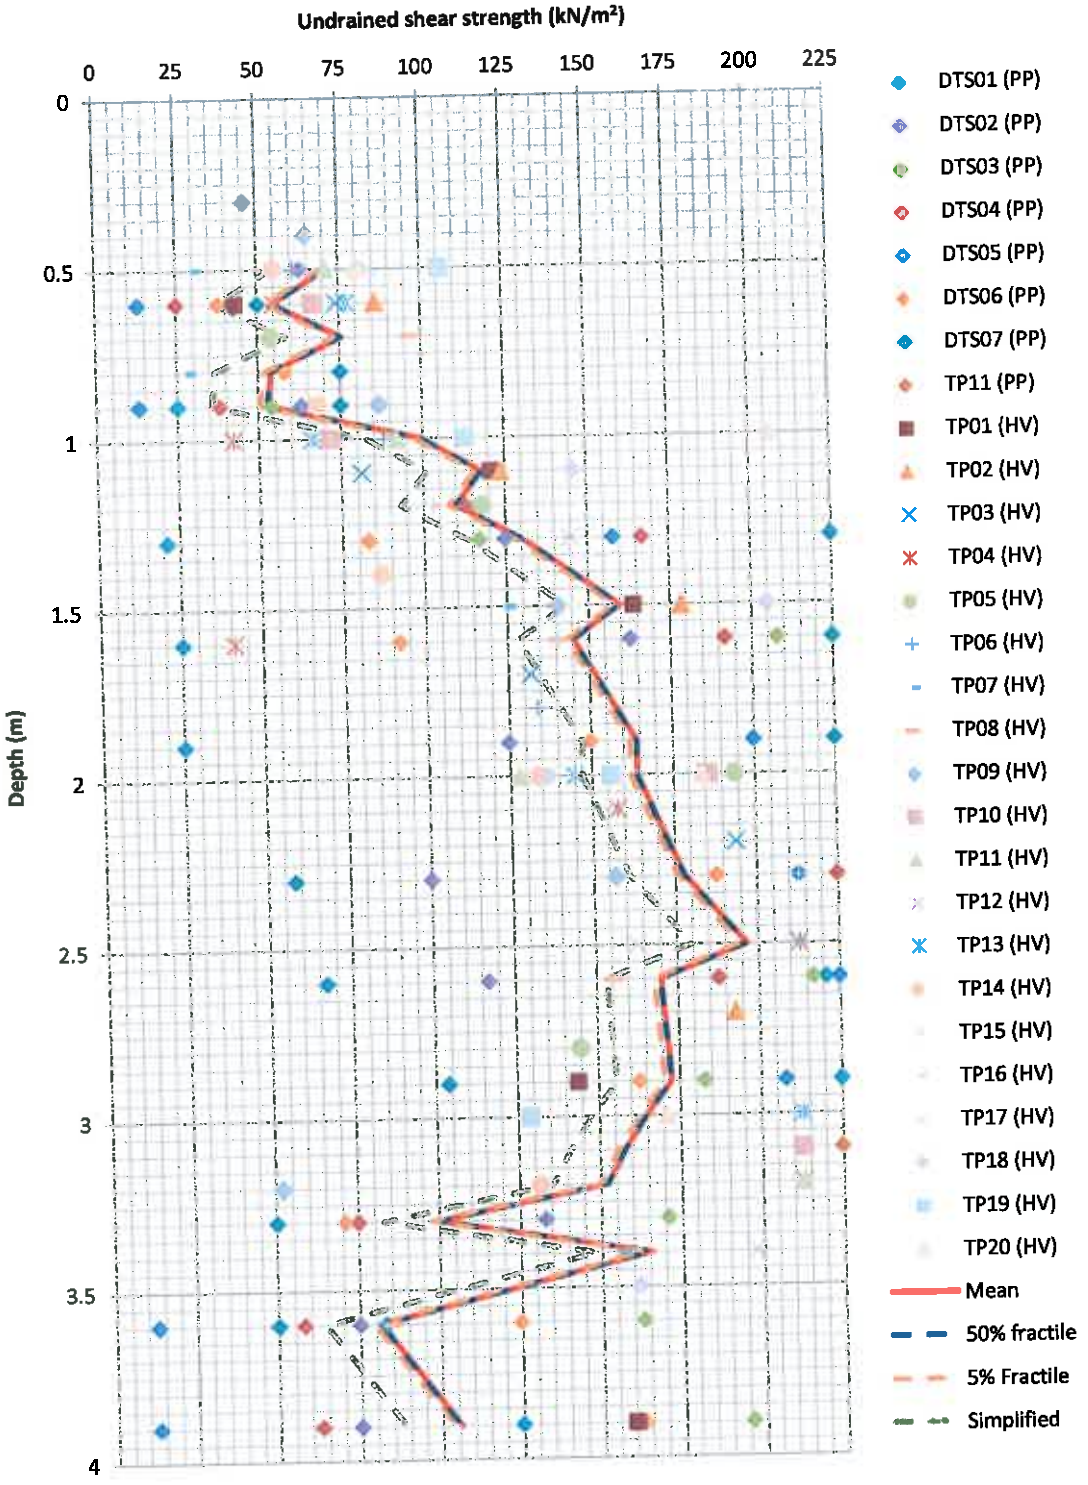
Title	Scale	Drawing number
Plot summarising results of pocket penetrometer and shear vane determinations by location	As shown	04

7.2.2.1 A detailed summary of ground conditions is provided in Section 5. Essentially ground conditions comprised of Topsoil overlaying cohesive Devensian Till deposits, the latter comprising low to very high strength brown mottled grey and orange brown/grey clay in the initial 1m-1.5m below surface level. Below such depths deposits generally exhibit an increase in shear strength and trend towards a brown mottled grey, dark brown and reddish brown colour with varying amounts of silt, sand and gravel. Locally, shear strengths were noted to reduce in value below depths of 2.5m-3.0m (refer to Drawing 04).

7.2.2.2 Suspected reworked Devensian Till deposits were also noted in borehole DTS01, extending to a depth of 2.1m below existing surface levels, which exhibited lower than average shear strengths from surface level in comparison to surrounding soils. It is possible that such soils are associated with a former track which is only evident on historical aerial imagery of the site, or long term water logging of near surface soils. Foundations will require deepening beyond the minimum recommended depth within this area (discussed in further detail below).

7.2.2.3 In addition to borehole DTS01, near surface naturally deposited Devensian Till also exhibited lower than average shear strengths in other localised areas of the site, associated with boreholes DTS03 to DTS06, and trial pits TP01, TP04 and TP07. Soft and low strength clay soils were encountered to depths of between 1.0m to 2.0m. Again, this may be associated with long term waterlogging of near surface soils and subsequently foundations will require deepening beyond the minimum recommended depth within these areas (discussed in further detail below).

7.2.3.6 As outlined in Section 7.2.2 above, localised areas of Devensian Till which exhibit lower than average shear strengths have been observed. It is recommended that foundations in such areas are deepened to locate stiffer soils which will reduce the risk of failure of supporting soils. The table below summarises these requirements, with the approximate extent of affected areas also highlighted on Drawing 07:-
