Drawing Title
Chimney flashings and lead to coping
Project
Number 4, Almhouses, Stydd lane, Ribchester, PR3 3YQ
Client
Your Housing Group

Job Number / Dwg. No. / Revision	RIBA Stage	Drawing Status
D_01	[ ] -	PLANNING

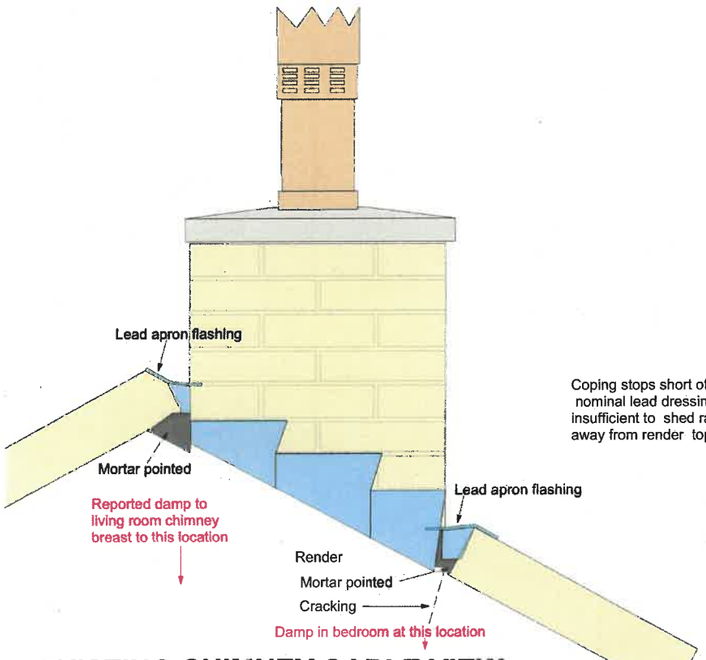
EXISTING CHIMNEY GABLE VIEW

Quoins standing proud of render, potential to allow water to track behind render. Recommendation: altering quoins or removing render is not an option that would be acceptable to conservation department. Only practical solution is to alter depth of render if practical or point joints and regular monitoring to ensure that this is kept in good order.

stops short of chimney,no overhang and coping, lead apron flashing appears to back fall. Recommendation is to repair using approved stone repair system as in listed building consent application and e lead flashings to chimney ensuring no ll and sufficiently laps over render

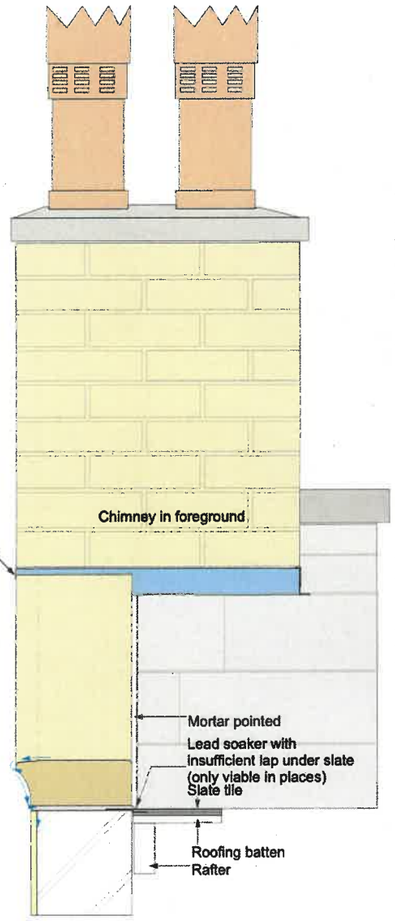
EXISTING CHIMNEY FROM REAR ELEVATION

No overhang and no drip to coping rain water running over the outside of coping and tracking behind render. There is also poor joints between copings. Cracks can be seen from just under the coping extending downwards with render debonding.

Cracking and de-bonding of render, evidence of repair having been undertaken, no overhang of capillary drip to stone coping, water tracking between joints in copings and between copings and render. Recommendation to repair render as set out in Listed building consent application, fit new lead under coping ensuring it laps over the top of render to prevent tracking water

Evidence of repair and lead under coping, with joint being mortar pointed.
Replacement of lead under coping would allow opportunity to see how effective soakers are as well as protecting render joint on gable

Remedial Options:

Option 1: Replace copings with new stone coping adapted to incorporate overhang and capillary drip. On a new development this would be the solution. This being a listed building, it is assumed this is the original copings albeit of a poor design. It is therefore deemed inappropriate to replace copings where another option exists
Option 1 rejected

Option 2: To mastic point the junction between stone coping and render and undertake stone repair to ensure better pointing and more defined stone edge. Whilst this may prevent moisture ingress in the short term the mastic will break down and ultimately fail
Option 2 rejected

Option 3: To carefully lift copings, set aside fit code 4 lead dressed down over upper edge of render terminating in a drip to prevent water ingress and refit copings using lime mortar bed with stainless steel support angles. This retains the original stone and detail whilst providing a satisfactory water proof junction.
Option 3 recommended option

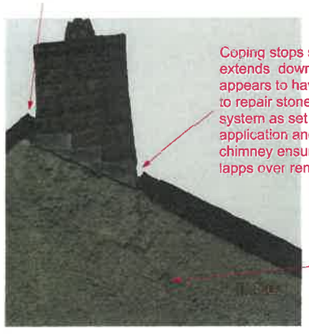
Gable chimney elevation

Coping stops short of chimney, crack in render extends down from lead apron flashing which appears to have a back fall. Recommendation is to repair stone using approved stone repair system as set out in listed building consent application and improve lead flashings to chimney ensuring no back fall and sufficiently lapps over render

Crack
