CLITHEROE LIBRARY  
CHURCH STREET  
CLITHEROE

MASONRY SURVEY

Clitheroe Library Report

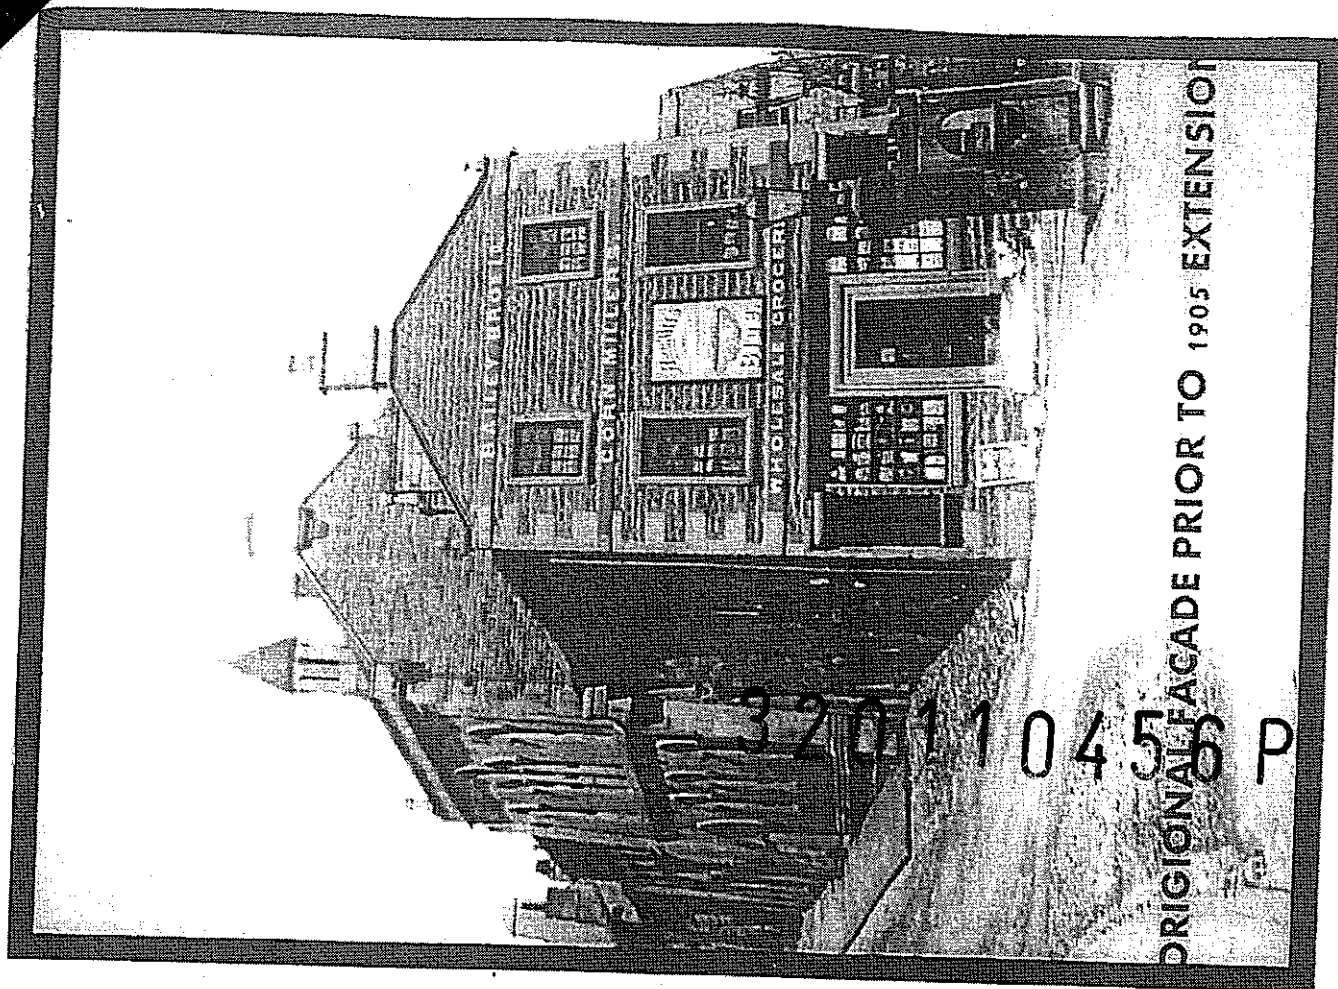
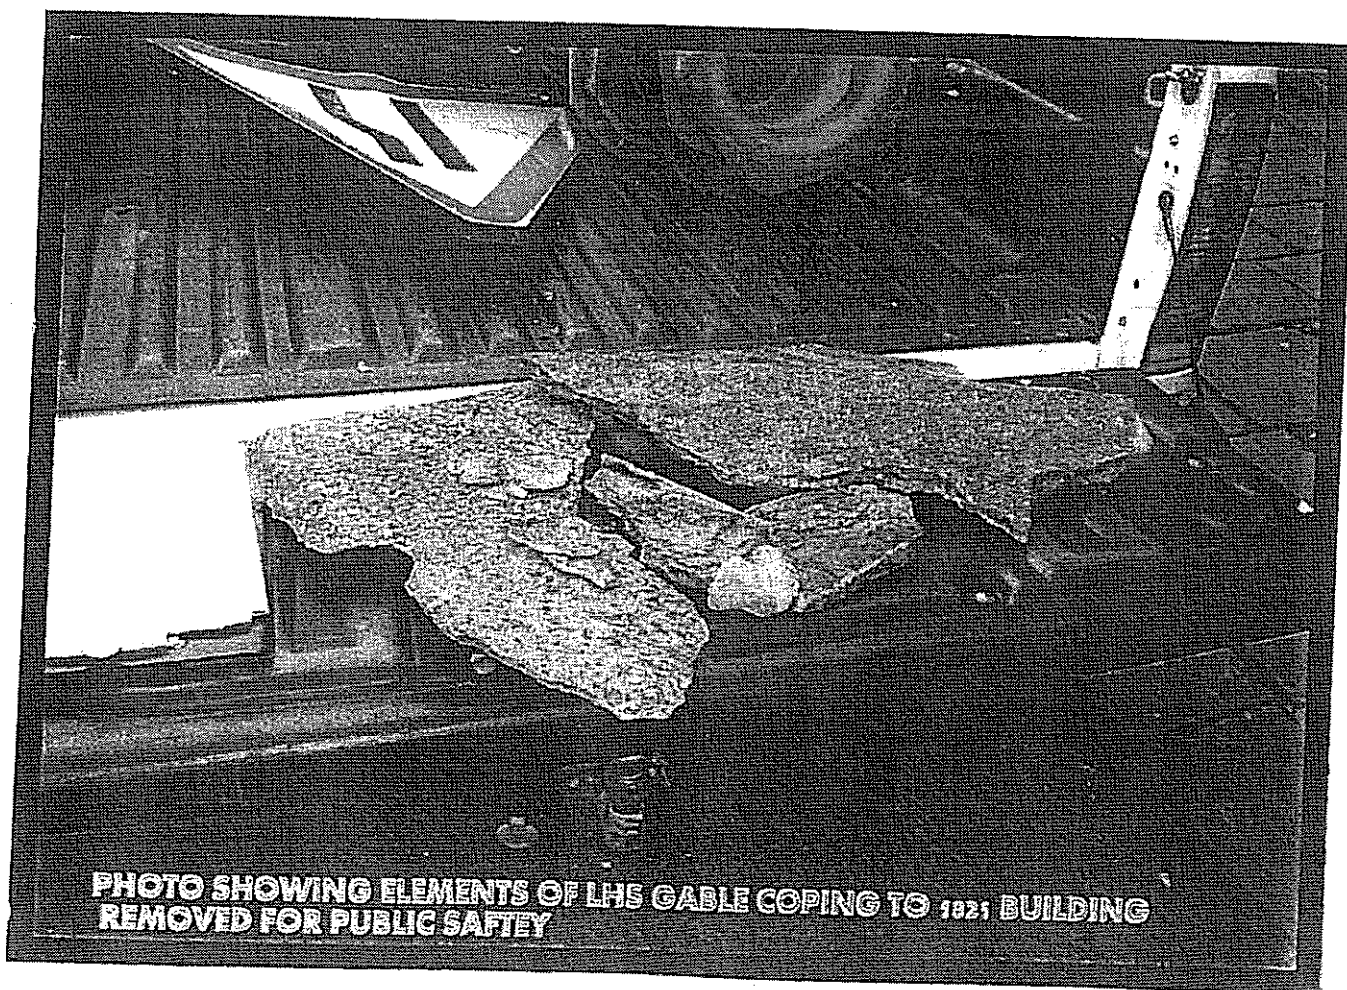
**CLITHEROE LIBRARY**  
**GENERAL PHOTOS**

There are several areas of severe decay to the stone particularly on the older 1821 section of Church Street. A large section of coping was removed by hand which could have fallen at any time particularly in high winds. (See photo 1 in General photo's appendix D). Several other small areas of failure were noted, which were also removed by hand. Some items had been caught in the bird netting system currently installed.

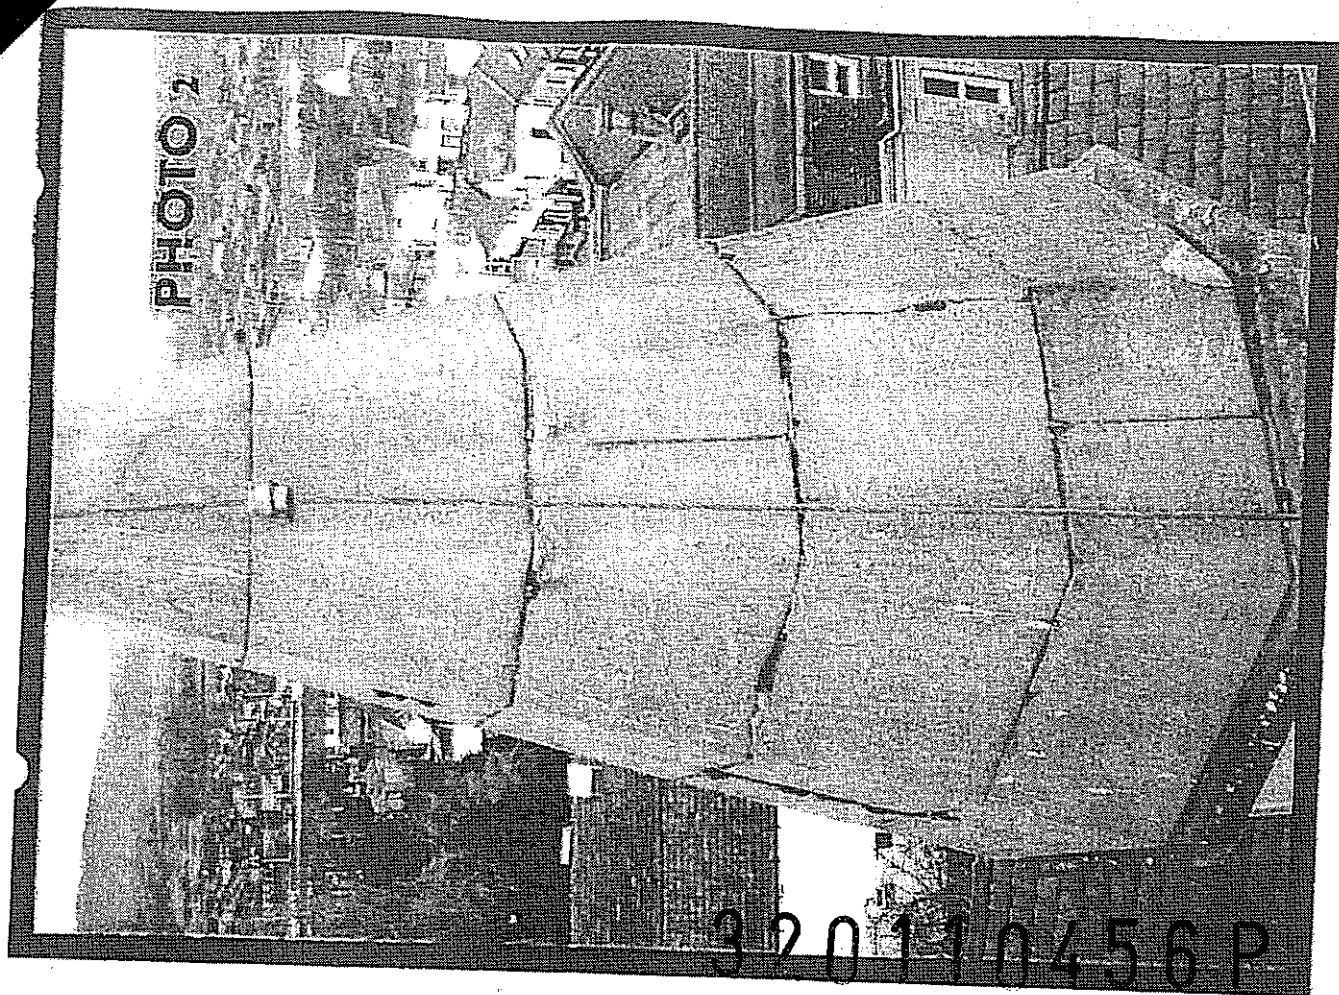
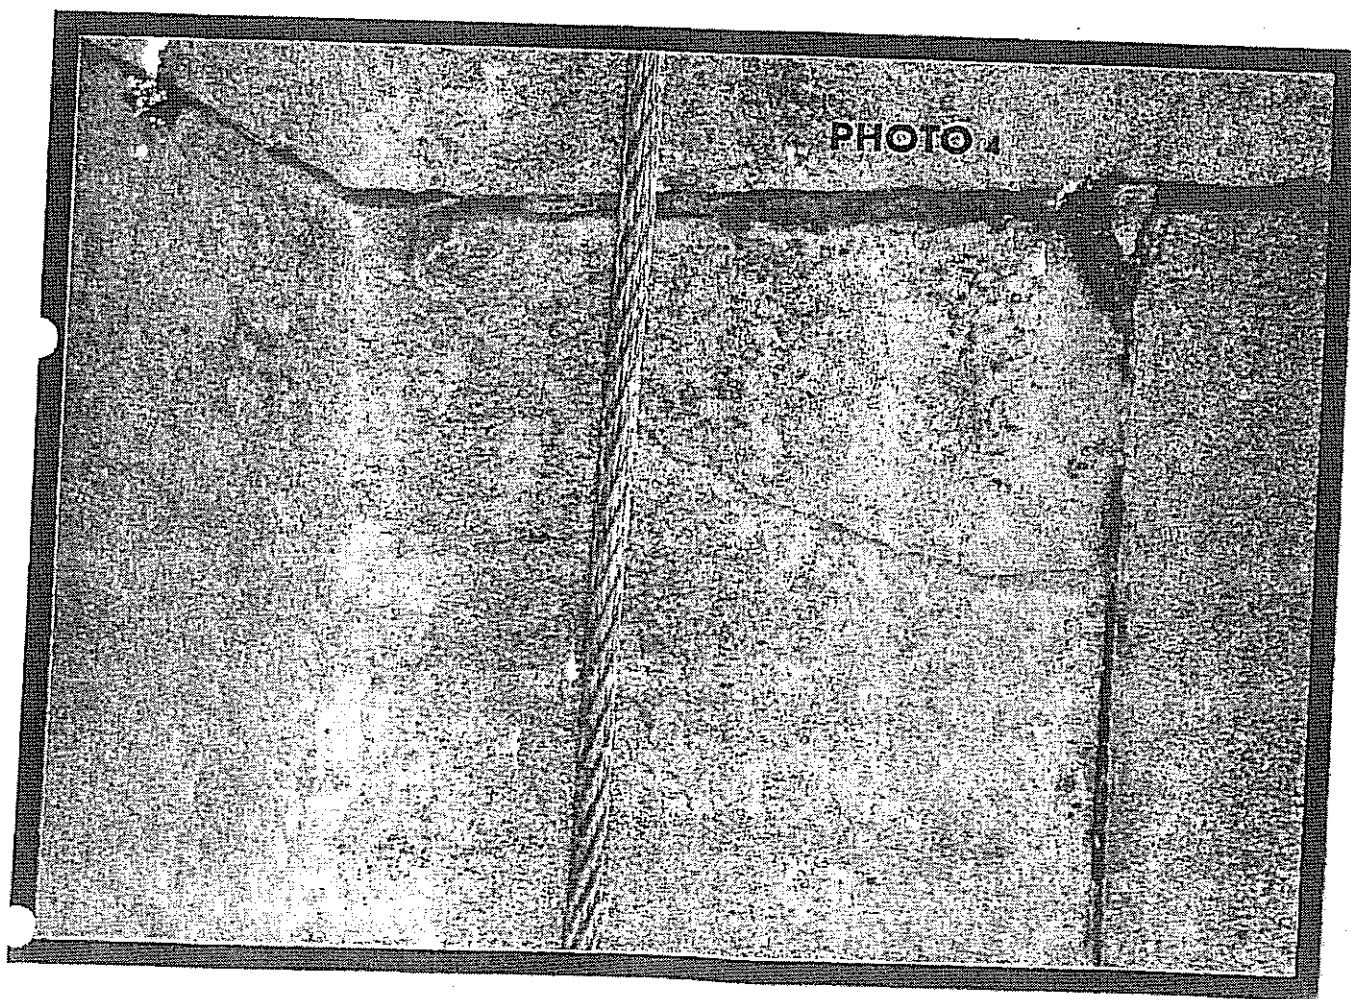
**LEFT HAND SIDE  
PINICAL / TOWER TO  
1821 SECTION  
PHOTOS**

The LHS gable over the adjoining property and the pinical above offer particular problems. When viewed closely the pinical shows signs of severe decay due to heavily corroded cramps at joint positions. This is resulting in spalls to the face and most worryingly lift to the bed joints. At

the 4th joint down light can be seen throughout the pinical. See photo 1 appendix 2) Pointing and packing only, would only offer temporary protection and relief from the deterioration in the steel, which is causing the lift. The alternative would be to dismantle the pinical and rebuild. The offending iron cramps could be removed and replaced with stainless steel. This solution however offers particular difficulties with access. The weight of the units would require the scaffold to be load bearing "masons scaffold". As this is over the main roof and the roof of the neighbouring property this would offer particular difficulties. A second option would be to crane off and on the units. This however would require a street positioned crane during the works. Which would possibly block the passage of traffic along Church Street.
