**4. INSPECTION PROCEDURE  
HODDER HIGHER (No: 1043/B1)**

The Principal Inspection was carried out by Thorburn Colquhoun on 25 January 1997. The weather conditions during the inspection were dry with sunny spells. The depth of the River Hodder passing under Hodder Higher Bridge was a maximum of 1.2m. It was not necessary to effect any traffic management measures on the C354 in order to carry out the inspection.

Lancashire County Council  
Hodder Higher Bridge (No: 1043) - PBI

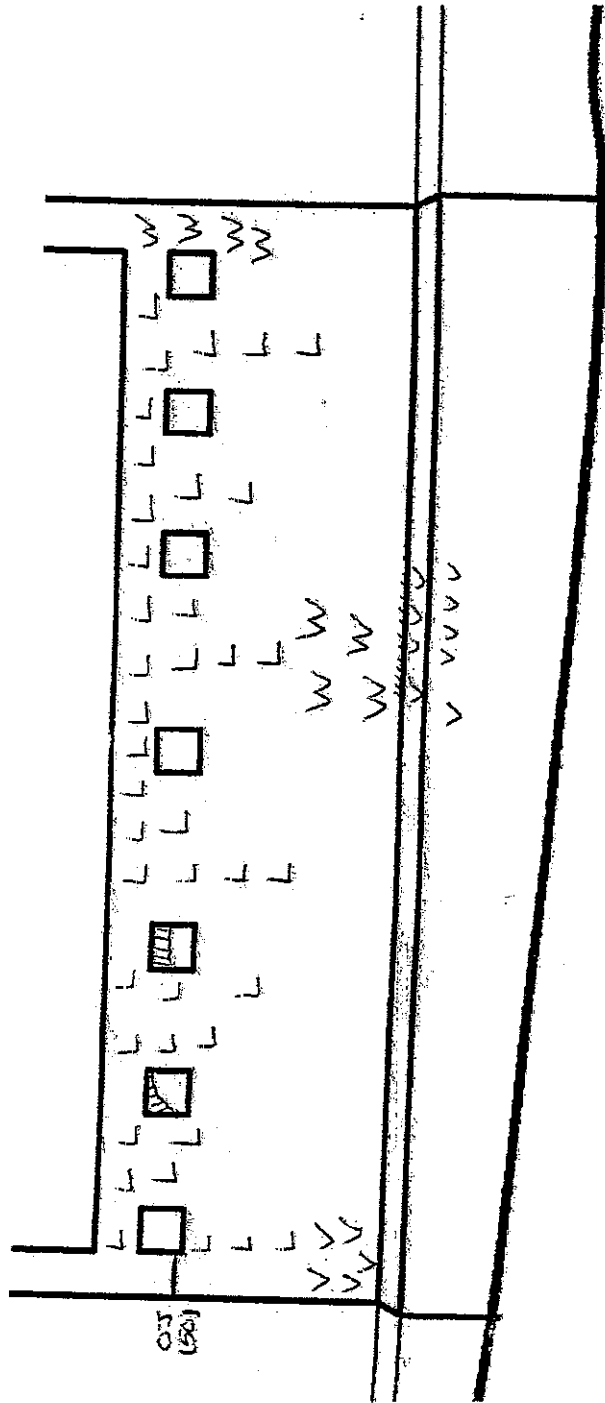
SK3 WEST ELEVATION OF EAST PIER

| COMPONENT | | INSPECTION RESULT | | PHOTO/<br>SKETCH | PAGE<br>No. | RECOMMENDATIONS/ACTION | TIME<br>SCALE |
|---|---|---|---|---|---|---|---|
| 4 | Piers | 4A | The two piers are constructed from close jointed, dressed, coursed masonry. The course depths vary between 200-260mm and joints widths are between 5-10mm. Generally they are in satisfactory condition with isolated areas of active seepage down the faces. | SK1<br>SK2<br>SK3 | 46<br>47<br>48 | Provide effective membrane waterproofing | L |
