# SLAIDBURN BRIDGE PBI

Lancashire County Council's Highway Consultancy undertook the Principal Inspection of Slaidburn Bridge, L.C.C. No. 4263, on 9 October 1996. The weather during the inspection was dry.

**SLAIDBURN BRIDGE L.C.C. No. 4263  
SPECIAL INSPECTION REPORT  
INSPECTION FOR ASSESSMENT  
APPENDIX A**

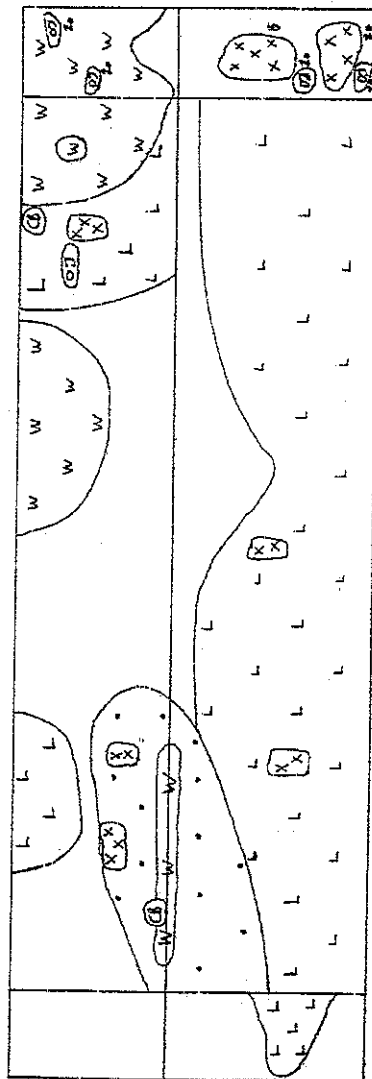
DETECTS SKETCH No. 1

| COMPONENTS | INSPECTION RESULTS | PHOTO (P) No &<br>SKETCH (S) No | PAGE<br>No | RECOMMENDATIONS/ACTION | TIMESCALE |
|---|---|---|---|---|---|
| | Weathered blocks, poor joint condition and cracked blocks to outer ring on northern side. | P19 S1, P20 S1 | 19 | Monitor. | |

| COMPONENTS | INSPECTION RESULTS | PHOTO (P) No & SKETCH (S) No | PAGE No | RECOMMENDATIONS/ACTION | TIMESCALE |
|---|---|---|---|---|---|
| | Cracked blocks. | P24 S1 | 21 | | |
| | Spalled blocks. | P25 S1 | 22 | | |
| | The outer face of many blocks are weathered. The extent varies and the worst areas have been highlighted. | P26 S1, P25 S1 | 22 | Replace spalled blocks. | M |

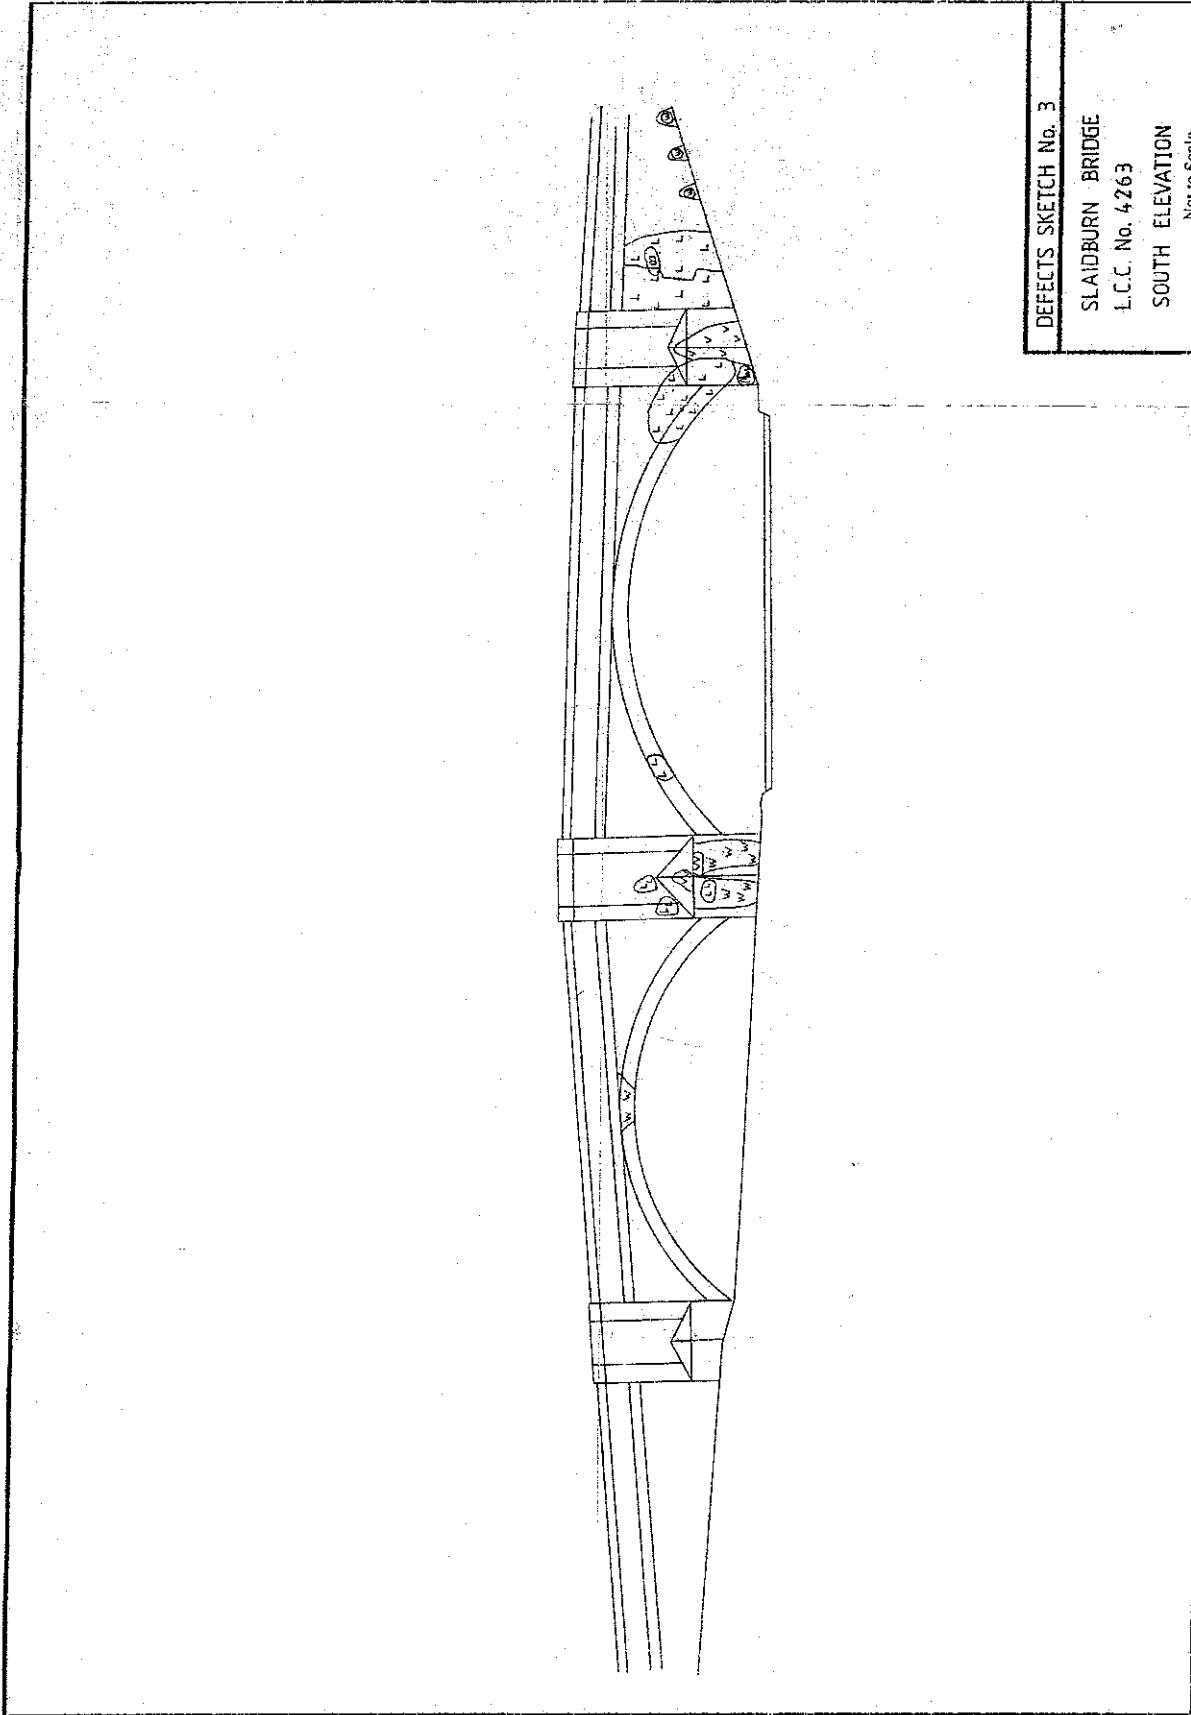
DEFECTS SKETCH No. 3

| COMPONENTS | INSPECTION RESULTS | PHOTO (P) No &<br>SKETCH (S) No | PAGE<br>No | RECOMMENDATIONS/ACTION | TIMESCALE |
|---|---|---|---|---|---|
| (ii) East | Spalled masonry. | P2 S3 | 10 | Repair spalled masonry. | M |

| COMPONENTS | INSPECTION RESULTS | PHOTO (P) No &<br>SKETCH (S) No | PAGE<br>No | RECOMMENDATIONS/ACTION | TIMESCALE |
|---|---|---|---|---|---|
| 6. Wingwalls<br>South East | Leached deposits, cracked mortar and open joints. | P12 S3 | 15 | Repoint and monitor. | M |

| COMPONENTS | INSPECTION RESULTS | PHOTO (P) No & SKETCH (S) No | PAGE No | RECOMMENDATIONS/ACTION | TIMESCALE |
|---|---|---|---|---|---|
| | Damage to outer blocks caused by gate on southern side. | P28 S3 | 23 | Monitor. | |

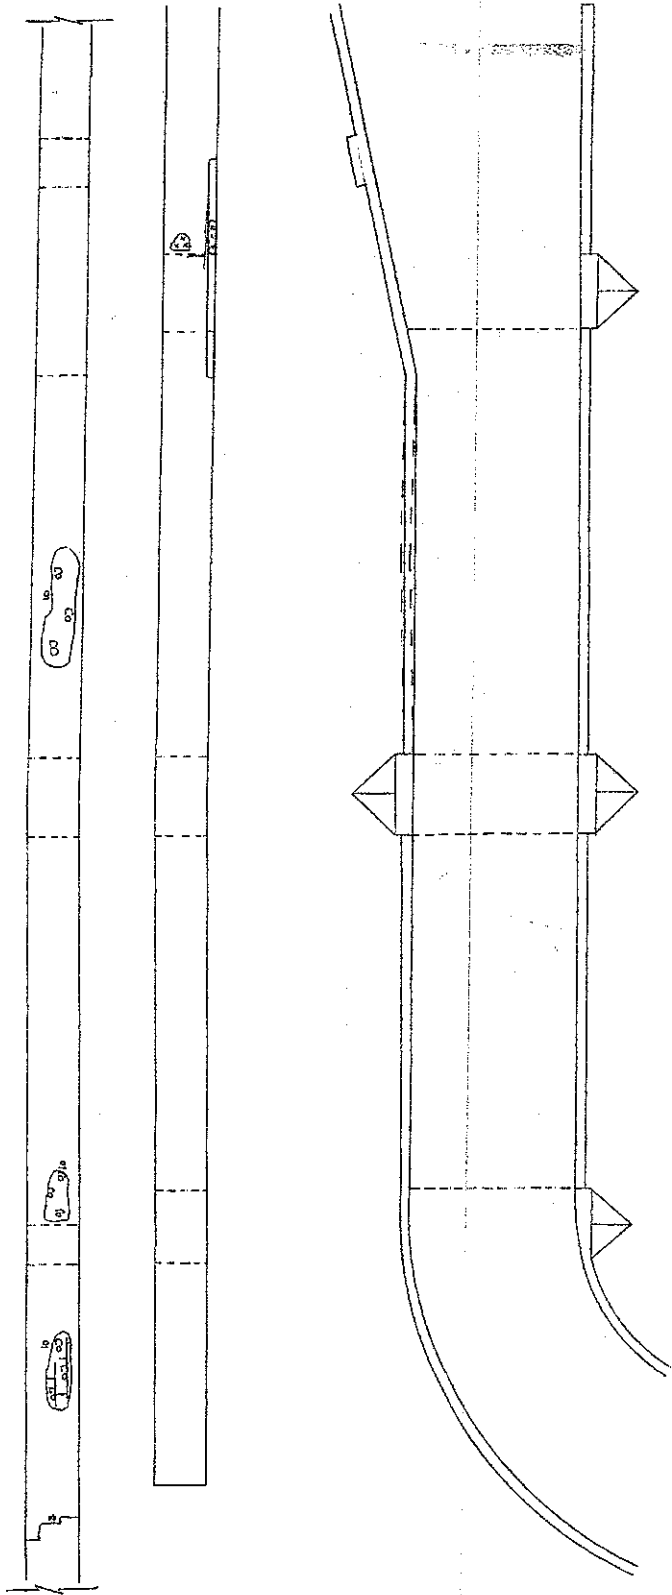
DEFECTS SKETCH No. 5

| COMPONENTS | INSPECTION RESULTS | PHOTO (P) No &<br>SKETCH (S) No | PAGE<br>No | RECOMMENDATIONS/ACTION | TIMESCALE |
|---|---|---|---|---|---|
| 24. Parapets<br><b>Northern</b> | Crack to masonry pointing. | P40 S5 | 29 | Repoint masonry. | M |
| | Generally poor quality of pointing to masonry, loose and missing pointing and open joints. | P41 S5, P42 S5<br>P43 S5 | 30<br>31 | Repoint masonry. | M |
| | Worn kerb stones, cracked mortar, open joints and impact damage on inside corner of bend. | P45 S5 | 32 | Replace spalled masonry kerbs on corner and repoint remaining cracks. | M |
