# Heritage Statement

Reinstatement of Existing Travel Agency  
Shop, Repair of Shop Front and Internal and  
External Repairs.

6 Castle Street  
Clitheroe  
Lancashire  
BB7 2BX  
United Kingdom

# **Heritage Statement for Internal and External Repairs.**

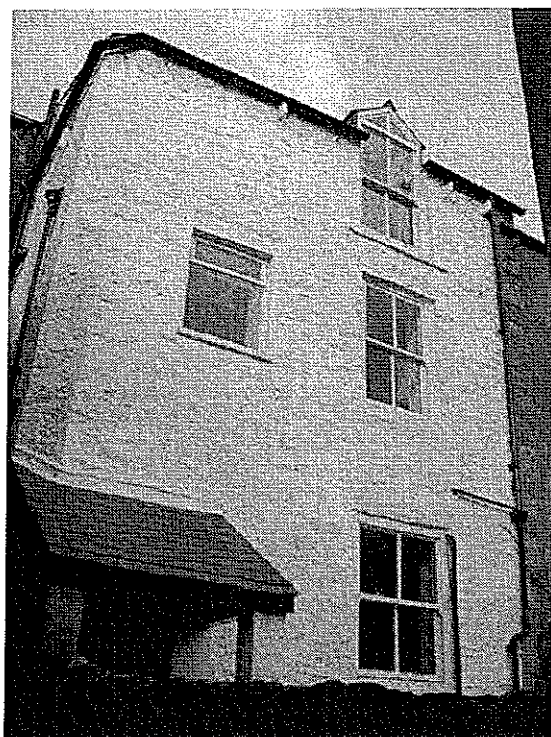
**3. Rear elevation of the building**
