# Design and Access Statement

Reinstatement of Existing Travel Agency  
Shop, Repair of Shop Front and Internal and  
External Repairs.

6 Castle Street  
Clitheroe  
Lancashire  
BB7 2BX  
United Kingdom

# **Design and Access Statement for Internal and External Repairs.**

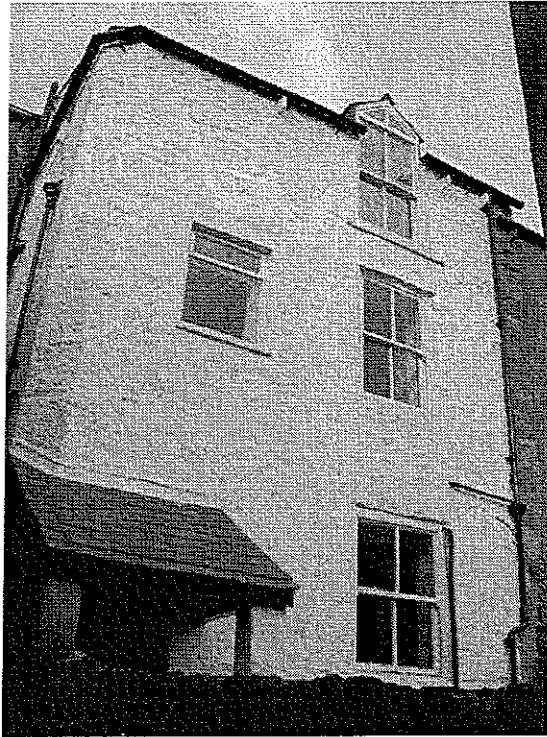
**3. Rear elevation of the building**

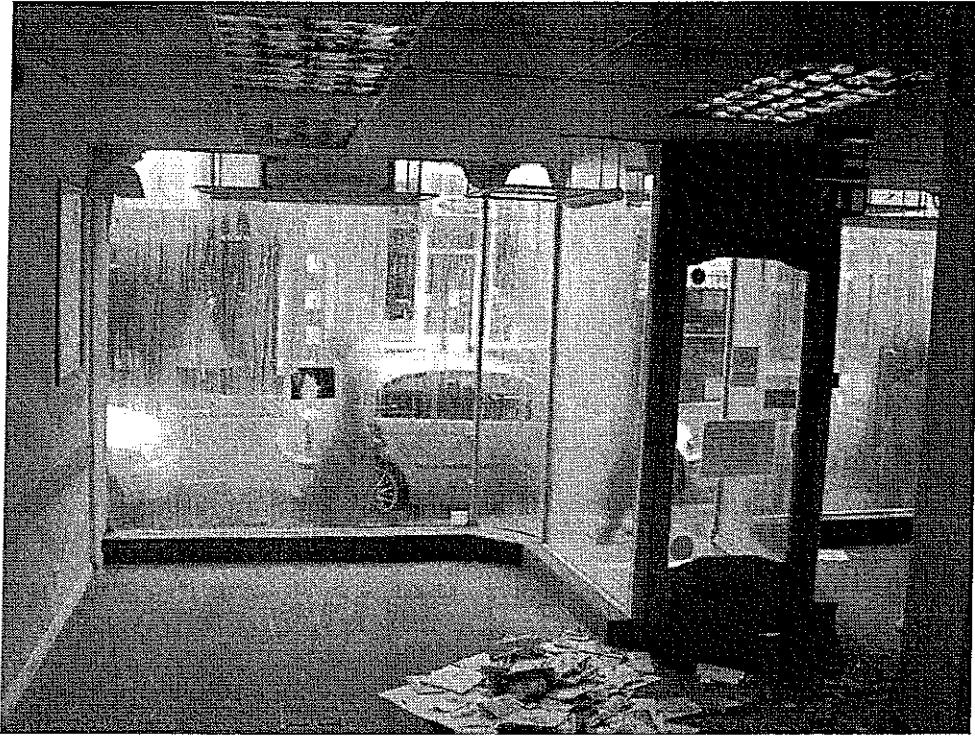
5. Internal view of front of house area

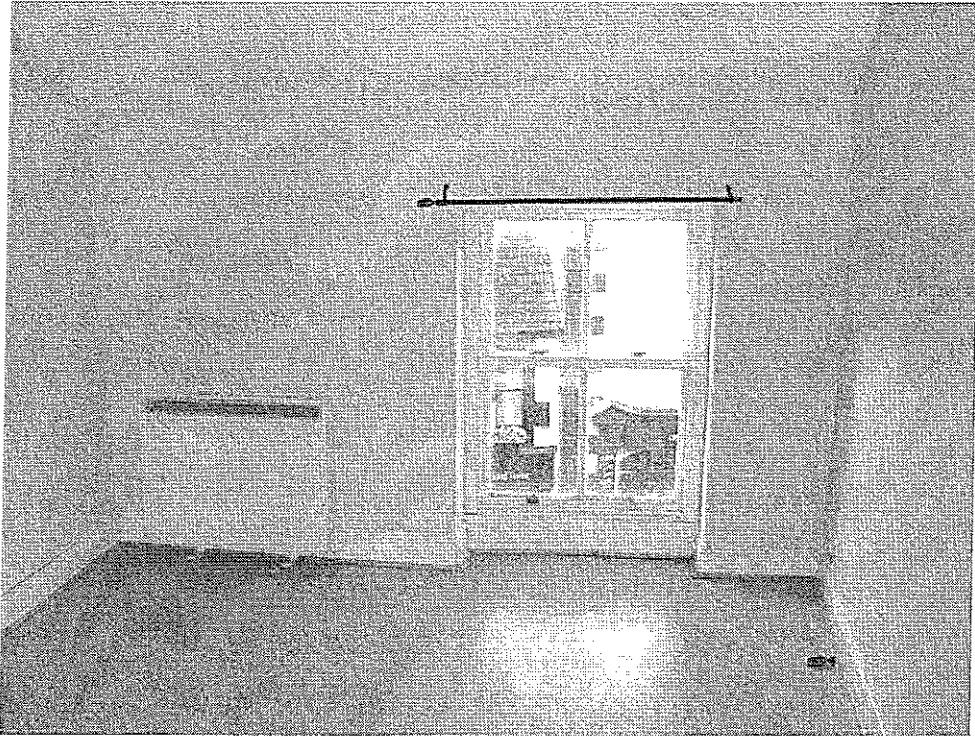
7. View of second floor flat room

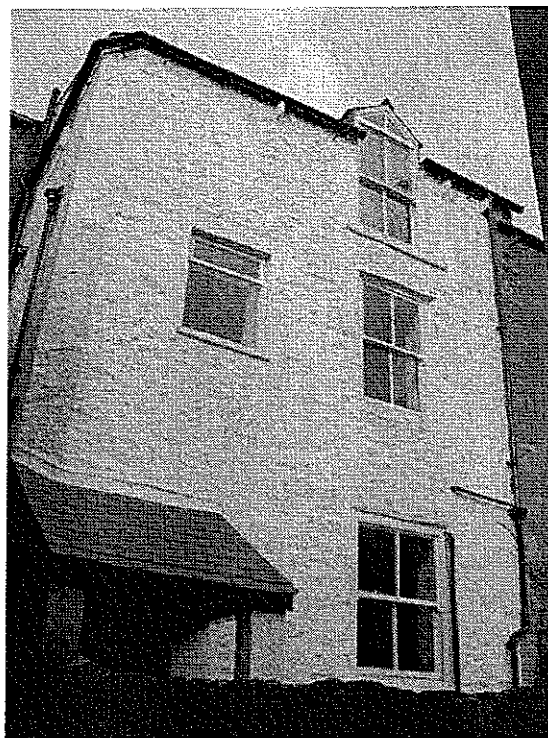
**3. Rear elevation of the building**

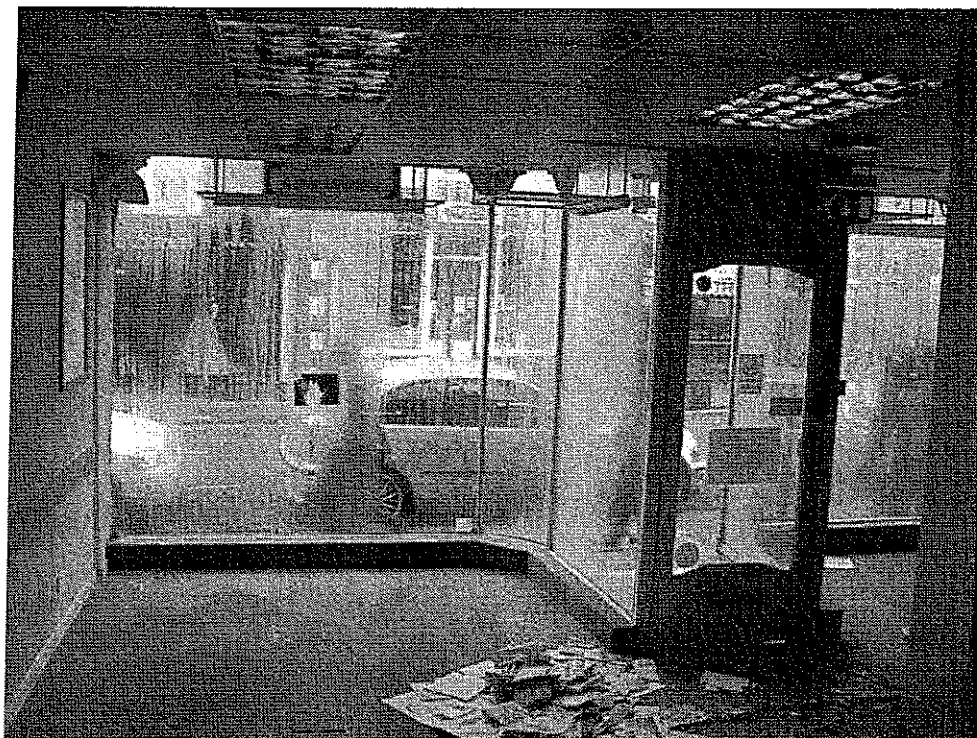
**5. Internal view of front of house area**
