**APPRAISAL OF ARCHITECTURAL & HISTORIC SIGNIFICANCE**  
**TO INFORM PROPOSED REPAIRS AND ALTERATIONS**

**RED SYKE GATE**

**TWISTON**

**The Trustees of The Hon. R. C. Assheton's Settlement**

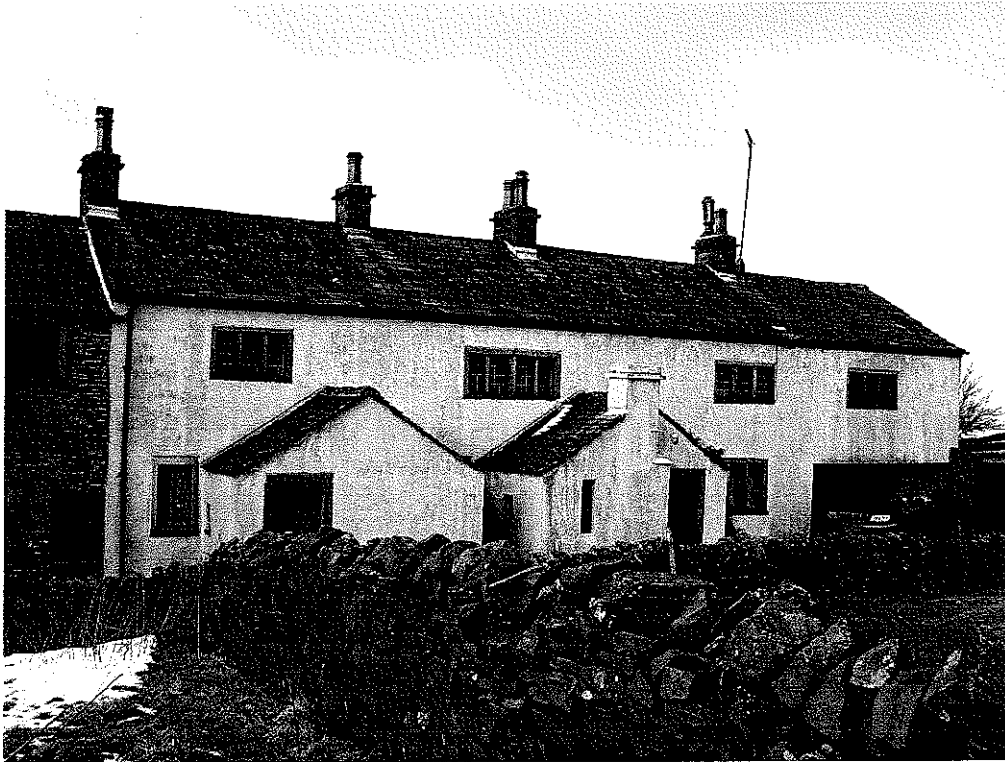
Image 1 - Front elevation showing cottages and extension to north

All windows are furnished with square cut surrounds and mullions of varying ages and designs (**image 1**). According to (Brunskill, 1978) this design typically ranges from around 1690-1780. The oldest exist to the front elevation (Sitting Room & Bedroom 2), the mullions to Bedroom 2 being chamfered internally with similar elements to the central mullion in Bedroom 3 suggesting some re-use and re-ordering of stone mullions in the past. Modern saw cut stone surrounds are evident to Bedrooms 1 & 5 and the rear elevation generally.

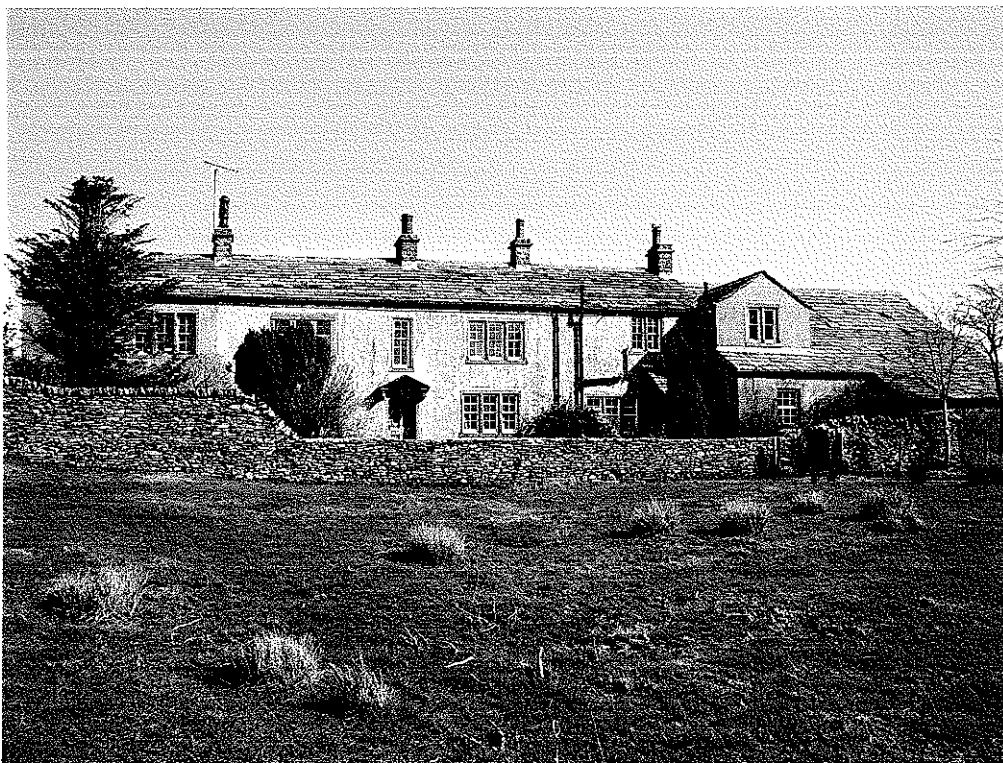
Windows and the main door to the rear elevation have also been re-ordered, again to bring some symmetry and verticality to the elevation (**image 4**). This was probably undertaken around the late 19<sup>th</sup> /early 20<sup>th</sup> C conjunction with installing the current staircase and combining the two units into one.

**Image 4 - General view of rear elevation, original central two-cell cottage, modern extension to left**

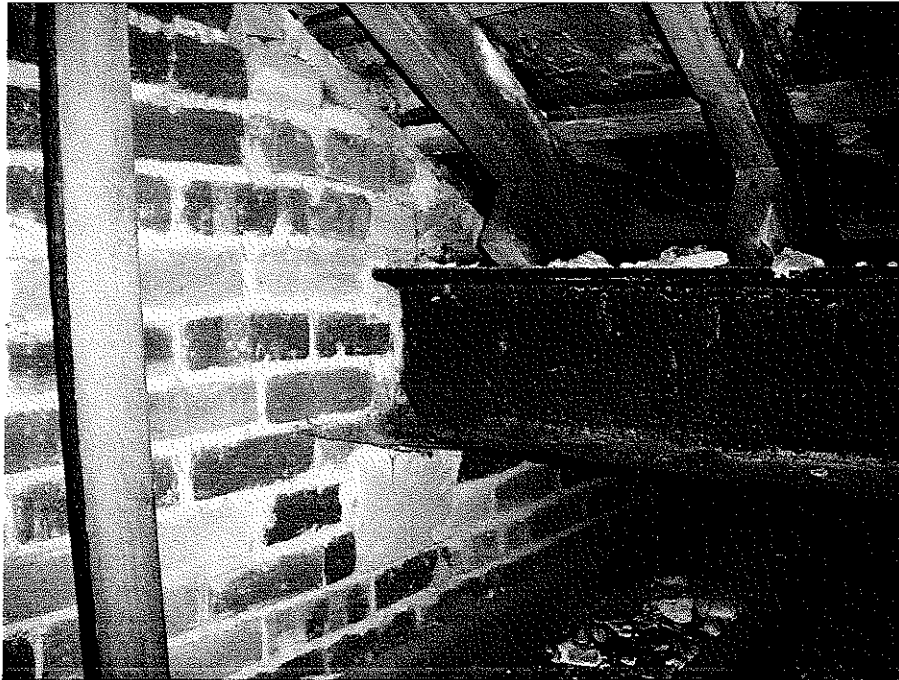
Roof structures are contemporary and are constructed from modern saw cut timbers common rafters, bearing on purlins (and steel to the new extension) spanning between cross walls (no requirement for or prior removal of trusses).

**Image 7 - Roof above Bedroom 1, steel beams supporting common rafters and stone slates**

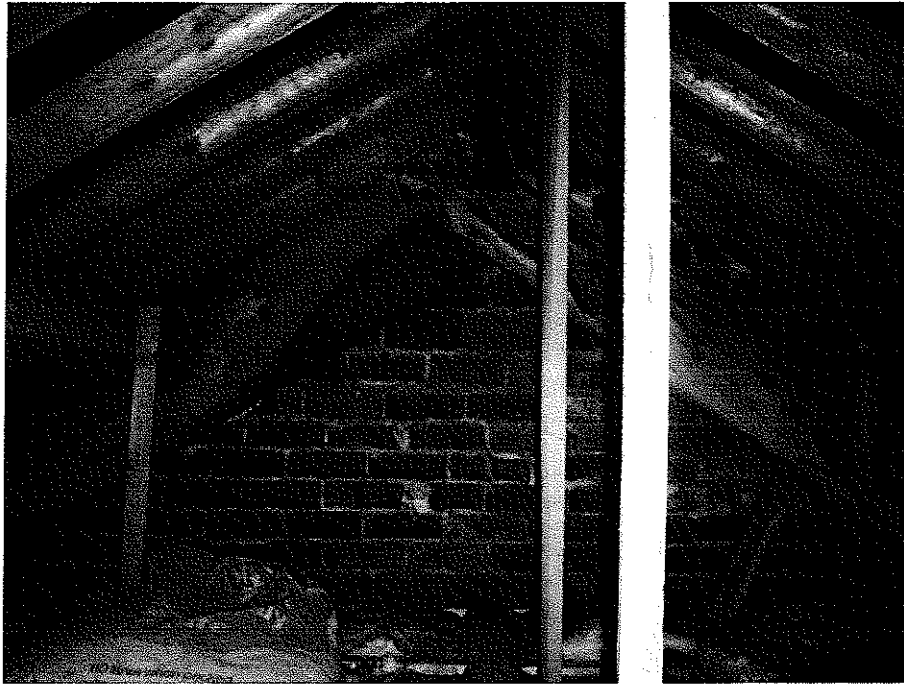
Only one historic roof truss remains (**image 9**) and this is the north truss to the barn, now within Bedroom 5. Other than this the whole roof structure has been renewed.

**Image 9 - Original roof truss above Bedroom 5**

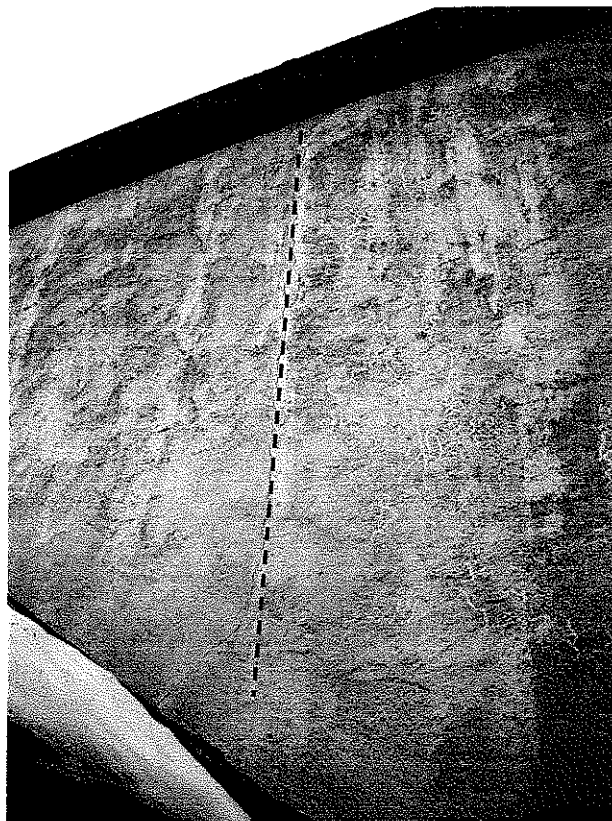
**Image 12 - Assumed straight joint to front elevation**

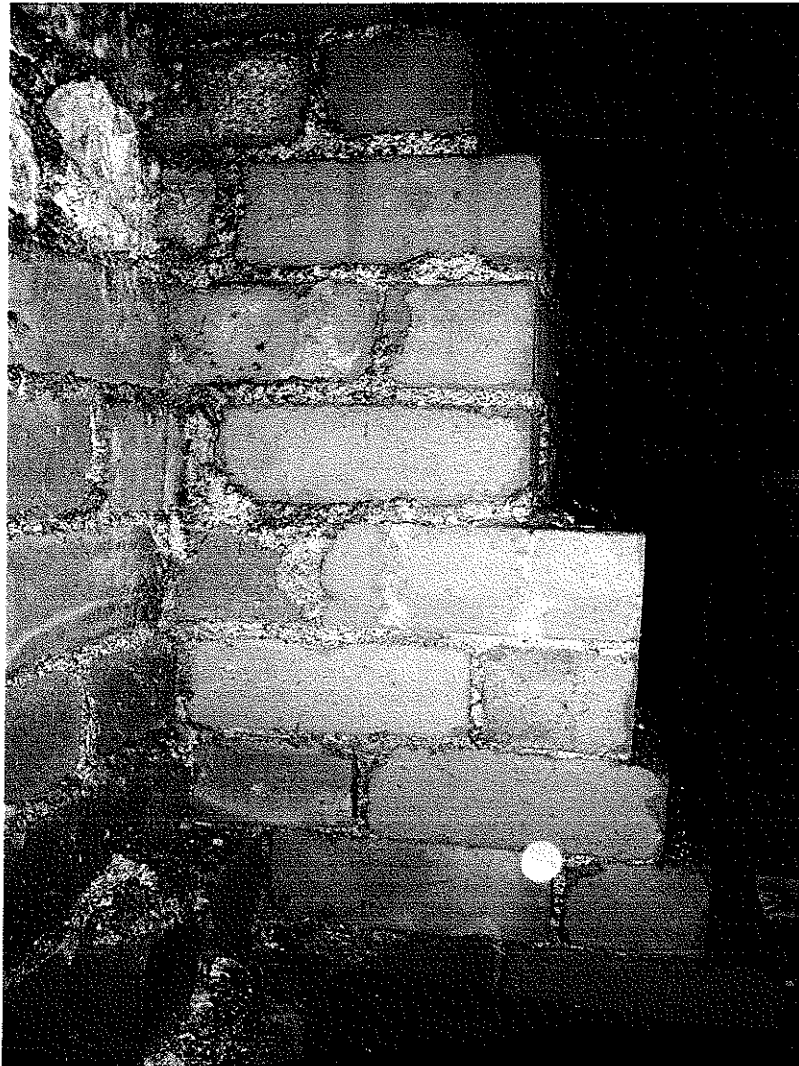
**Image 13: Mid 20th C brick chimney in roof void above Bedroom 4 (kitchen)**

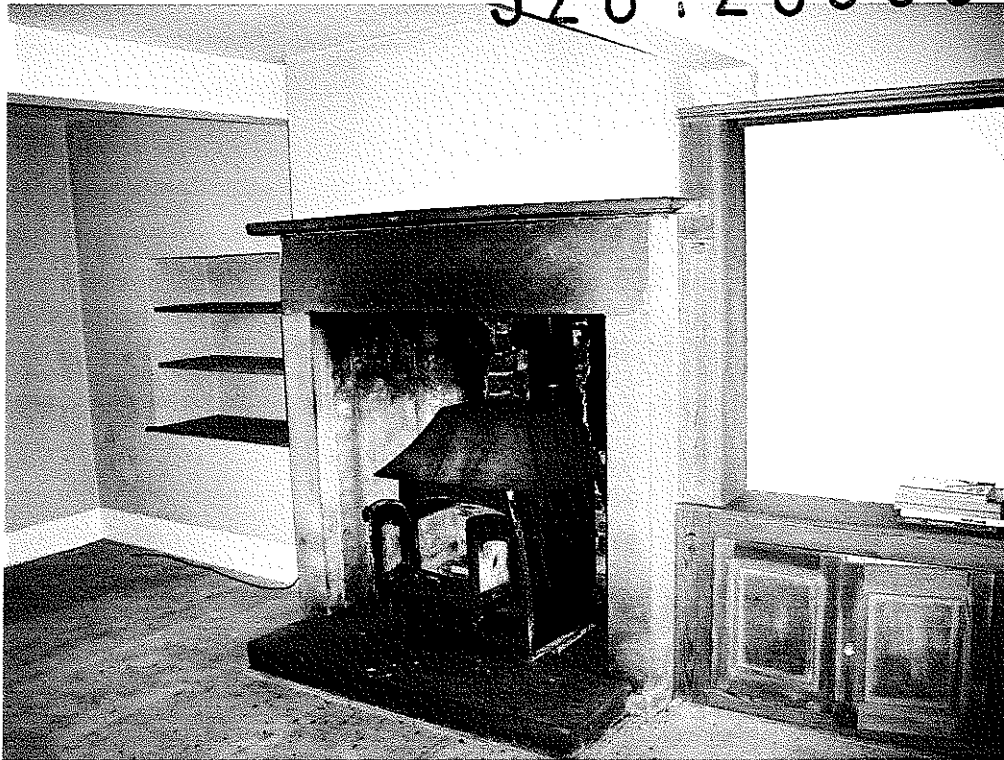
**Image 14 - Plain stone fireplace (with brick backing) to Sitting Room**

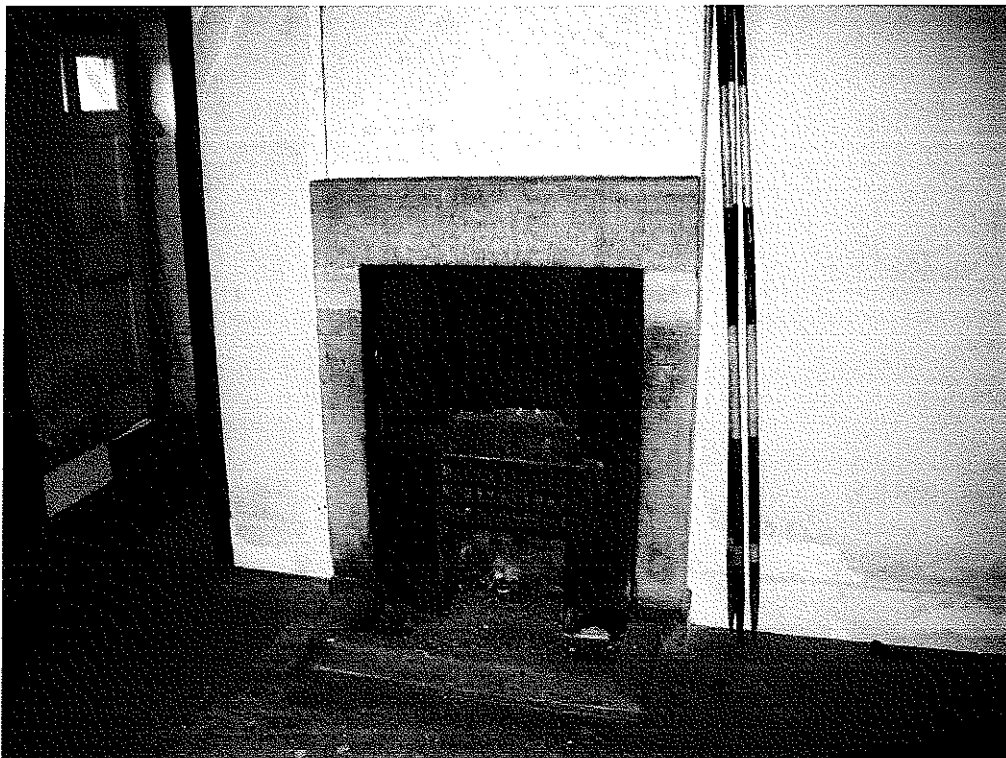
**Image 15 - Fireplace to Dining Room**

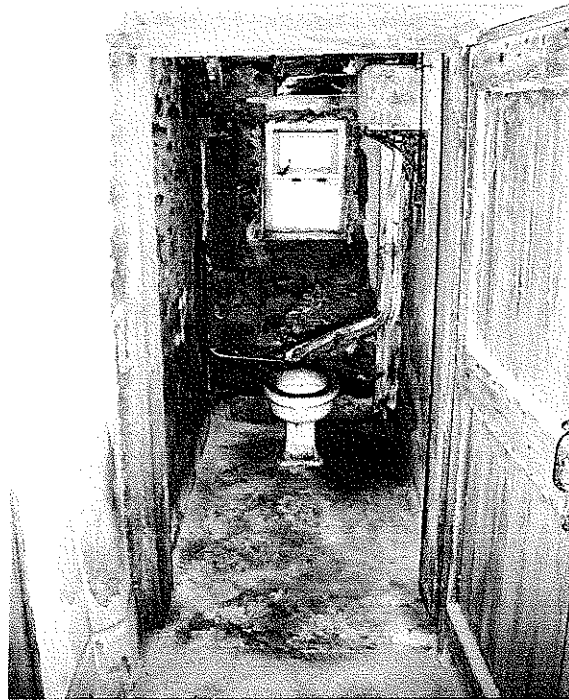
**Image 16 - Original stone door surround and wrought iron ironmongery to WC**

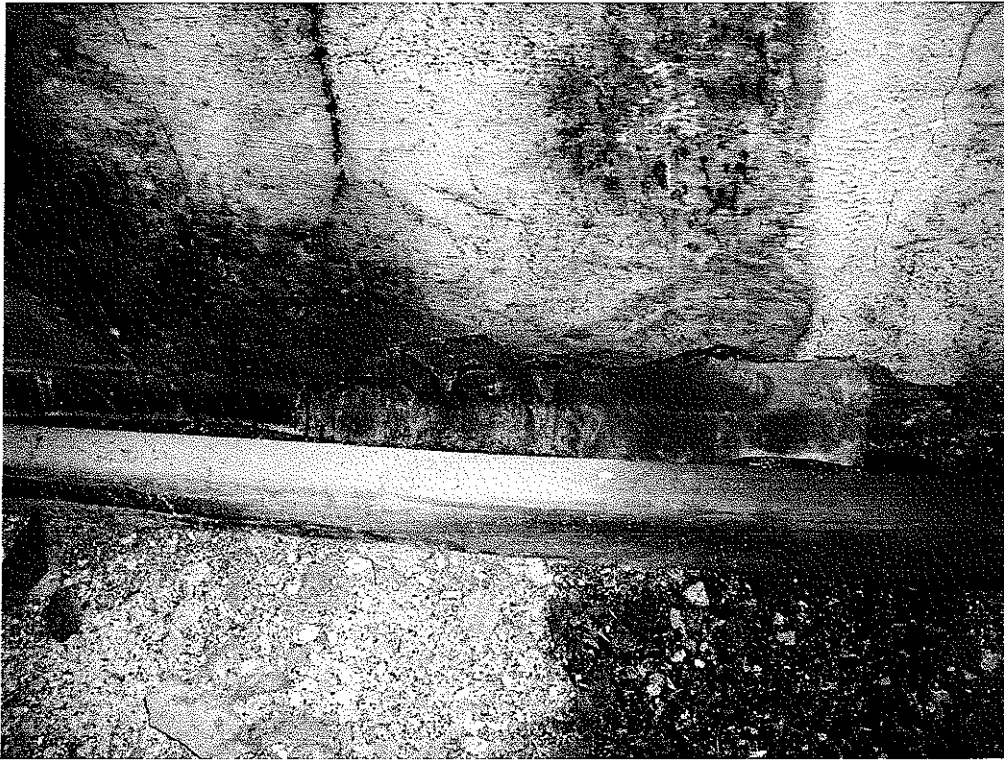
The final phase includes the extension to the north and installation of steelwork, concrete beam and block floors and a new roof to facilitate this. A new flue and chimney was constructed serving the boiler; new external, presumably cavity walls were constructed and a new roof structure replaced the original lean-to where the lead flashing is still visible. It should be noted that the external render pre-dates this work as the cement render is still visible to the original north gable wall in the roof void.

**Image 17 - Cement render and lead flashing indicating earlier lean-to roof (void above Bedroom 1)**

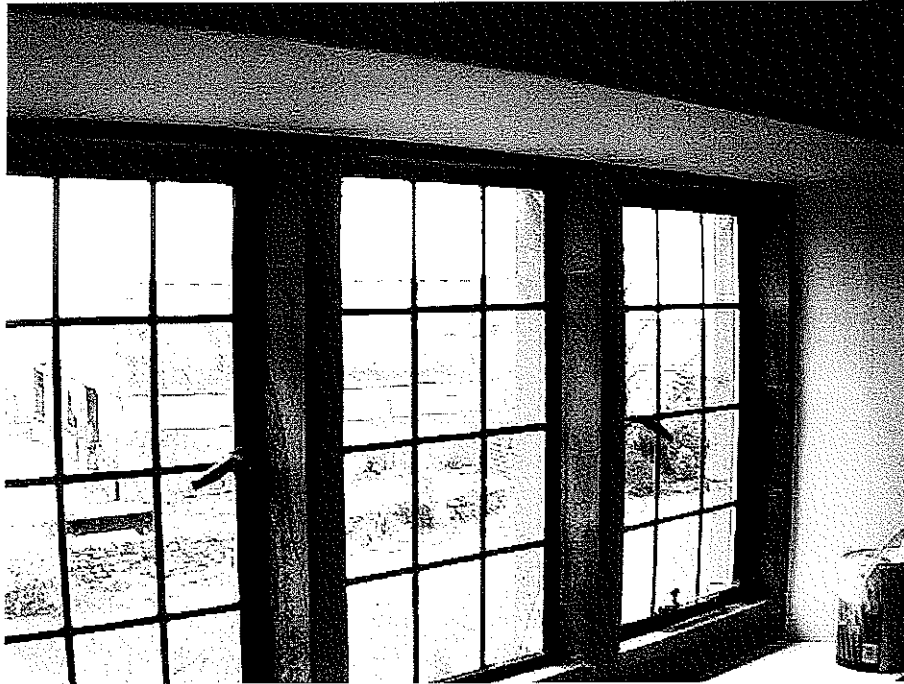
Image 22 - New fixed casement metal windows to a similar window detail in Northumberland

Replacement windows will be sourced from a company such as The Cotswold Casement Company who produce traditional steel units and leaded lights with good quality period hardware – [www.cotswold-casements.co.uk](http://www.cotswold-casements.co.uk). Neoprene gaskets are also supplied to improve draft proofing and reduce thermal bridging. These windows have been used previously with success at a property in Northumberland (images 22 & 23).

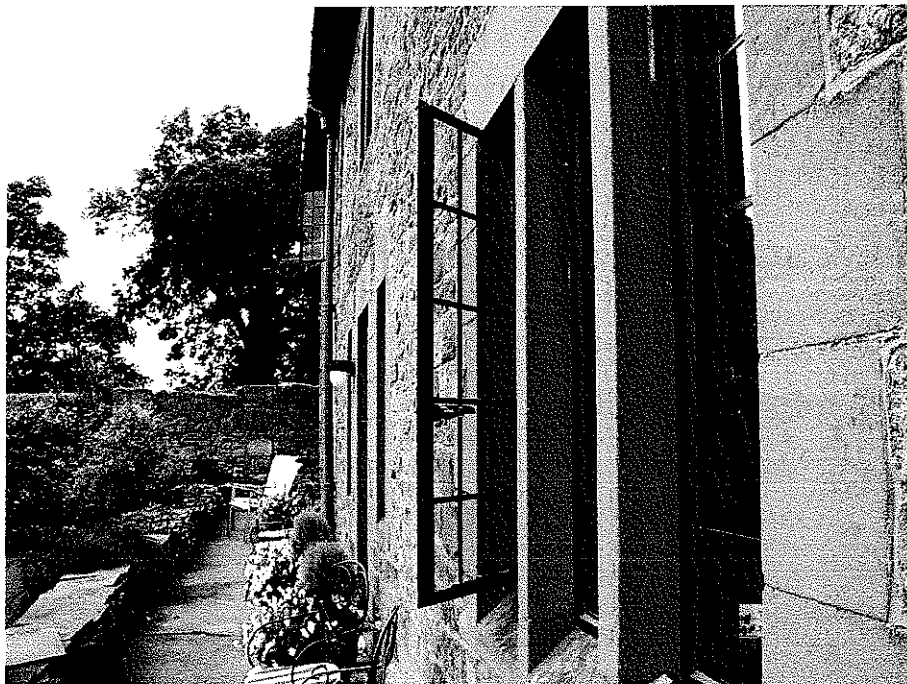
Image 23 - New metal opening casements, note neoprene gaskets and security to hardware

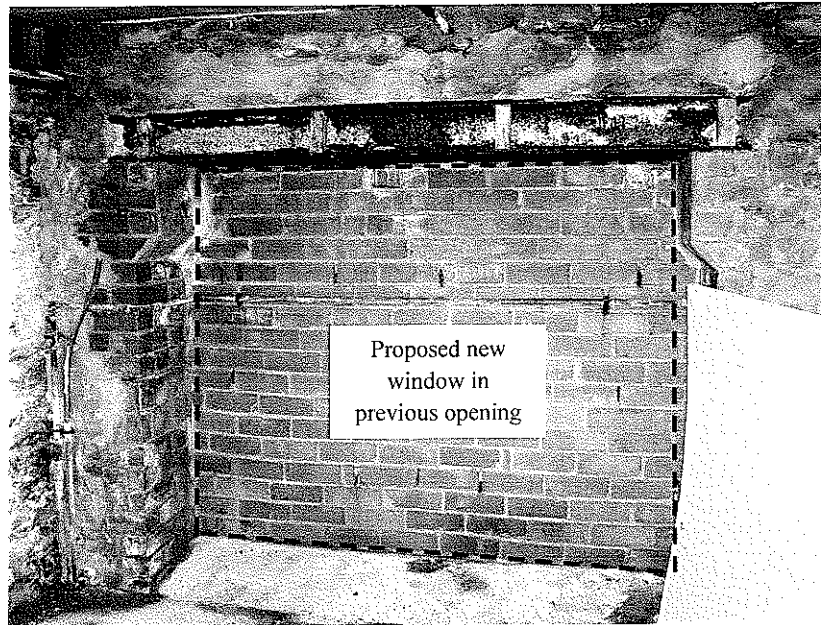
**Image 26 - Existing garage to be converted to office**

Also the original infilled opening to the rear will be opened up to form a window with views out to the rear of the property (**image 26**)

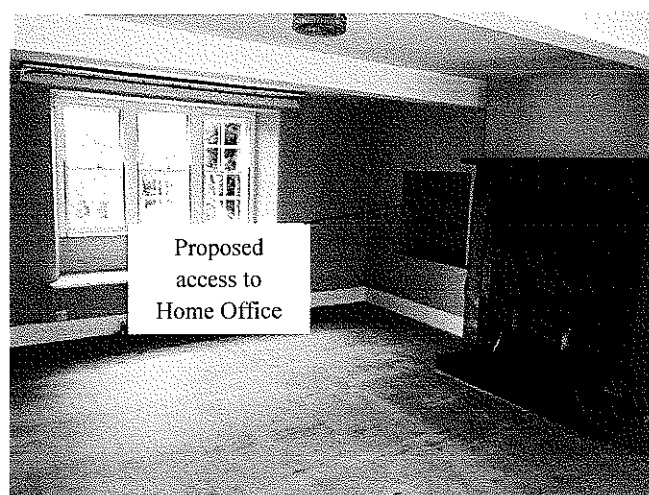
**Image 27 - Proposed position of access to Home Office**

It is proposed that an existing recess, to the left of the Sitting Room fireplace, will be opened up to provide access into the Home Office (**image 27**). This will result in minimal intervention as there already exists a recess. It is considered that the minimal loss of masonry can be balanced against the long term sustainability of this historic asset. All making good of plasterwork will be undertaken using natural lime plaster.

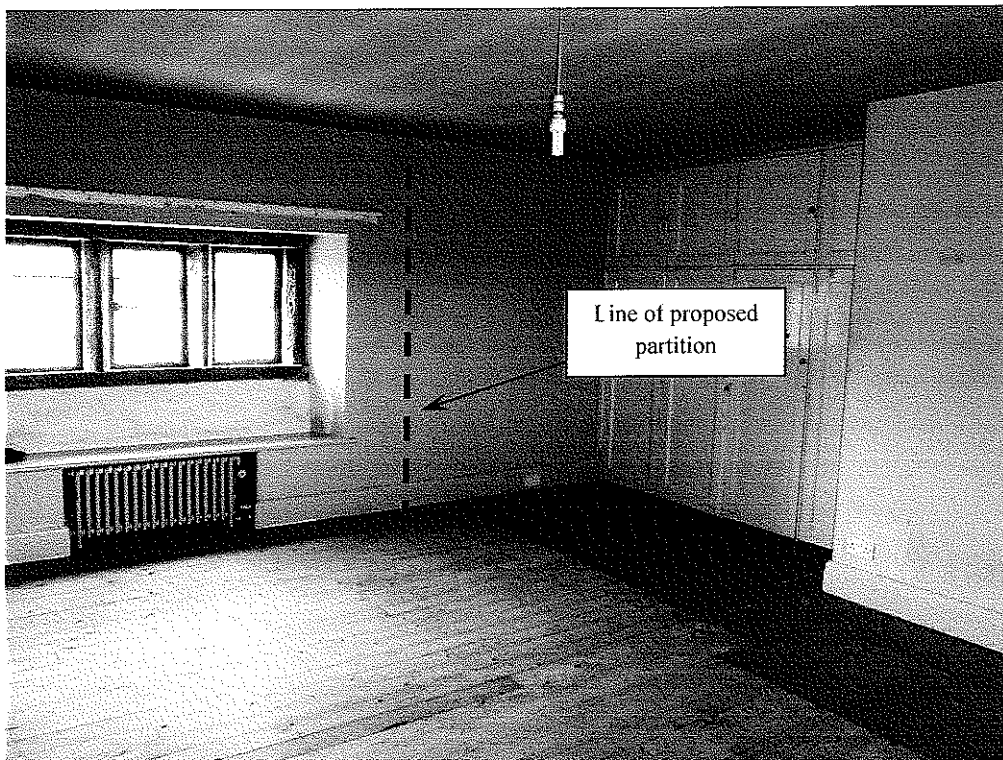
**Image 28 - Approximate location of stud partition to Bedroom 2**
