## PROPOSED CHANGE OF USE OF PART PRIMROSE MILL INTO APARTMENT, DESIGN WORKSHOP AND INTERNAL GARDEN

### DESIGN AND ACCESS STATEMENT

**FOR THE FORMER MILL BUILDING  
PRIMROSE ROAD  
CLITHEROE, LANCASHIRE, BB7 1DR**

**JOB REF: 4221, DATED: 19/06/2012, VERSION 1.01**

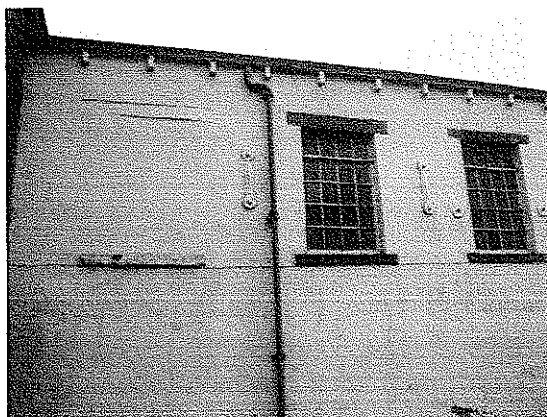
COMMENTS: The south east gable elevation is stone as is half the courtyard elevation nearest to the house. It changes to a white painted render finish as the building extends past the court yard.

Front elevation at the top end of the building.

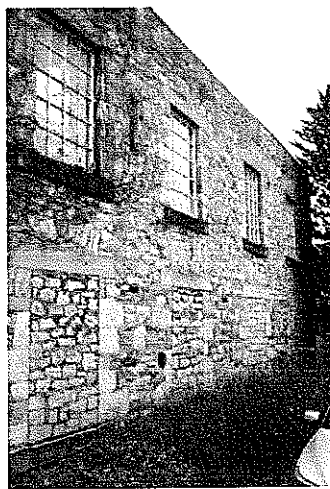
Front elevation to the court yard

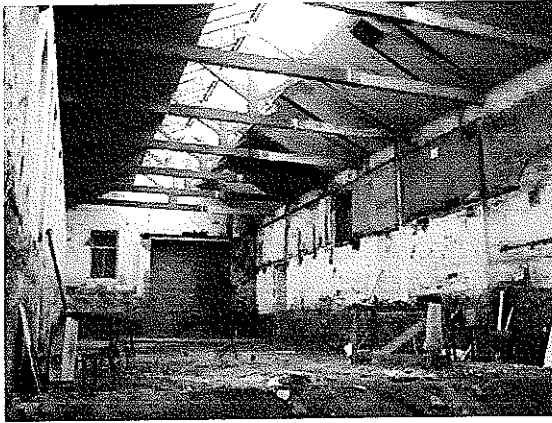
COMMENTS: The roof is open internally with the rafters being lined on the underside with timber boarding.

Internal view
