Application for Planning Permission. Town and Country Planning Act 1990

3. Description	of the Proposal	·			
Please describe the	e proposed development including any change of use:				
Conversion of barn	into two dwellings, creation of curtilages and installation of new pa	ackage treatement plan	nt.		
Has the building v	vork or change of use already started? Yes	No

Proposed Conversion of Ancillary Agricultural Building at Windy Hill Farm, Chipping Structural Appraisal Report

320120639 P WILDLIFE SURVEY FOR BATS AND OWLS

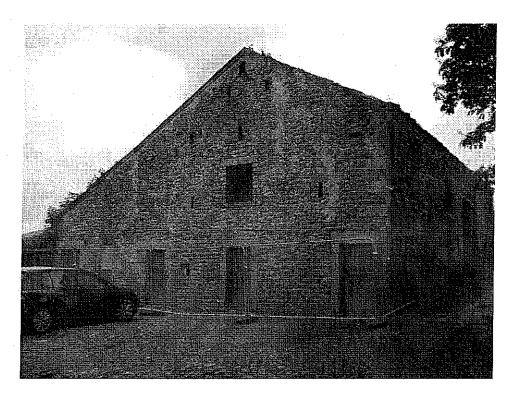
Historic movement of the elevation is noted The window opening situated adjacent to the south facing gable junction has 'dropped' at its north bearing (Plate 08). The elevation

Plate 8 – Lintel bearing movement

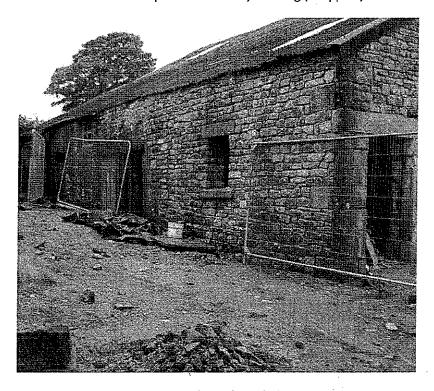
Two parallel, vertical cracks have been the subject of extensive mortar filling, emanating from eaves level of the front roof pitch to mid and ground floor door opening head height (Plate 10). Further cracking has also been subjected to a similar remedial process at the junction of the postulated 'Shippon' extension and the 'original' structure (Plate 11).

Plate 11 – 'Re-pointed' masonry cracking ('Shippon')

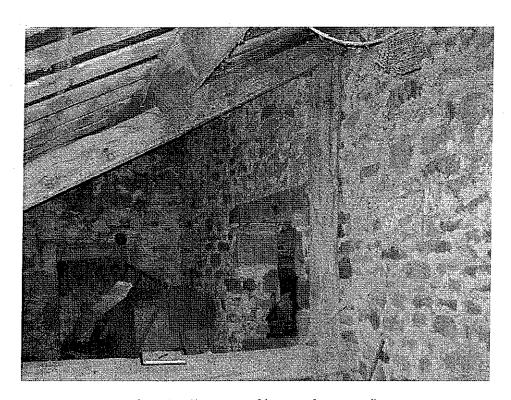
Shippon, With access gained to the first floor area/roof void via an opening formed within the rear elevation of the barn (Plate 26), visual inspection of structural timber purlin and truss roof members revealed historic wood boring insect infestation and section depletion (Plates 27-29 inclusive). Exposed roof members to the remaining northern area of the Shippon are consistent with the defects noted however, purlin end damp penetration is clearly visible at the bearing with the north facing gable (Plates 30 & 31).

Plate 26 – Opening within rear elevation of barn to roof void of Shippon

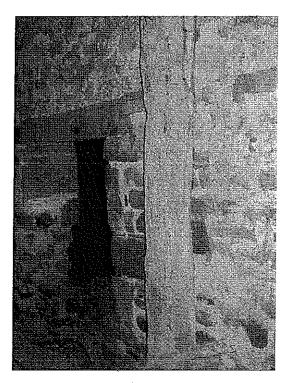
Plate 27 – Shippon roof (truss in foreground)
