**Subject:** FW: 3/2011/0247 Low Moor Clitheroe

Please find attached the Remediation Validation Report

**October 2012**

Ref: MC539/11

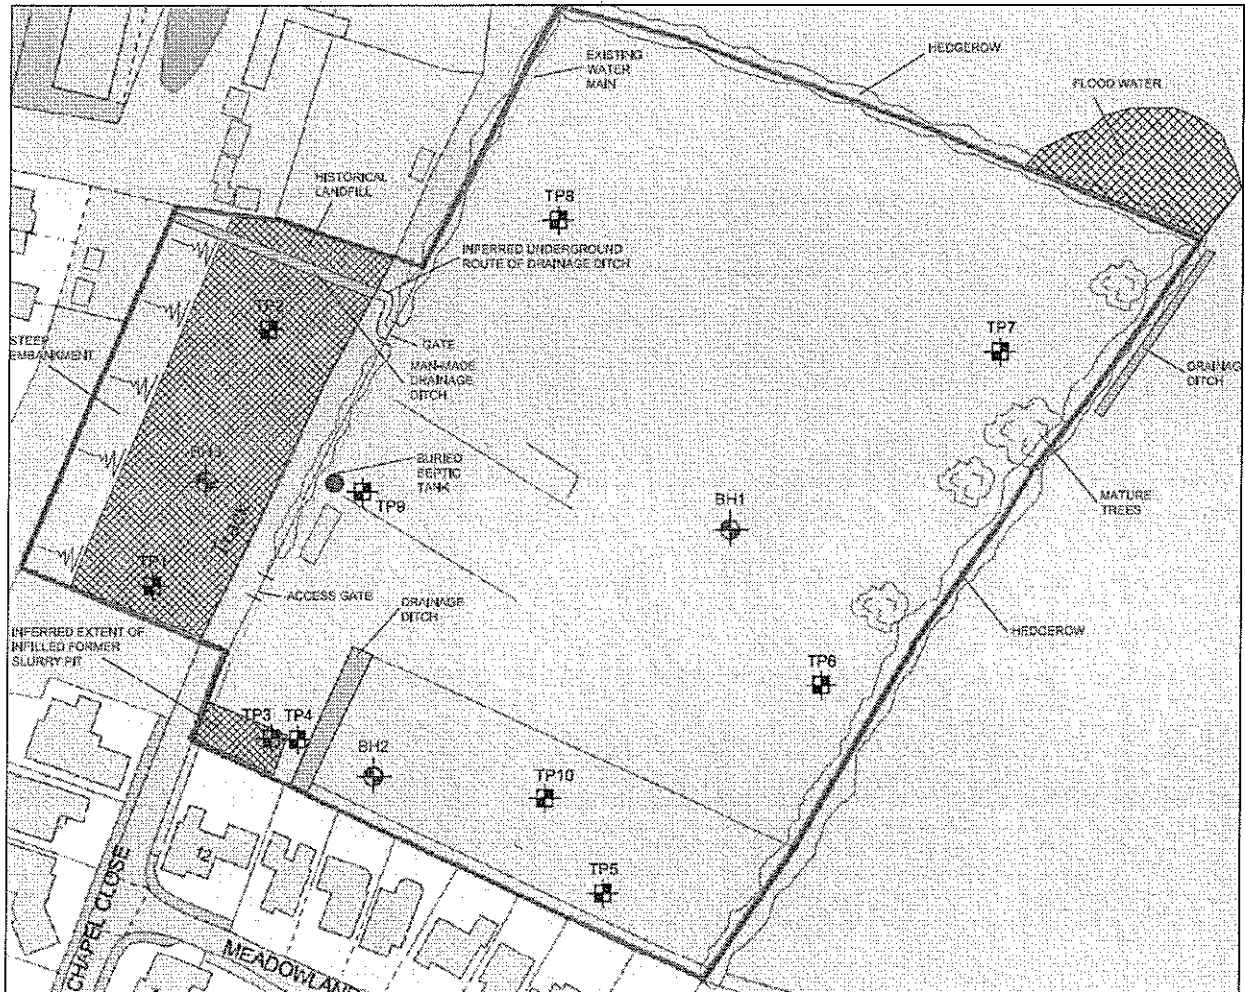
**Figure 2 RSK Sampling Locations**

A previous site investigation was conducted on the site in April 2011 by the RSK Group. Figure 2 (below) shows the location of the RSK sampling locations together with identified development constraints.

The site investigation proved the presence of topsoil across the site underlain by natural glacial clay (soft to firm in consistency) deposits and tipped material upto 2m thick within the western parcel of the site. Due to the presence of weak and compressible clays within certain areas of the site the consultants recommended that several plots would need foundation loadings transferred to competent strata.

Subsequent chemical testing proved an absence of any contaminants of concern within soils or groundwater on the site. The consultants however recommended the adoption of a cover system in garden areas in the western parcel of the site and cess pit area, due to the presence of tipped materials.

Gas monitoring by RSK suggested elevated methane concentrations within BH3 which was located within the tipped materials in the western parcel. Amber 1 gas precautionary measures were recommended for the tipped and cess pit based upon the limited monitoring dataset and nature of the materials. Further gas monitoring was recommended in order to confirm the ground gas regime and design mitigation measures.

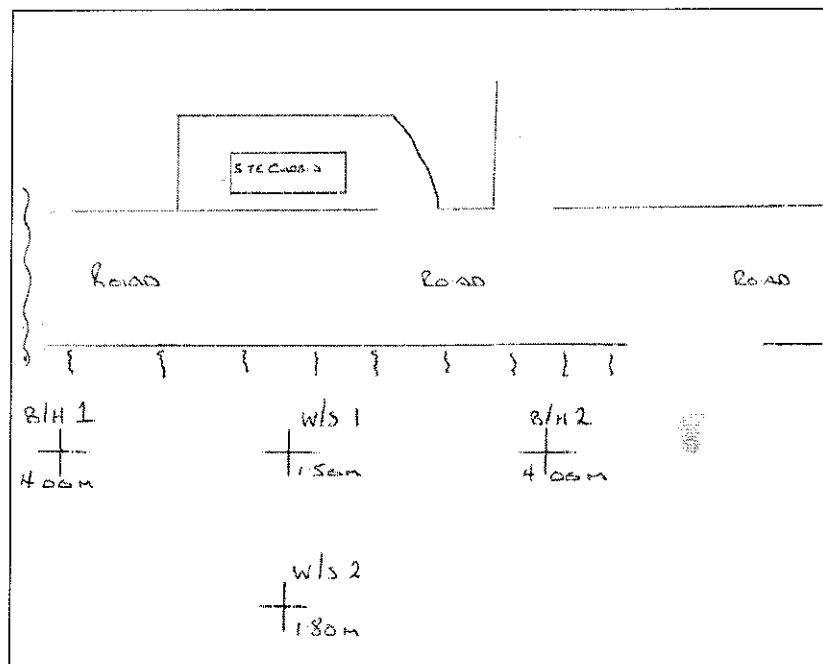
**Figure 3 Additional Ground Gas Monitoring Locations**

Four boreholes were drilled by McAuliffe to allow for additional monitoring of the ground gas regime to be undertaken. Figure 3 (below) shows the location of the sampling points.

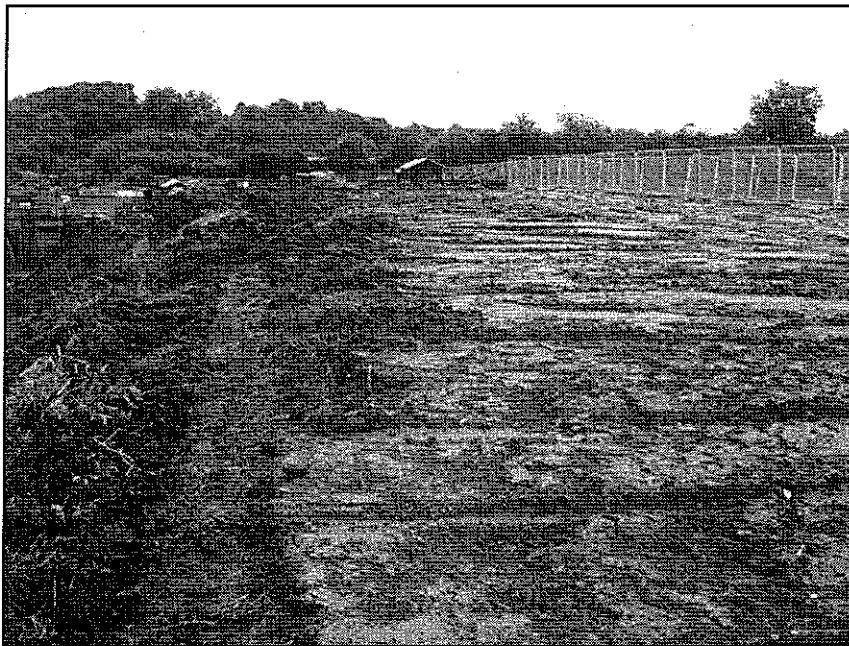
**Photograph 4 showing the old tip site after clearance**

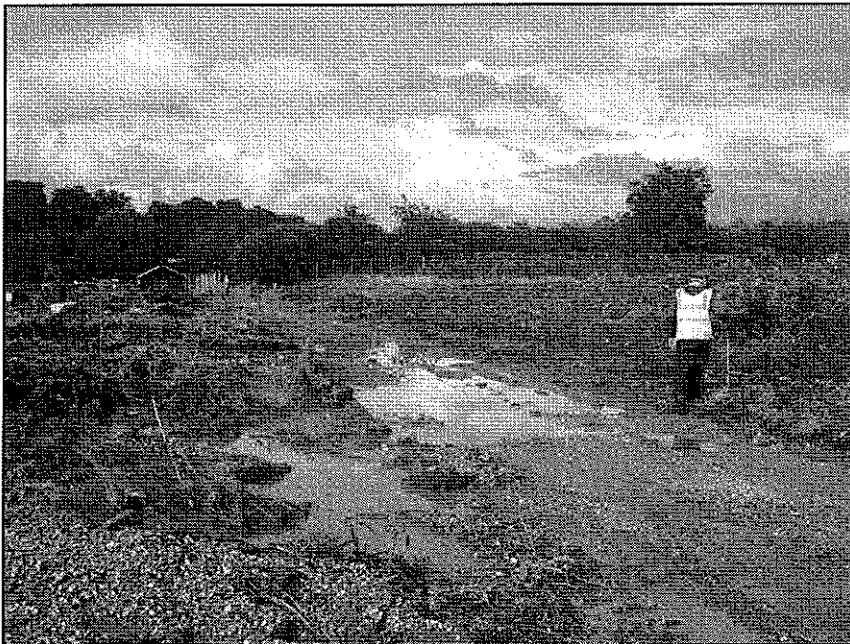
**Photograph 6 showing the site of the removed hedgerow**

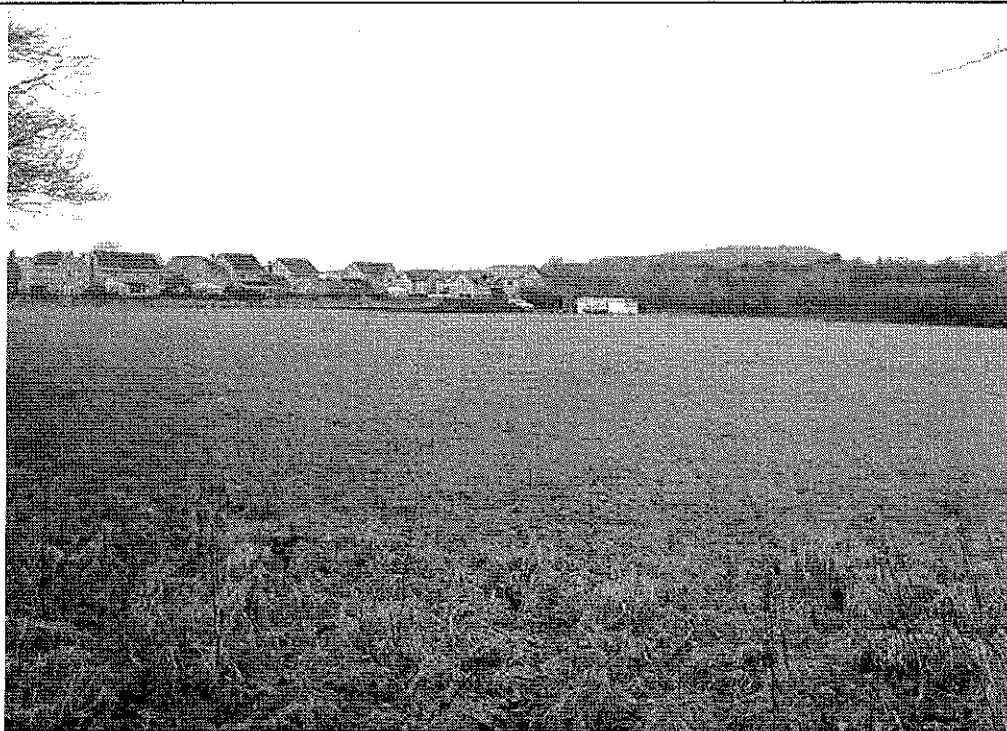
General view overlooking  
site from the northeast  
corner of the larger land  
parcel

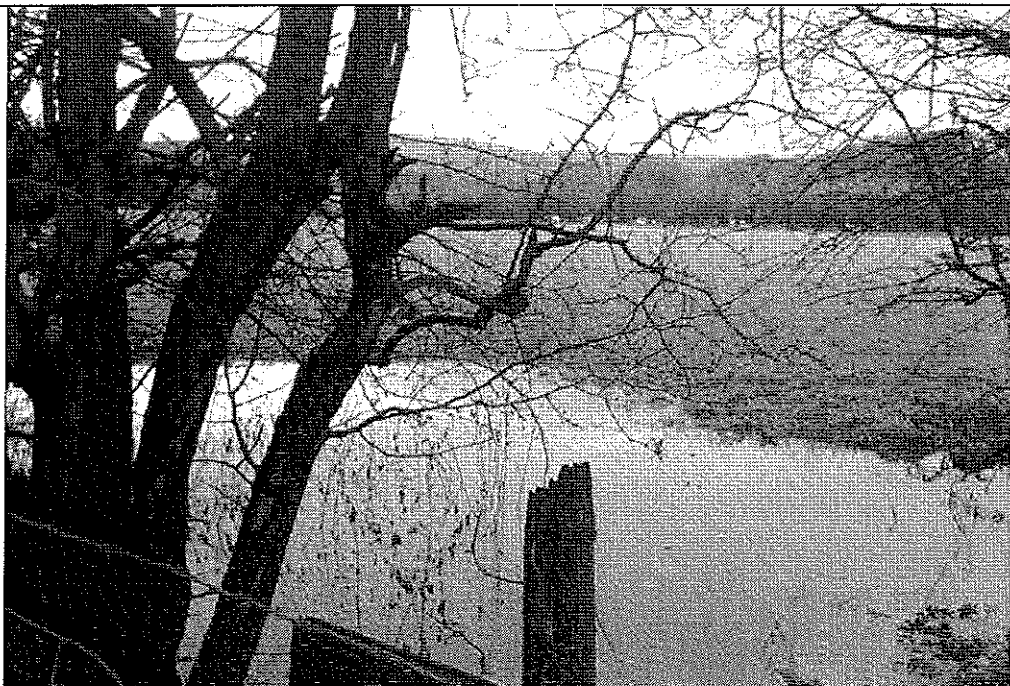
**Photo No.****8****Date:**

Flooding in the field  
adjacent to the  
northeast of the larger  
land parcel

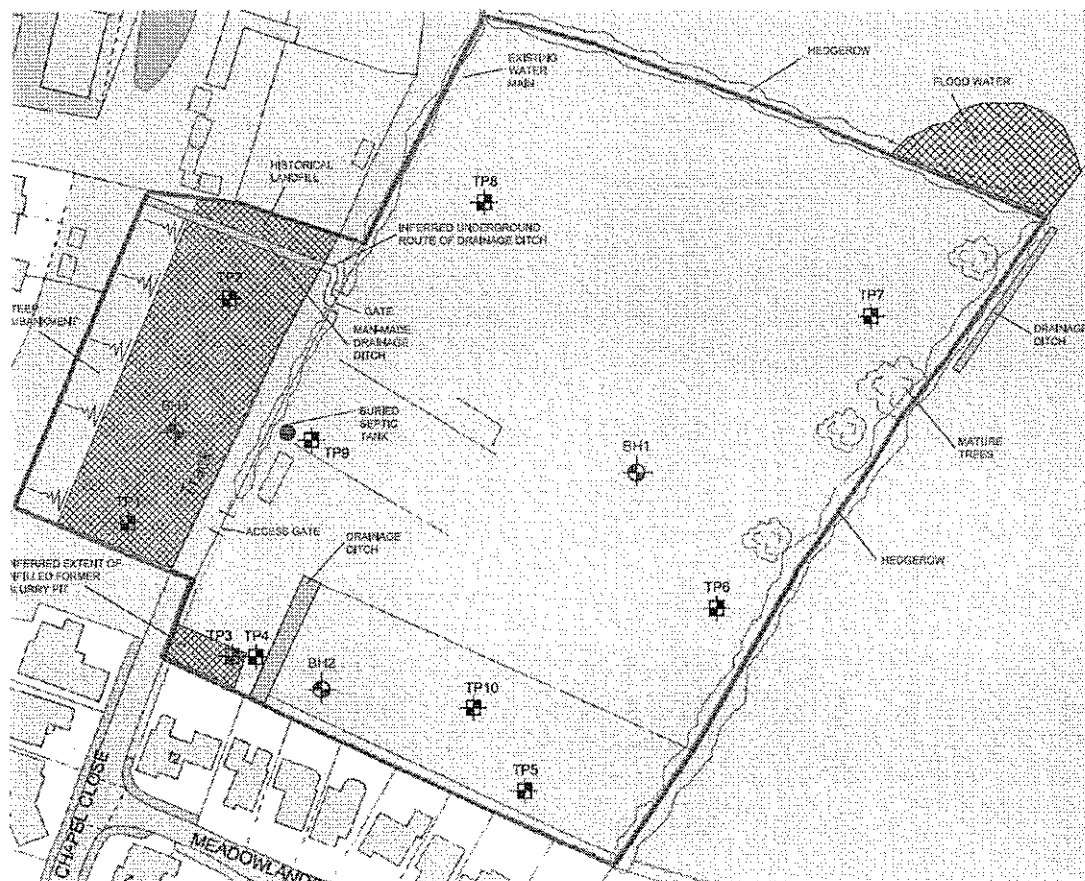
**Figure 2 Site Features Plan (extract from RSK Report)**

Figure 2 (overleaf) provides an overview of current site features, including the western parcel former tipped area, buried septic tank, drainage ditches, flooding areas and former cess pit. During the site visit on 21<sup>st</sup> March 2012 the site owner indicated that the housing development to the south of the eastern parcel of land has encroached onto the proposed development. As a result of the encroachment it is possible that the buried cess pit may partially be within an adjacent garden, as well as within the development area.

Figure 2 refers to a historic landfill which appears from visual examination and anecdotal evidence to occupy a narrow strip of land on the western parcel and a small tract of neighbouring land. It is understood that during a planning application consultation (by Bowsall) the Environment Agency misinterpreted the landfill as a former munitions training ground that was located to the north west of the site. It is understood that this area was remediated over ten years ago.

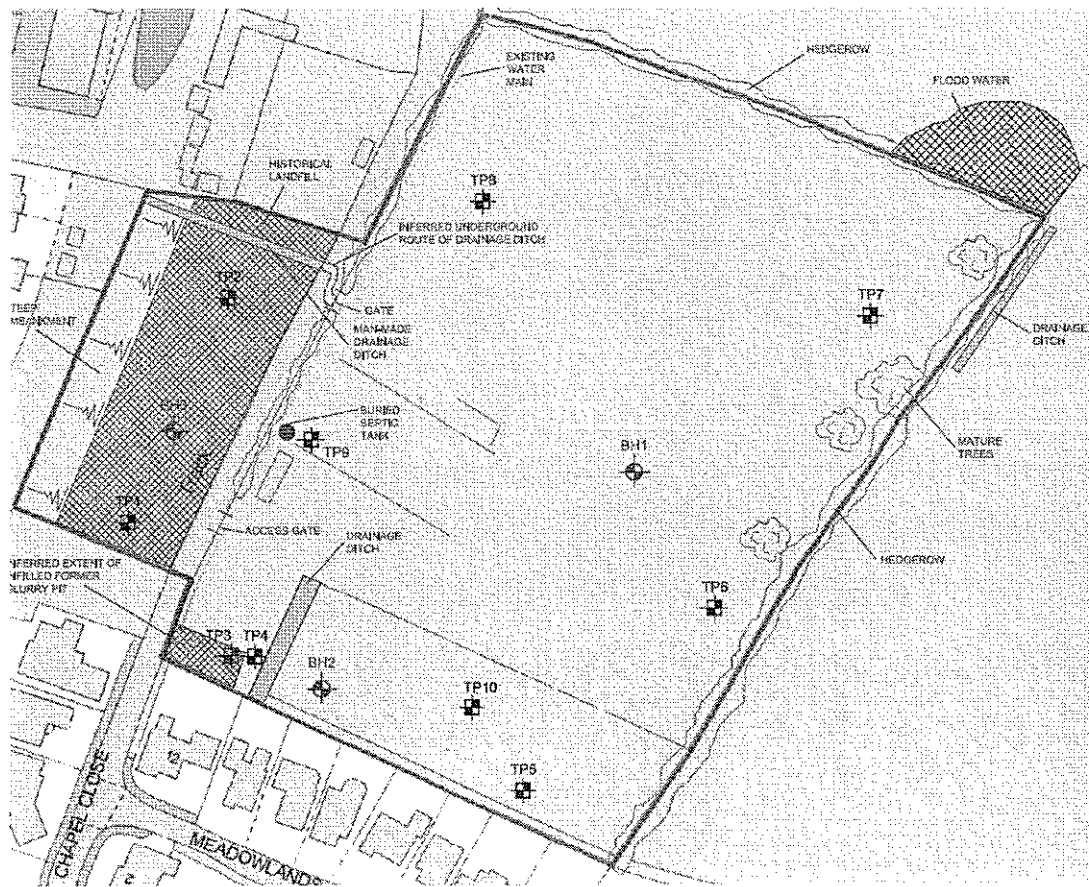
**Figure 2 Site Features Plan (extract from RSK Report)**

Figure 2 (overleaf) provides an overview of current site features, including the western parcel former tipped area, buried septic tank, drainage ditches, flooding areas and former cess pit. During the site visit on 21<sup>st</sup> March 2012 the site owner indicated that the housing development to the south of the eastern parcel of land has encroached onto the proposed development. As a result of the encroachment it is possible that the buried cess pit may partially be within an adjacent garden, as well as within the development area.

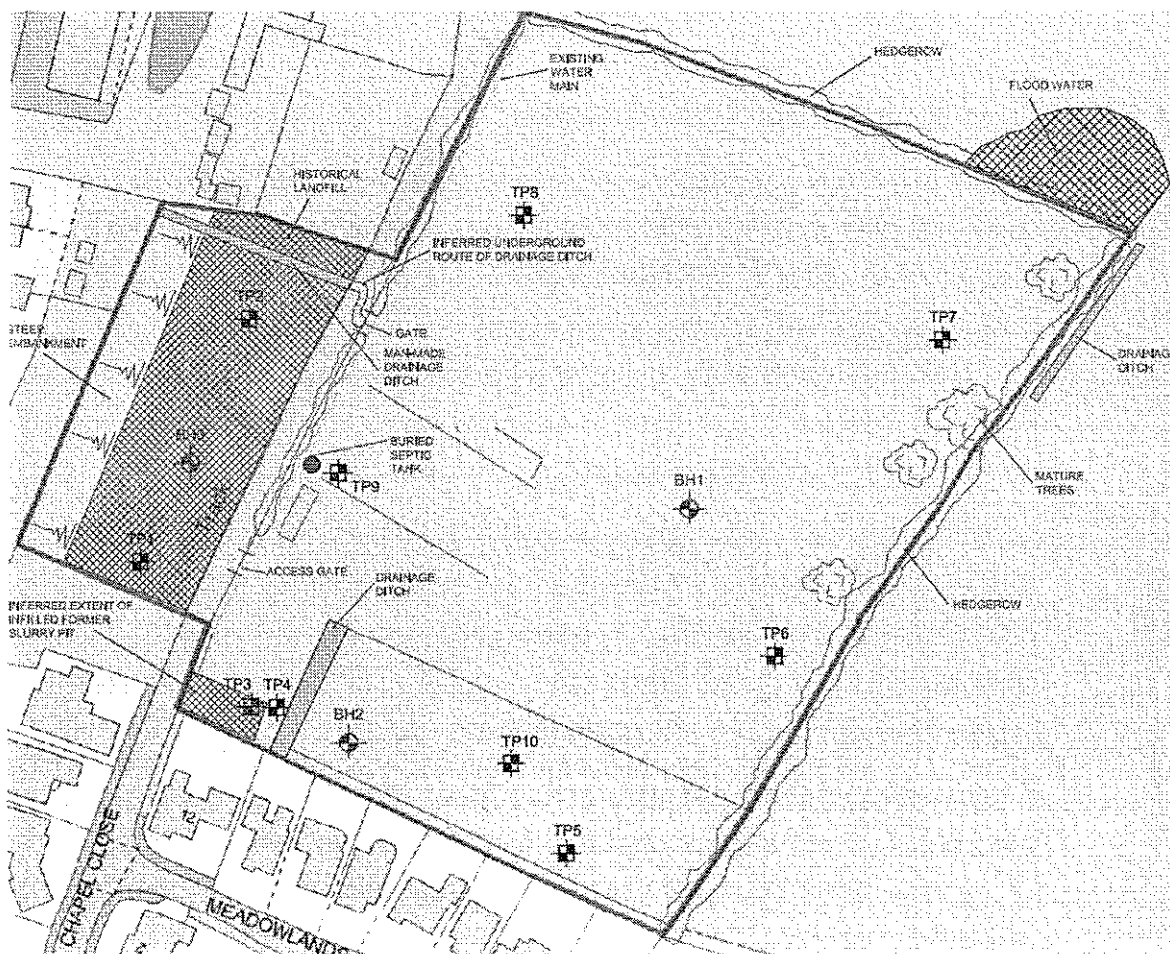
Figure 5 RSK Sampling Location Plan

Figure 5 (overleaf) shows the location of the RSK sampling points, which have been distributed across the former landfill (BH3, TP1, TP2), cess pit (TP3), septic tank (TP9) and pond area (TP10) and wider site area

Outside of the former landfill area ground conditions are consistent with a thin topsoil horizon present at all locations varying in thickness from 50mm to 400mm, underlain by a soft to firm clay (Glacial Clay). A thin (0.1m) band of peat was found at TP10 at a depth of 1.0m, associated with a pond feature.
