**STRUCTURAL CONDITION SURVEY**

**PROPOSED RENOVATION OF  
THE REDUNDANT COTTAGES**

**AT TOP ROW**

**Date:** 12<sup>th</sup> December 2012  
**Author:** L.F Gill B.Sc. (Hons.)

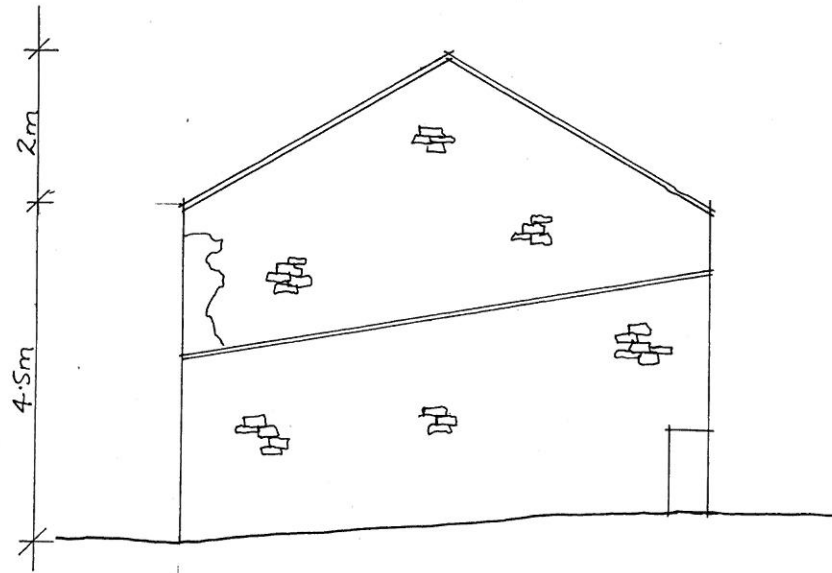
East Elevation

The gable wall to the east elevation is built from random rubble stone; the wall has a single storey outbuilding abutting it but the proposal involves the demolition of this building. The stonework is in good condition but does need re-pointing. The wall is straight and plumb. Metal ties are visible on the East elevation; these have been used to hold in place the corrugated roof sheeting that has been used to re-roof the eastern cottage in the past.

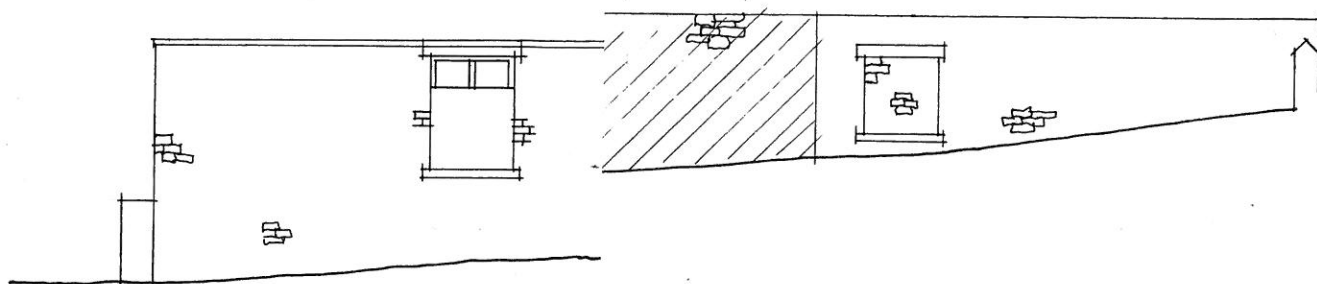
North Elevation

The wall to the north elevation is constructed out of random rubble stone. The middle section of stonework to the cottages appears in reasonable condition and is plumb.

The top half of the wall to the north elevation, which forms one of the remaining walls to the fallen down cottages to the west is in poor condition; it is bowing out at the top. This is due to the fact that the roof would have originally provided lateral restraint to the walls of the cottages, when this collapsed/was removed the walls would no longer have had the restraint required to hold them in place, resulting in the bowing at the top of the wall.

It can also be seen in photograph (13) below that a crack has formed at the north/west corner, this indicates that the wall which will form the proposed Utility and Garage is moving away from the gable wall of the western cottage. This movement would have begun when the roof was removed from the adjacent cottage and maybe on going.

The proposals involve building part of this section of wall higher than it is currently (as it would have been originally). Although the bottom section of the wall is in reasonable condition, it is recommended that this section of wall which will form the proposed Utility and Garage be rebuilt. This is because even though the movement of the wall away from the gable wall of the western cottage can be stopped, the wall would also need to be reduced in height until the stonework is in reasonable condition to build up off, which may in turn lead to stability issues.

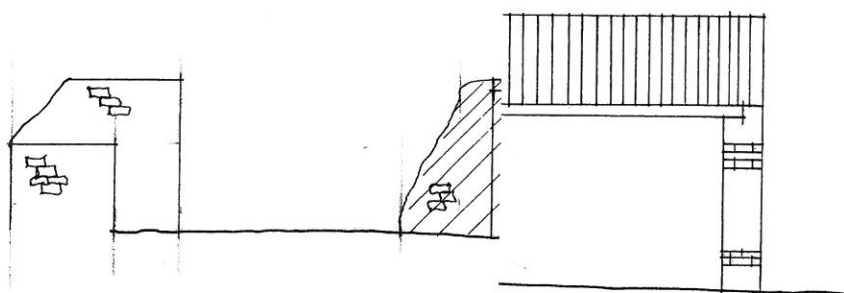
South Elevation

The wall to the south elevation is constructed in random rubble; this random rubble has a sand/cement render finish. The render finish is in poor condition with numerous hairline cracks.

Photograph (5) below shows the western door opening to the south elevation that is no longer plumb. The stoned up door opening is gradually falling over, this is due to the fact there is no wall above the door surround to hold the surround in place. The pointing is also missing around the door surround, as a result the surround is no longer tied into the structure and as a result it is slowly falling over. It is recommended that this section of wall is taken down and rebuilt.

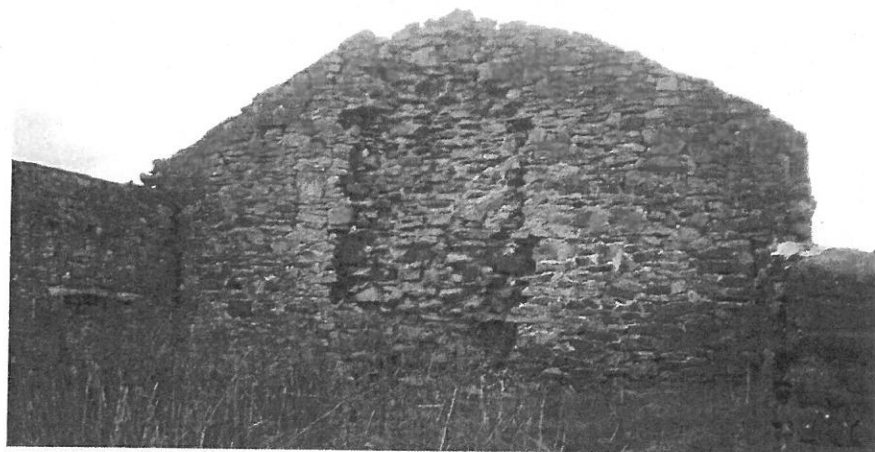
COMMENTS: One cottage has grey slate roof covering the cottage to the east has corrugated cement sheets.

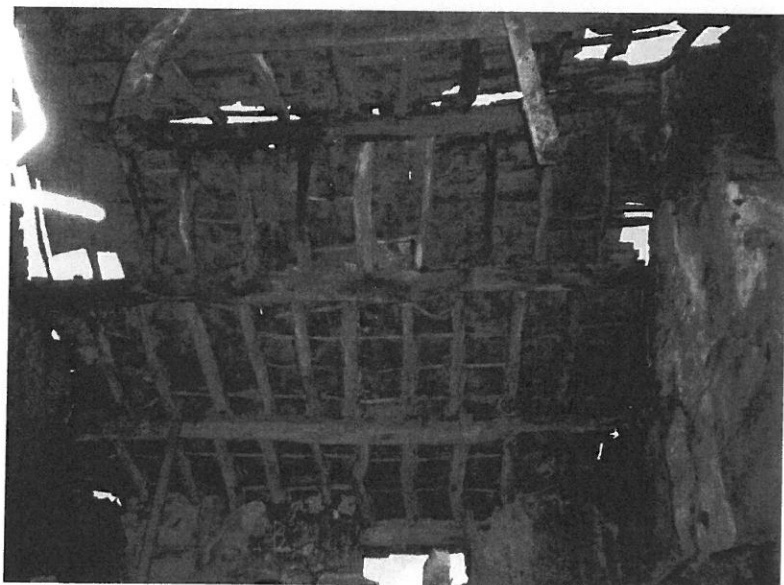
COMMENTS: The cottages are partially fallen down and the rubble walls have numerous cracks and crevices. The interior of the building is not enclosed.
