DACW/2871

20th November 2012

Bailey Hall Barn, Hurst Green
TRIAL PITS & CRUCK RESTRAINTS

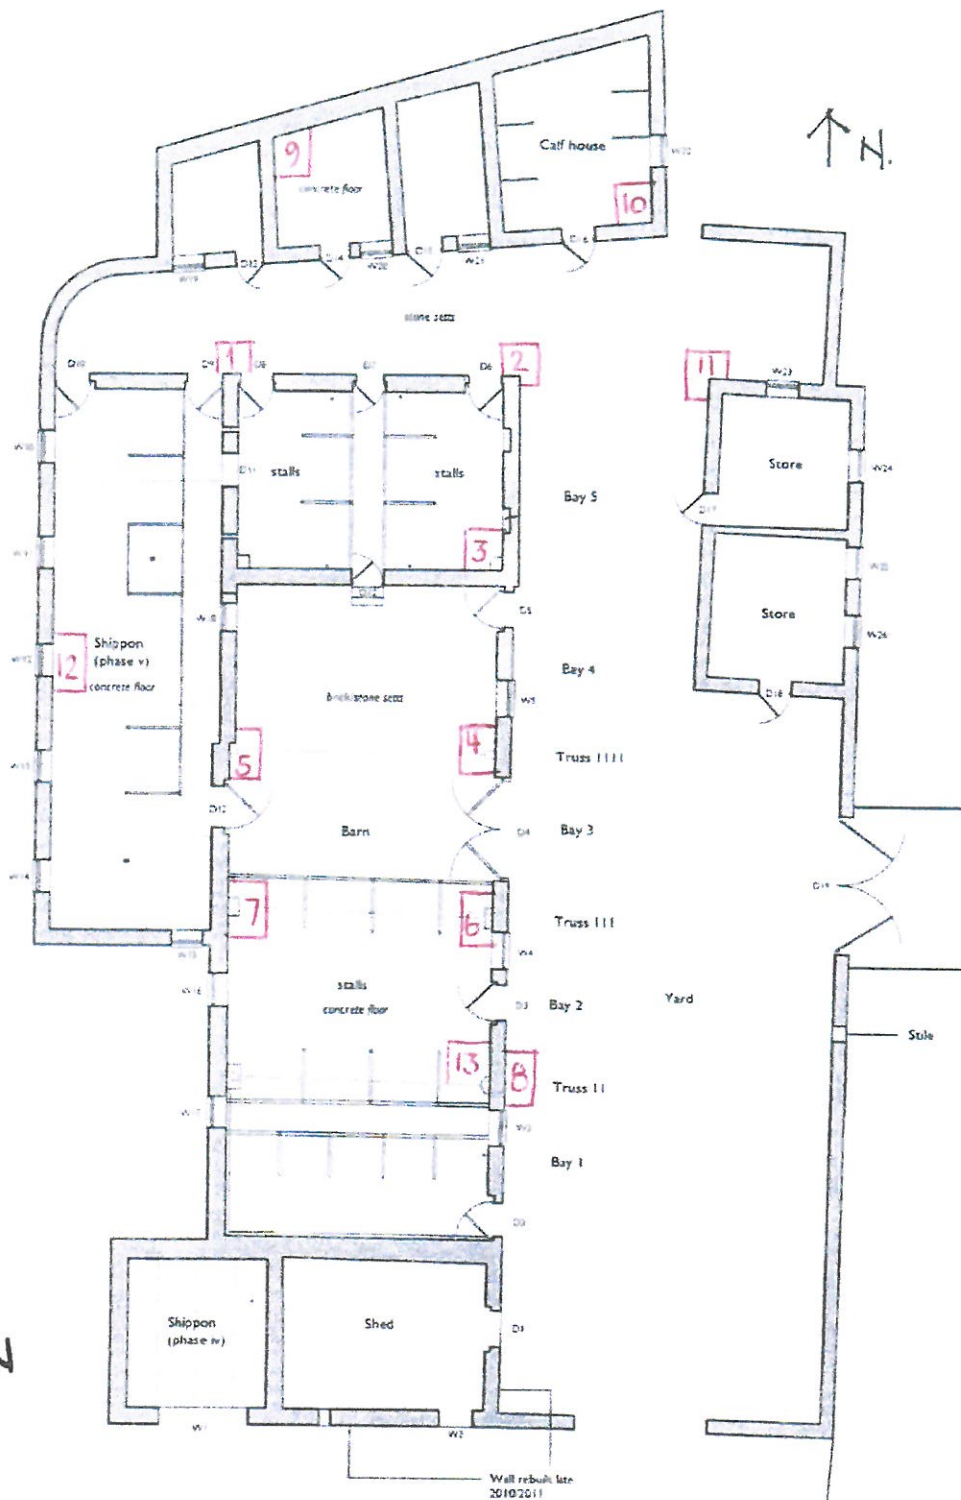
TRIAL PITS log 6.11.12
LOCATION PLAN

13 trial pits were dug at the locations shown on the plan and the findings are recorded on the logs sheets 1-3 enclosed with this letter. The trial pits revealed that the walls of the barn have mostly no projecting footing and are founded at between 130 and 450mm below the adjacent ground level. Ground conditions below the footings were consistent across all the pits comprising a firm light-brown sandy-silty clay. The only exception was trial pit 11 on the northwest corner of the storehouse where a layer of cobbles was found below the footing, bedded in the sandy-silty clay.

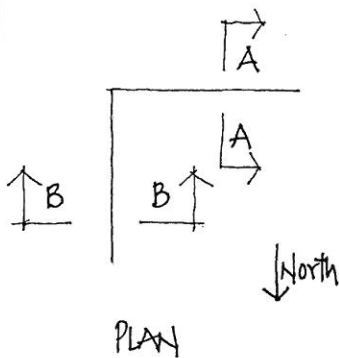
TRIAL PIT 3

The north and east walls are founded between 400 and 450mm below ground level (TPs 1,2 & 3). Providing the finished floor level is at present ground level or better still slightly above, then underpinning can probably be avoided.
