# ABBOTT & LOMAX LTD

Re:- Parkhouse Farm, Clitheroe

Further to your instructions we have visited the above property in order to carry out a visual inspection and prepare a written report on the structural condition of the property.

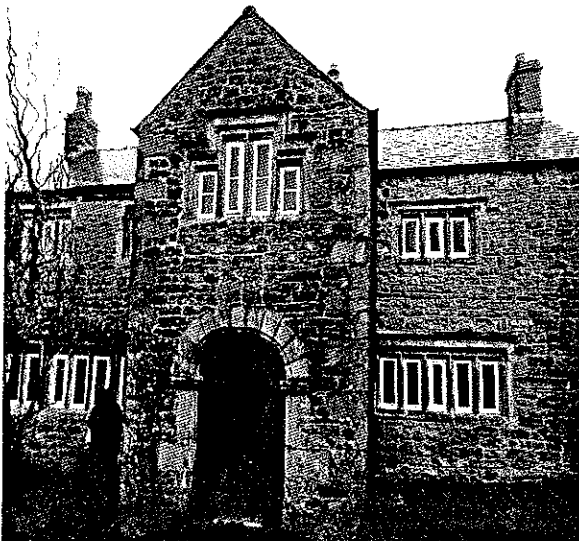
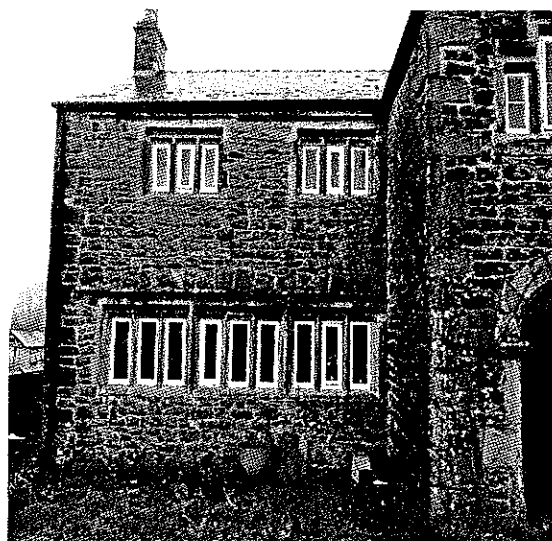
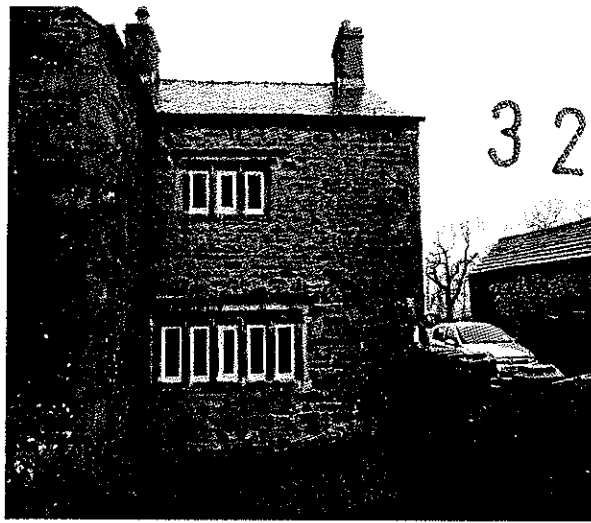
The front elevation contains an approximately central two storey entrance porch with the main external wall flanking either side as shown on photographs below.

All the external walls were checked for vertical alignment using a 1.2metre long builder's spirit level and, whilst minor local undulations were noted in some areas, the overall alignments were found to be acceptably plumb. The horizontal alignment was similarly checked along the window cills and found to be acceptably level overall. Localised cracking was noted to the dressed stone window surrounds to the left hand side of the entrance porch at both ground and 1<sup>st</sup> floor levels together with some erosion evident to the stone window mullions. In addition the keystone to the stone arch to the entrance porch door has dropped.

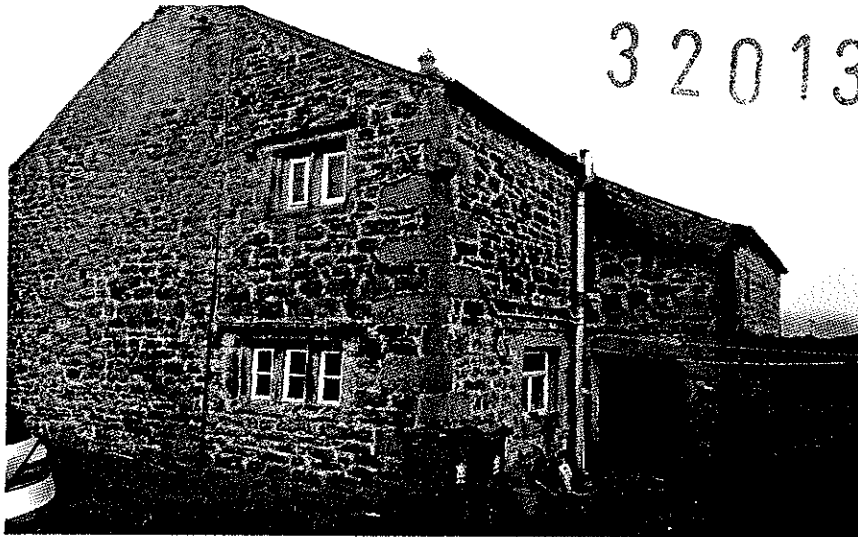
The gable elevation adjacent to the entrance drive was similarly checked and found to be acceptably plumb and level overall.

The stone lintel over the side entrance door was found to be cracked vertically at the left hand bearing with the wall.

- 1) The cracked stone lintel to the side entrance door should be repaired/replaced.
- 2) The vertical crack noted on the rear elevation gable corner should be repaired using a "Helifix" system of reinforced bars or similar approved.
- 3) The movement noted to the keystone to the front porch arch would appear to be of a long-standing nature with no evidence of any recent movement. We do not consider that a repair is necessary at this moment in time, nevertheless we would recommend that this area is inspected at regular intervals to ensure no further movement is taking place.
- 4) We would offer similar comments with regard to the opening up of the joint in the bowstring truss at 1<sup>st</sup> floor level.
