**BAT SURVEY**

**AT  
INTACK FARM  
DUTTON  
LONGRIDGE**

**DATE AND TIME OF VISIT**  
21<sup>st</sup> May 2013 8.30 - 10.00pm

**REFERENCE NO. 4368**

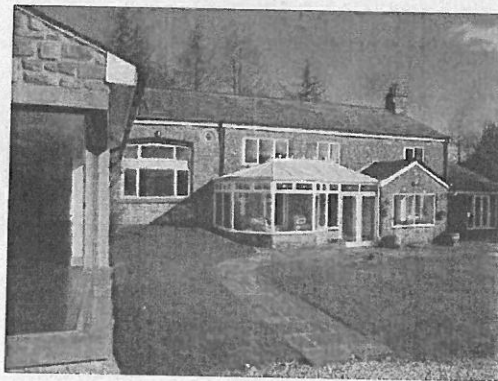
South elevation

COMMENTS: The property is a barn and existing farmhouse conversion probably carried out around 1980's. To the south elevation there is a single storey outrigger which is a more recent addition.
