## **STRUCTURAL APPRAISAL REPORT**

**Cocklick End Farm, Slaidburn**

**United Utilities Property Services**

**March 2012**

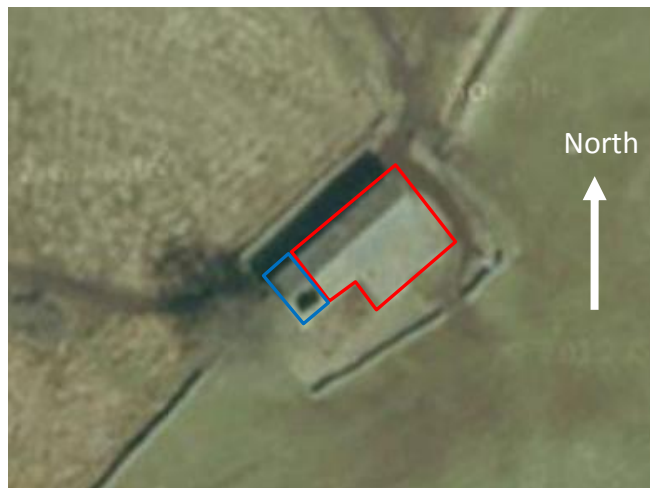
The building consisted of a large barn with attached house. The date stone on the barn door gave 1827. For the purpose of this report the orientation of the building is taken as north/south with the barn to the north.

The original property appears to have consisted of a large barn with a small attached house attached. At a later date an additional house has been added to the southern end of the property.

The property is constructed in natural stone with a timber roof support York stone slates or Welsh slates.
