BAT SURVEY
AT
SPRINGFIELD
WHITEACRE LANE
BARROW

DATE AND TIME OF VISIT
25th Nov 2013 2.00pm external inspection.
27th Nov 2013 11.00am Internal inspection

REFERENCE NO. 4291

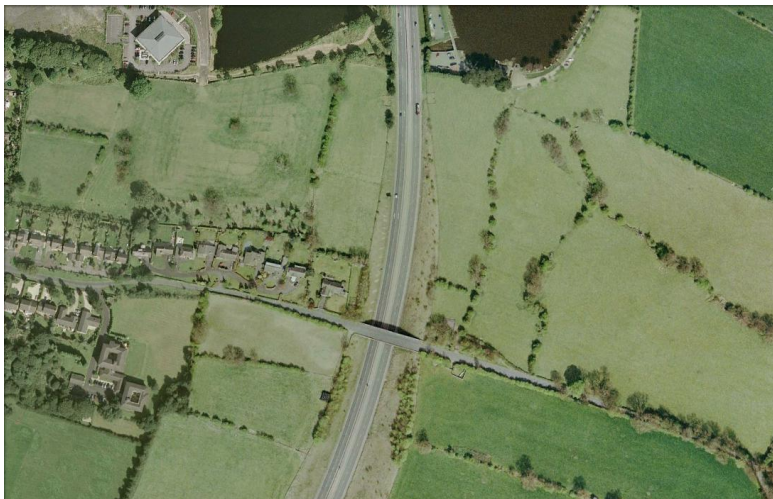
COMMENTS: The bungalow is located in a large garden with its eastern boundary being adjacent to the A59. It is the last house within the settlement area of Barrow off Whiteacre lane the road leading to Wiswell.

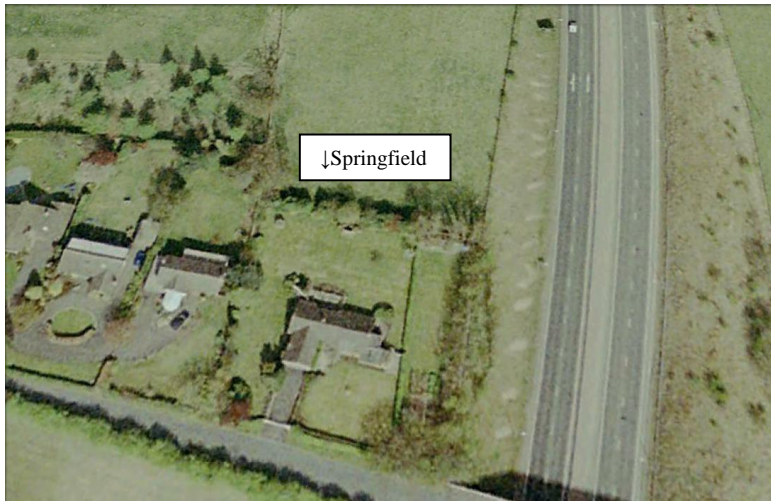
COMMENTS: The garden boundary is lined with a mixture of mature trees and leylandii, various potential foraging routes (lines of trees) radiate in a southern and westerly direction from the property. The route to the east is broken by the A59.
