**Structural Appraisal carried out on 12<sup>th</sup> March 2014**

**Cowley Brook Farm  
Higher Road  
Longridge**

**For the Proposed Barn Conversion to 2 Dwellings**

**Project Ref: BUTC/02**

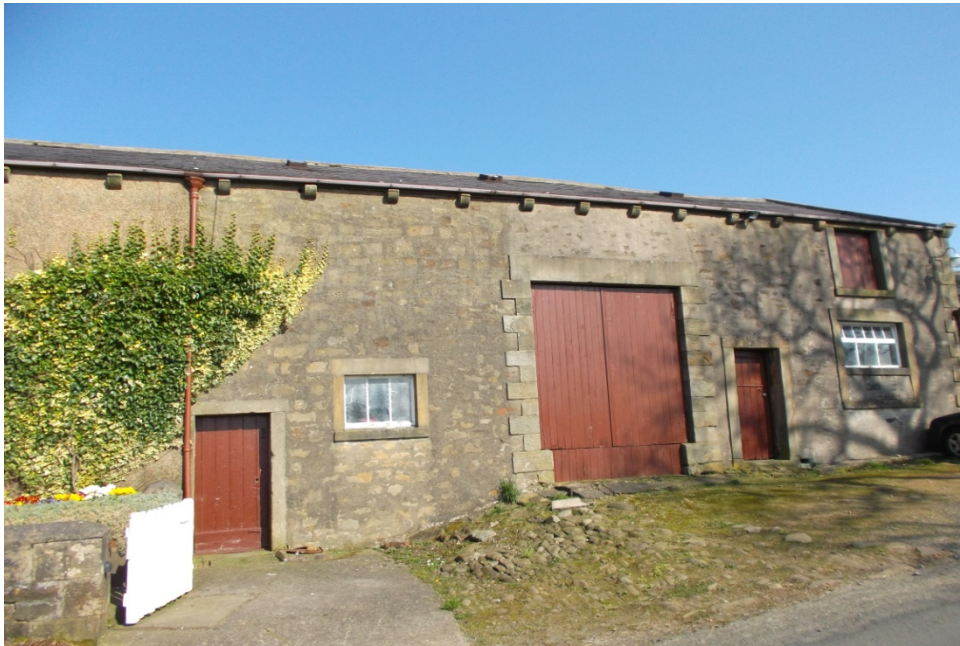
The main farm house is currently occupied residentially; with a two storey attached barn to the East and a single storey lean-to at the rear, which houses 3No. Stables.
