BAT SURVEY

**AT
53 KNOWSLEY ROAD
WILPSHIRE**

**DATE AND TIME OF VISIT
7th MAY 2015 8.30 - 10.00 pm**

REFERENCE NO. 4186 EVENING SURVEY

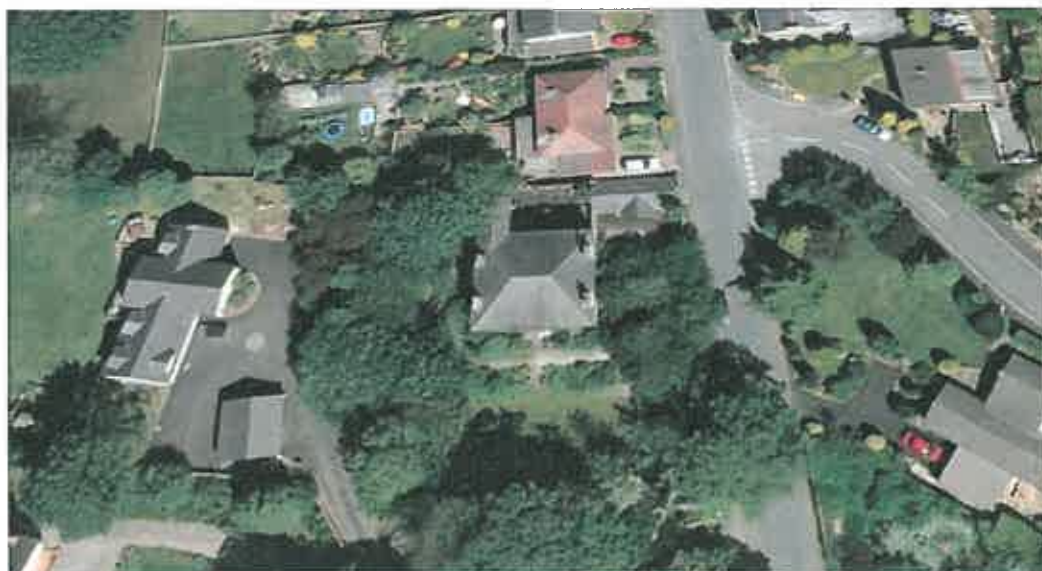
COMMENTS: The house is located in large mature garden extending to the west, south and east, an adjacent house being located close to the north boundary. This aerial photograph does not accurately represent the current planting in the garden, some of the trees have been removed from the site. Mature trees are located in the adjacent gardens. There is medium level foraging potential in this location.
