Desk Study Report

**Mearley Brook
Clitheroe
Lancashire**

Beck Developments Limited

J11218

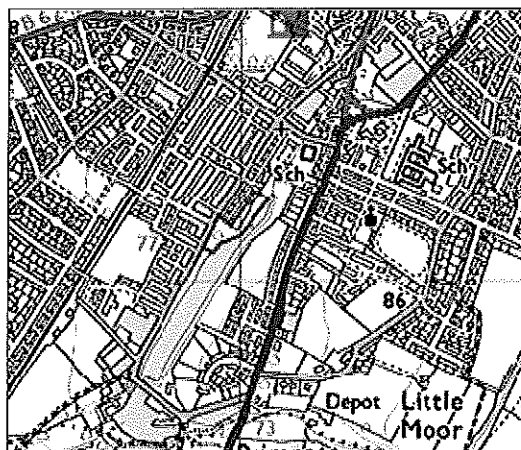
The site is in an overgrown and untidy state with fly tipped waste covering much of the surface. Part of the site to the rear of the houses that front onto Woone lane was, at the time of walkover, being used to keep poultry. The site slopes steeply down from Woone Lane towards Mearley Brook and the gradient reduces with increasing proximity to the brook.

It appears that the site was once accessed from Woone Lane as entrances for pedestrians and vehicles have been bricked up and 'Keep Out' and 'Deep Water' warning signs are displayed. Some remnants of former buildings were noted in the north of the site, including what appears to have been a vehicle inspection pit.

The fly tipped material noted at the site was generally observed to be demolition rubble; this rubble contained some fragments of corrugated cementitious panels which may
