STRUCTURAL INSPECTION

NEW HALL BARN, RIBCHESTER

STANTON ANDREWS ARCHITECTS

August 2015
Project No P2531

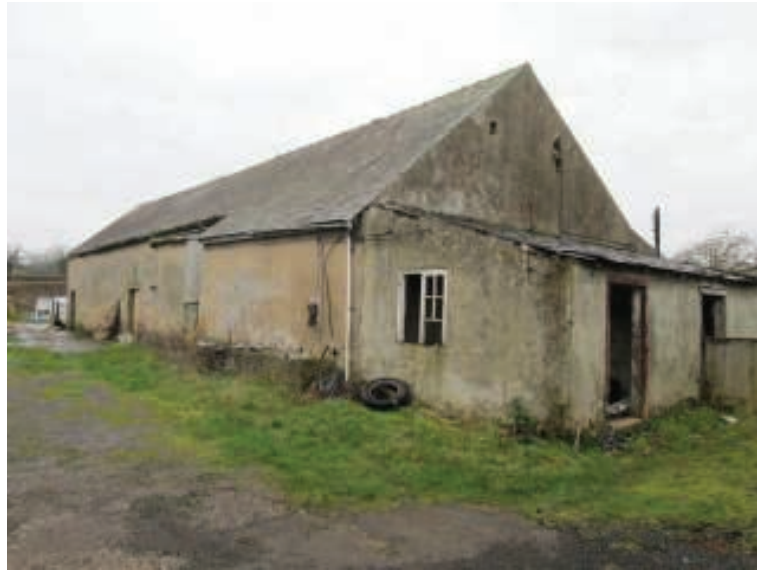
Photo 1 – Front Wall and Right-Hand Gable Wall of Barn

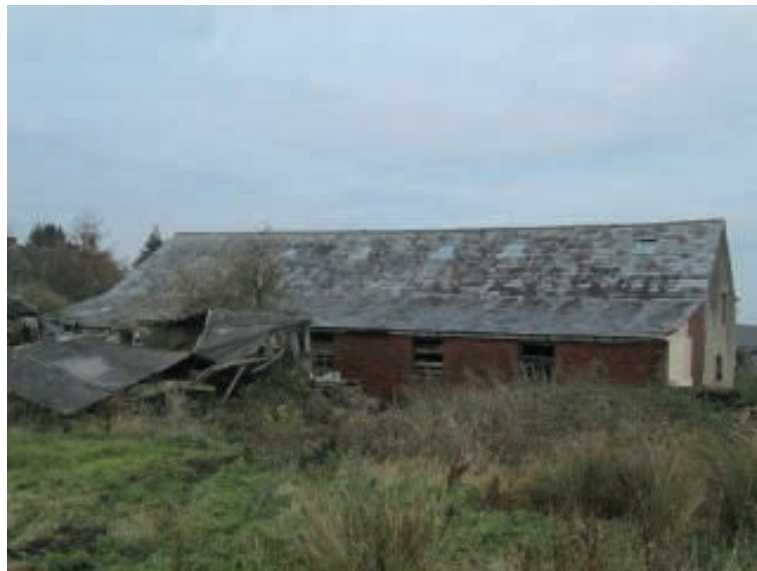
Photo 2 – Rear and Left-Hand Gable Wall of Barn and Shippon

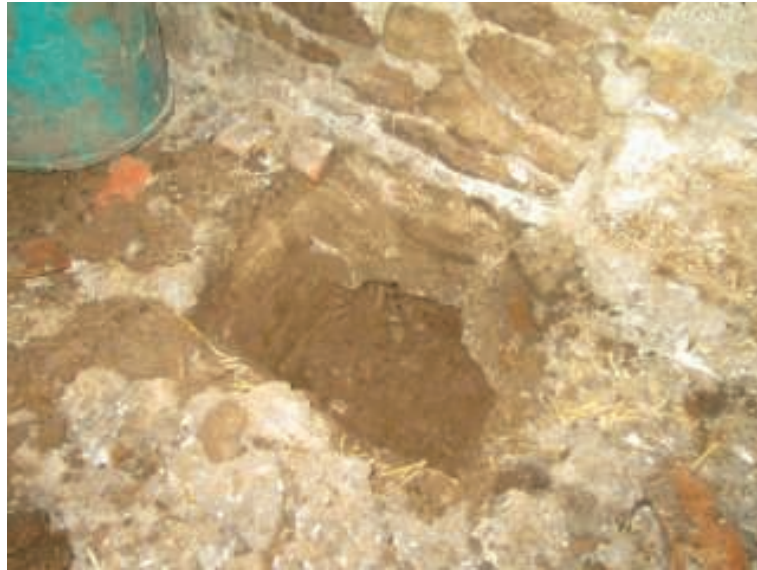
- There is a vertical crack of width up to 25mm over the full height of the rear wall near the door leading to the shippon (**photos 24&25**).
- Three trial pits had been excavated, alongside the inside face of the external walls. Trial pit 1 was located at the left-hand gable (**photo 26**), trial pit 2 at the right-hand gable (**photo 27**), and trial pit 3 at the front wall in the double-height barn space. All three revealed that the walls are founded in stiff clay and extend no deeper than approximately 150mm below the floor.

Photo 27 – Trial Pit 2 – Right-Hand Gable Wall

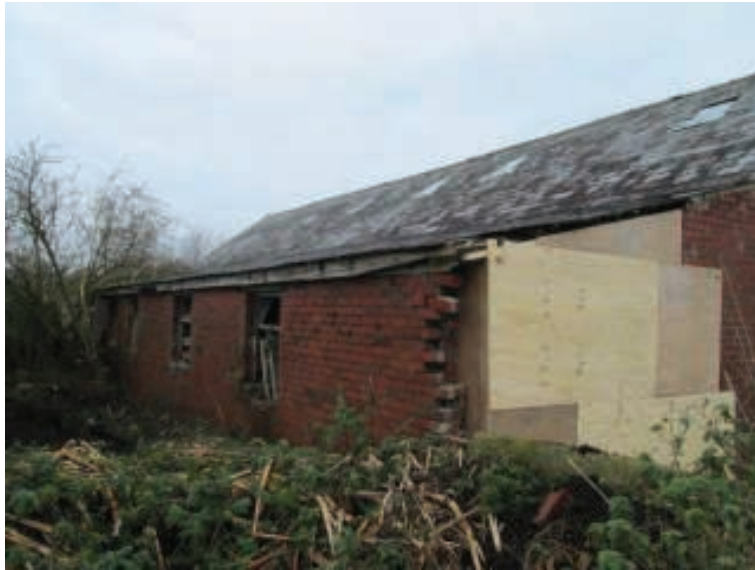
- The slating on the main barn and most of the shippon is good, reflecting the fact that they have recently been re-slatted. The roof over the outhouses on the right-hand side is poor.
- The front wall of the barn shows the significant outward lean at the left-hand corner as noted internally (**photo 34**). The wall leans inward at the main entrance door (**photo 35**).
- The right-hand gable wall of the barn is reasonably straight and vertical. There is some cracking where the rear outbuilding joins the main barn (**photo 36**).
- The rear wall of the shippon is reasonably straight and vertical (**photo 37**). The timber lintels over the windows have decayed (**photo 38**).
- The gable wall of the shippon has been partially demolished and the gap closed with plywood sheeting (**photo 37**). A gap has opened where the brick gable wall of the shippon joins the main barn (**photo 39**).

Photo 37 – Rear Wall and Left-Hand Gable of Shippon

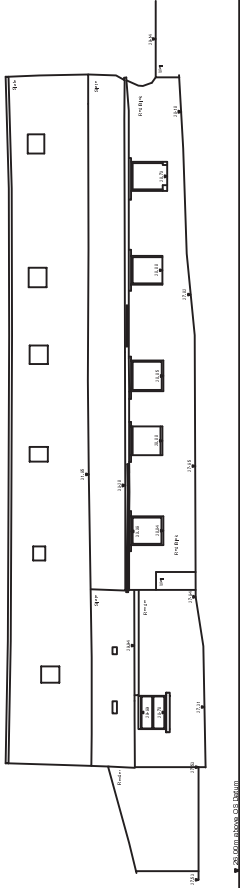
North East Elevation

The front wall of the barn leans out significantly at the left-hand corner. This area should be re-built (see marked-up plans in Appendix B), or otherwise stabilised with new steel posts or framing. The left-hand gable wall is distorted, cracked and bulging near the in-filled first floor window. This area should be re-built (see Appendix B). The right-hand gable wall is reasonably straight and vertical. The architectural proposals show that a large part of this wall will be removed over its full height. A rigid steel frame will be needed to support the roof and to give overall lateral stability to the barn. The rear wall of the barn is reasonably straight and vertical.

This area to be rebuilt
