BUILDING (STRUCTURAL) CONDITION SURVEY
IN CONNECTION WITH
BARN AT HIGHER BOYCE FARM,
RIBCHESTER

MR M. SELLS AND MISS M. HOWORTH,
HIGHER BOYCE FARM,
STONEYGATE LANE, RIBCHESTER, PR3 3YN

JOB REF: 4874, DATED: 23/09/2015, VERSION: 1.00.

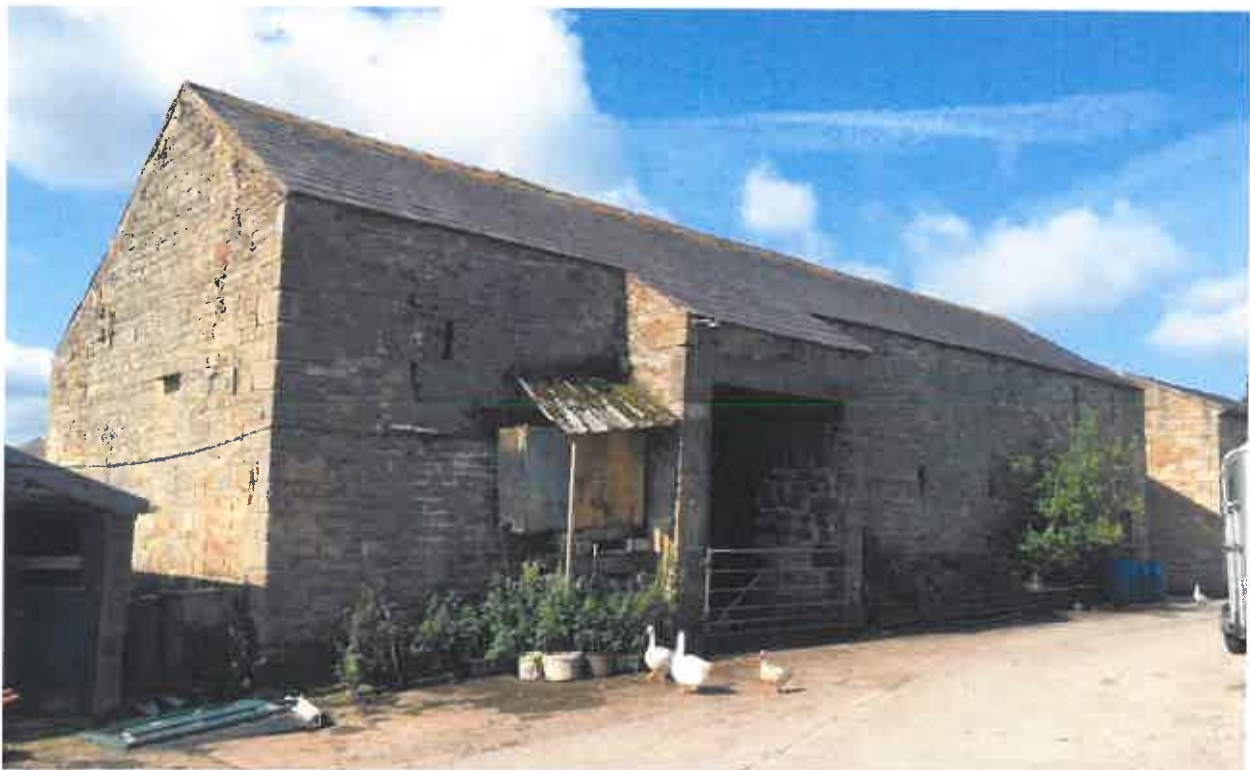
PL16: North Elevation of the Barn

The condition of the external walls to the barn is that of average condition throughout with no obvious structural cracking and breaches. However this is with the exception of the presence of ventilation holes and vertical wall cracking to the north and east elevations with associated patch mortar repairs. Potential minor, isolated areas of remedial crack stitching / lateral restraints required at these points. Mortar degradation and missing mortar pointing was prevalent throughout particularly to the base of the walls where the mortar is more susceptible to decay through the splashback of rainwater. Hairline cracking of the mortar joints was also evident throughout. Mortar cracking was also noted to the right hand side face of the stone lintel over the barn entrance to the north elevation.
