# **STANDEN HALL, WORSTON ROAD, CLITHEROE, LANCASHIRE**

## **Historic Building Survey Report**

**Oxford Archaeology North**

August 2017

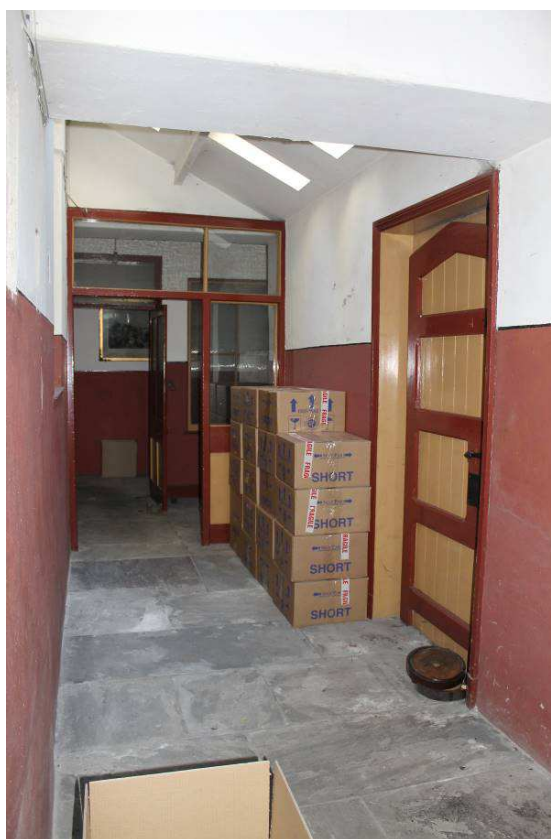
*Plate 7: Room G9a, facing east*

- 4.2.1 **Room G9a (Fig 2):** **Room G9a** formed a short east/west-aligned corridor within in the service wing of the house, with a rectangular circulation area at the western end (Plate 7). To the east it was divided from **G9g** by a glazed partition, while to the south, door **GD47** led into an external yard. At the western end, doorway **GD18** connected **Room G9a** to the south-western wing via a small vestibule **G7b**, with another door **GD19** immediately to the west through which, access was gained to the cellar. At the centre of the western wall, door **GD20** led into the room **G11** to the west, while to the north door **GD25** linked the space to **Room G9b**.

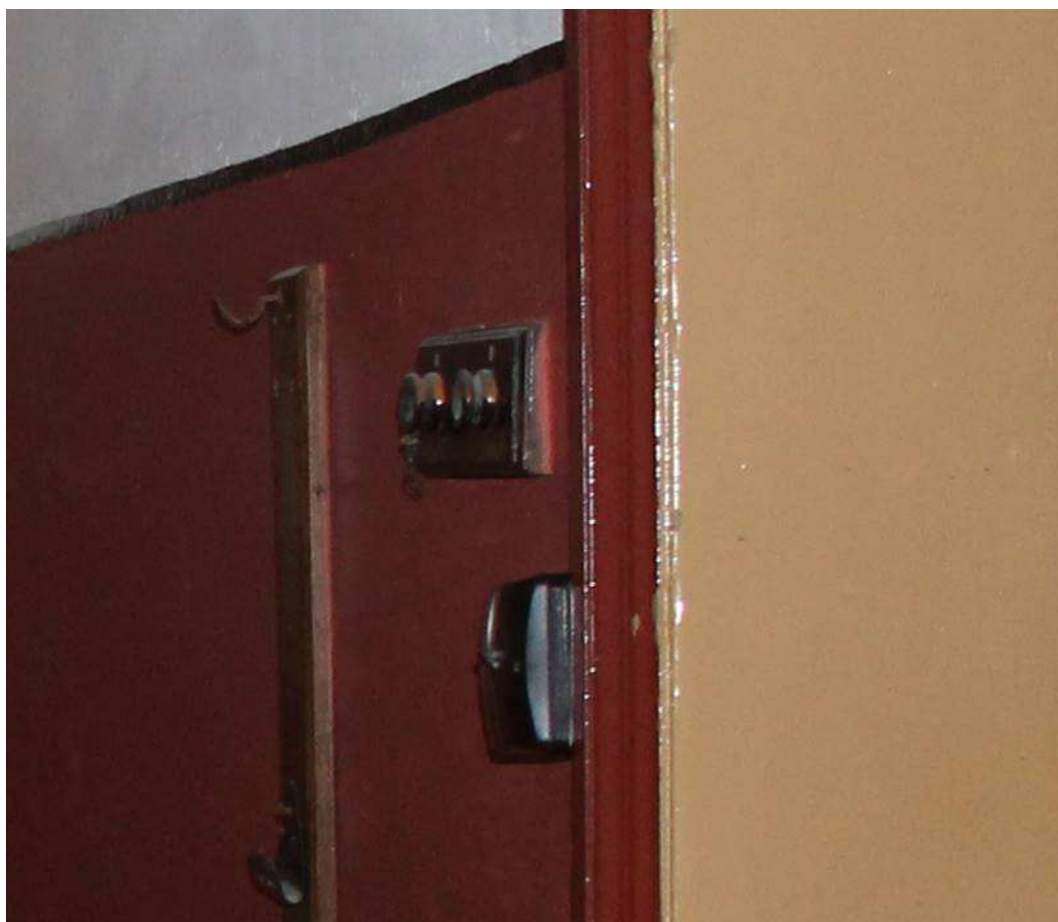
*Plate 9: Intercom system on western wall*

- 4.2.5 On the western wall, to the south of door **GD20**, there survived what appeared to be a basic intercom system through which, it was presumably possible to communicate with other stations within the house. It consisted of a pair of circular moulded apertures mounted upon a wooden board (Plate 10).

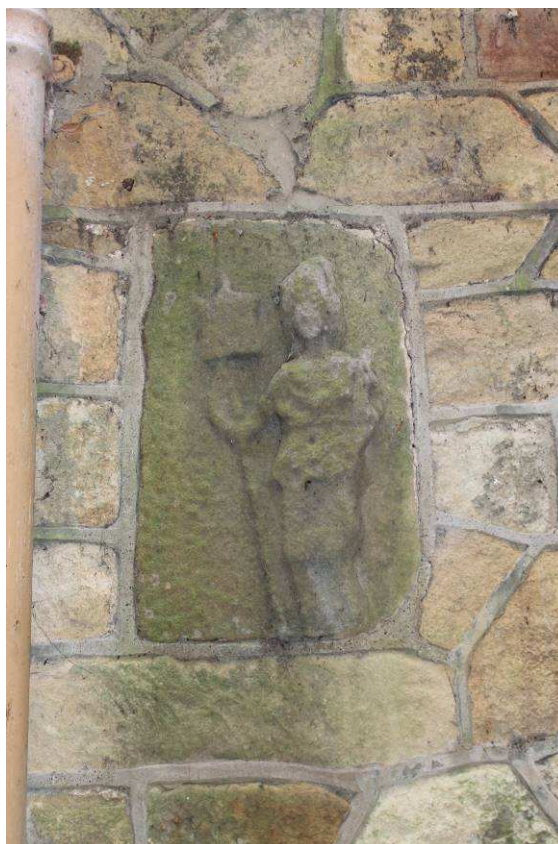
4.2.20 **The Yard (Fig 2):** the yard was a small rectangular space at the centre of the house, enclosed upon all four sides, with its only access from doorway **GD47** in the north-west corner. The north wall extended to just a single storey in height and formed part of a lean-to structure enclosing corridor **Room G9a**. It was constructed of a cream-coloured rubblestone, that had been ribbon pointed with a cement mortar. A piece of rectangular stone had been incorporated into the wall towards the centre at about head height, upon which had been carved in relief a figure holding a staff or banner (Plate 16). The piece of sculpture was heavily weathered and possibly of Roman date.

*Plate 16: Roman sculpture on north wall of yard*

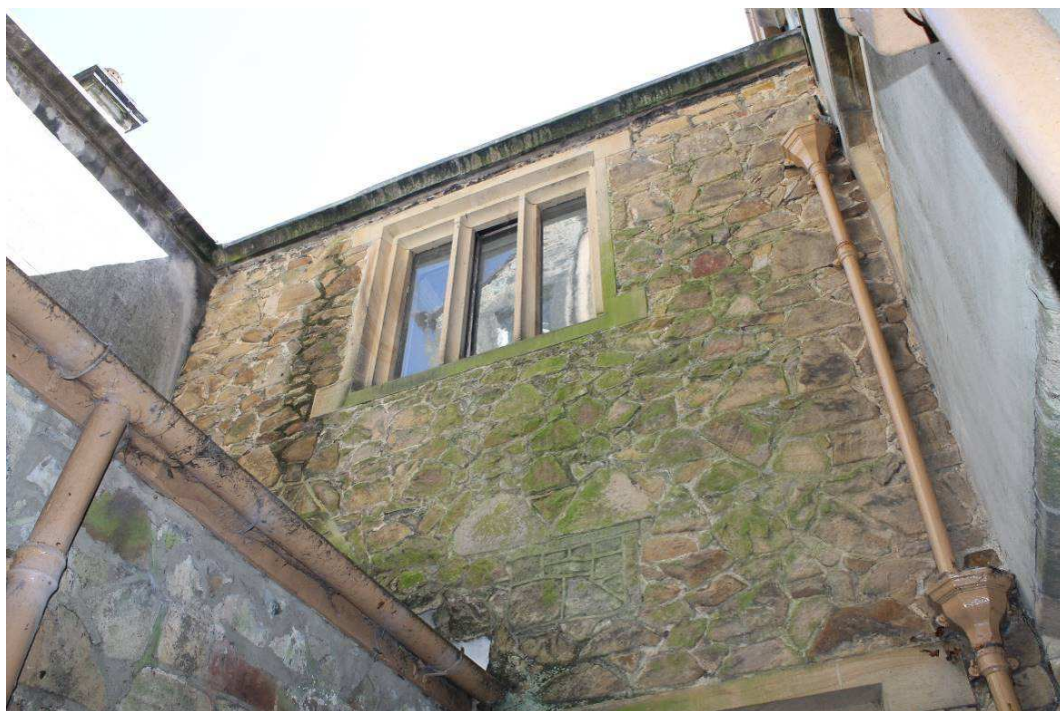
*Plate 17: Central yard, facing east*

- 4.2.22 The eastern wall was of two-storeys and similar construction, although without the ribbon pointing (Plate 17). It preserved a four-light cross window **GW43** at ground floor level and a three-light mullioned window **FW39** at first floor height. There was some evidence to suggest the remnants of an additional aperture at the base of the first floor, where a pair of narrow stones met, one vertical the other horizontal to form a right angle. Notably, this was the only area of the wall where ribbon pointing had been employed across a small area.

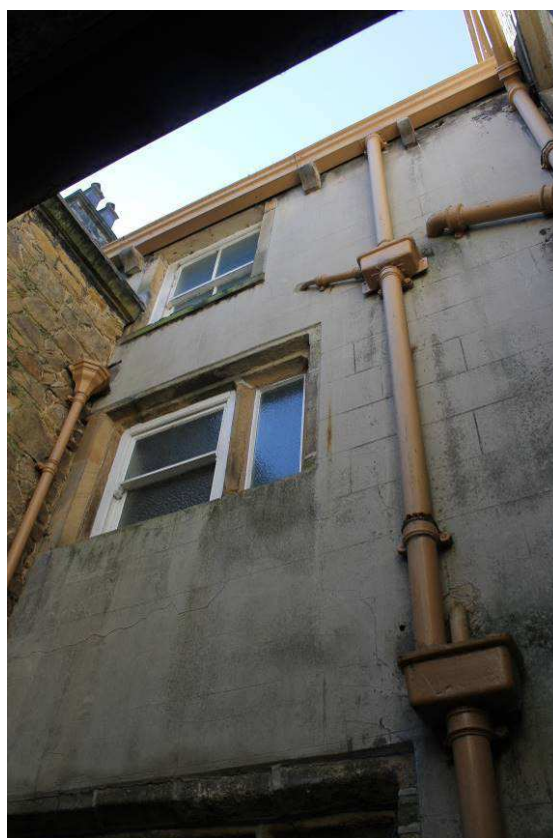
*Plate 18: South wall of central yard*

- 4.2.23 The southern wall extended to three storeys but had been cement-rendered and scored to produce an ashlar effect (Plate 18). It carried a cast iron downpipe to the west with another waste pipe at the western corner, and there were a series of three stone corbels at the head of the wall supporting what appeared to be an original timber gutter. The elevation included a four-light window **GW44** at ground-floor level, a modified two-light window **FW40**, a four-light windows at first-floor level and a two-over-two sash **SW21** at second-floor height.

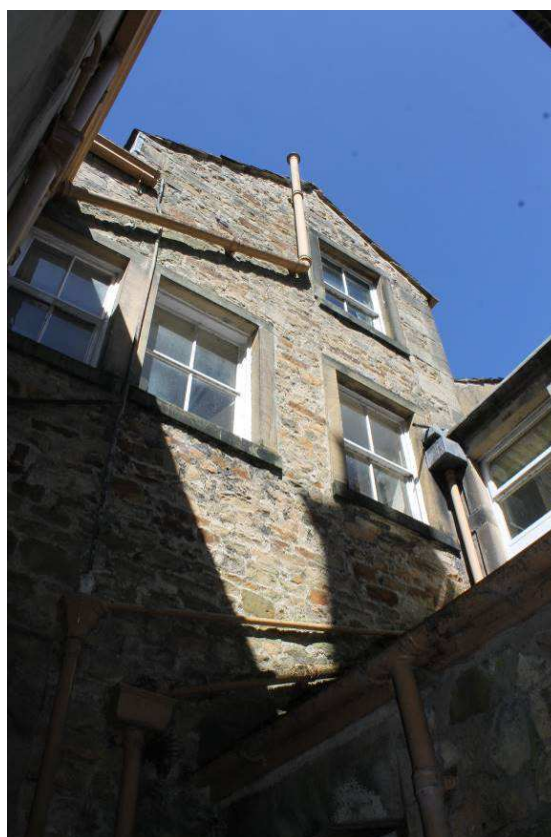
Plate 19: Central yard, facing west

- 4.2.24 The western wall reached three storeys, with the upper storey forming a gable, and was constructed of coursed rectangular rubble blocks set in a lime mortar, with alternating quoins on the top floor (Plate 19). The ground floor had a narrow two-over-two sash window **GW42** at its southern end, with three further two-over-two sashes at first floor height **FW35-37** and another on the second floor **SW13**.

- 4.2.25 A cast iron soil stack extended above the gable at the centre of the elevation, with a down pipe to the north carrying water over the lean-to roof to another pipe at the centre of the wall.

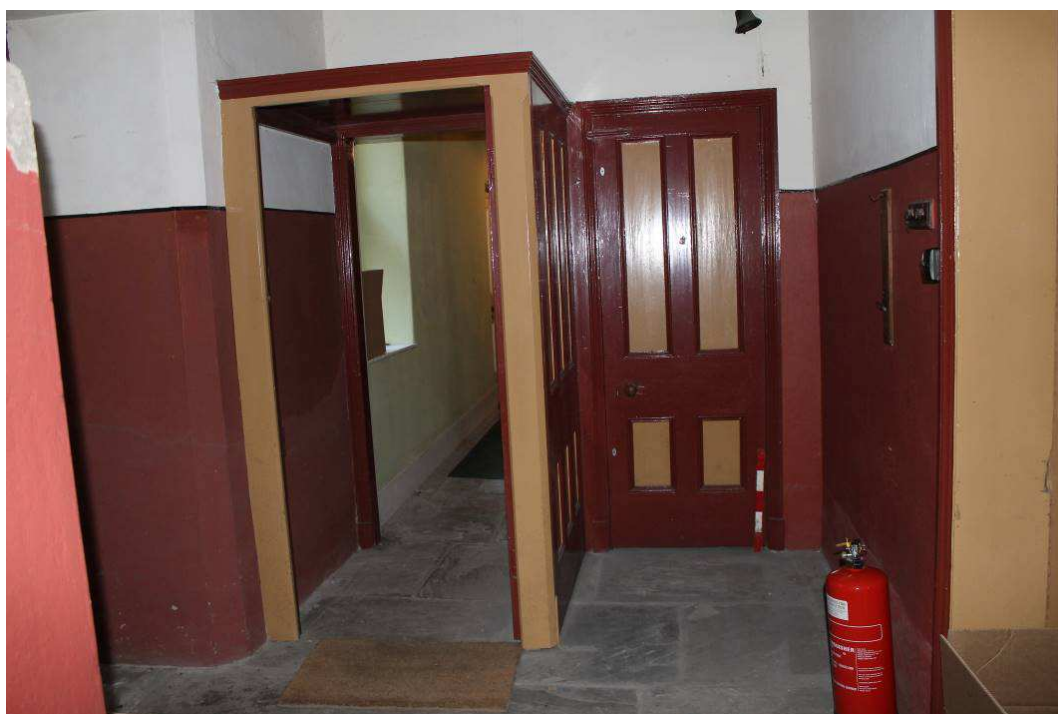
Plate 20: **Room G7b**, facing south

- 4.2.26 **Room G7b (Fig 2):** this was a small vestibule area in one corner of **Room G9a** (Plate 20). It had been subdivided from **Room G9a** by the erection of a short timber panel partition that formed the western side, the installation of a door to the north and the fitting of a flat timber ceiling above. It was decorated in the familiar red and mustard paint scheme and included a moulded cornice across the head of the outer face of its northern and western walls. The flagstone floor identified in **Room G9a** continued through the vestibule and into corridor **Room G7a** beyond. The room had presumably been built to reduce drafts between the family rooms and service rooms and a part glazed door **GD17** defined its northern extent.

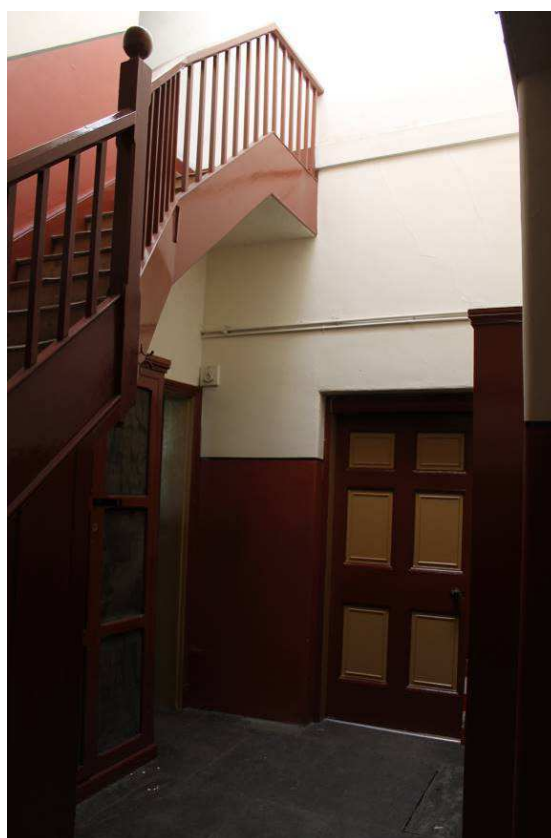
Plate 21: **Room G13**, facing east

- 4.2.27 **Room G13 (Fig 2):** this room lay to the south of the pantry **Room G14** and east of the scullery **Room G12** in the north-western corner of the service wing. It formed a short east/west-aligned corridor with a timber staircase occupying the north-western corner, that led up to the servant's quarters on the first floor (Plate 21). The room had two doors, one at the north-east corner **GD31**, and a second on the east wall **GD32**, that gave access to the pantry and kitchen respectively. Both doors had six-panels, with moulded margins and insets.

- 4.2.28 The red and white paint scheme continued, as did the flagstone floor. The room was lit from above by a glazed lean-to roof and at the base of its southern wall, a low window provided a degree of light to the cellar steps beyond.

- 4.2.29 The stairs appeared to be of softwood and of relatively utilitarian design, with square section balusters. The edges of the treads showed significant wear indicative of a long period of use.

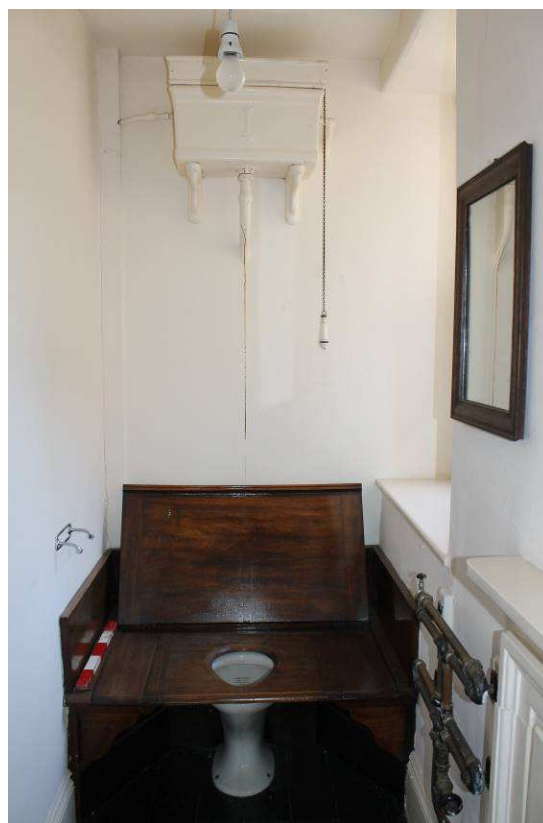
Plate 22: **Room F13a**, facing north, 0.5m scale

- 4.3.1 **Room F13a (Fig 3):** this was a narrow toilet located to the west of corridor **Room F13** that served the bedrooms in the western half of the house (Plate 22). It was accessed via a door **FD15** at the southern end of the room and lit by a single window **FW35** in the north-east corner. The toilet was mounted upon the north wall, set within a timber surround beneath a hinged lid and the cistern was attached the wall above. The makers name was visible;

- 4.3.2 To the south of window **FW35**, copper pipes formed a radiator and to the south of this, lay a fire place with timber surrounds. The room was painted white and had a moulded skirting board in the same but was otherwise fairly plain. The floor was of timber and carpeted along the centre.

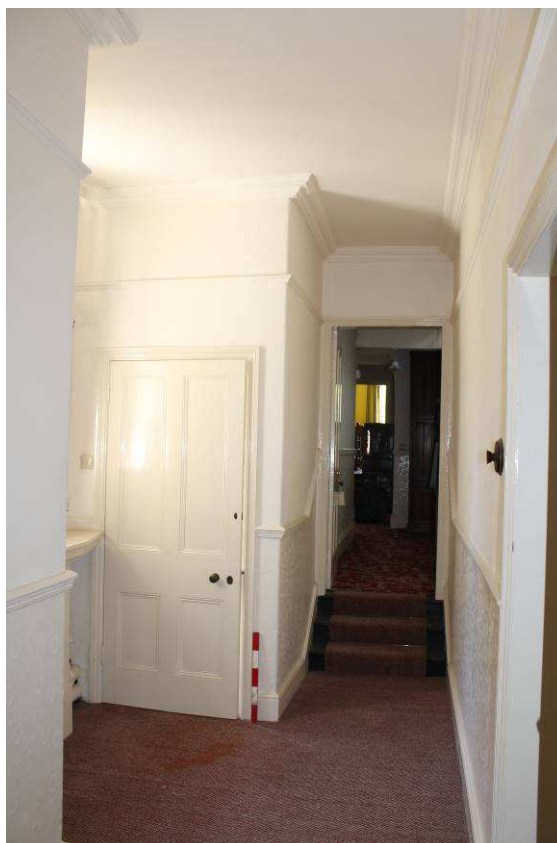
Plate 23: **Room F14a**, facing south, 0.5m scale

- 4.3.3 **Room F14a (Fig 3):** this room formed a north/south-aligned corridor that provided access to the bedrooms in the north-western corner of the building (Plate 23). At its southern end, it led up a short flight of steps into corridor **Room F13** via door **FD16**, while doors **FD18** and **FD20** on the western wall led into bedroom **Room**

**F15** and the connecting corridor **Room F18** respectively. At the northern end, it served as the upper landing for staircase **Room F14c**, from which, it was divided by door **FD25**. At its north-eastern corner, the corridor led on to a small vestibule-like area, **Room F14d**, that connected the corridor to the kitchen **Room F14e** beyond. A small storage cupboard **Room F14b** accessed via door **FD17** occupied the south-eastern corner of the corridor and to the north of this, a two-over-two sash window **FW35** on the east wall overlooked the central yard below.

- 4.3.4 The corridor was painted off-white and had a moulded skirting board, dado and picture rails and a moulded cornice. The wallpaper above the picture rail and below the dado rail was embossed and the floor was carpeted. Beneath the window on the eastern wall there was a radiator comprising large bore pipes under a wooden shelf, while on the western wall, was a wooden intercom system mounted to the south of door **FD18** (Plate 24).
- 4.3.5 **Room F14b (Fig 3):** was a small store cupboard fitted with a four-panel door **FD17** in the south-eastern corner of corridor **Room F14a**. It was lit to the east by a modified four-light sash **FW36** beneath which, lay a sink set into a work surface. The floorboards were covered by rubber matting and the plain white decoration was accompanied by a skirting board.

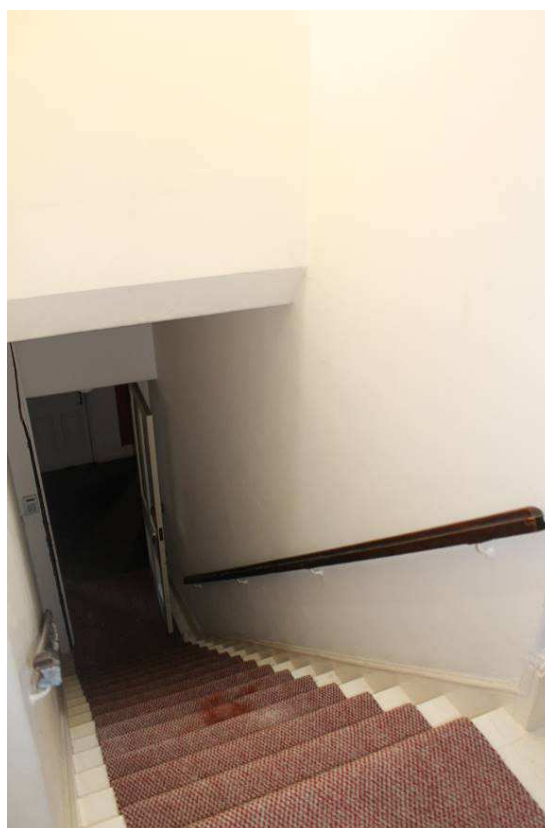
*Plate 25: Staircase **Room F14c**, facing east*

- 4.3.6 **Room F14c (Fig 3):** this room comprised a quarter-turn staircase with a quarter-pace mid-floor landing that connected the service area at ground level to the bedrooms at first floor level (Plate 25). At ground floor level, the stairs were enclosed by a part-glazed four-panel door **GD37**, while at the top of the staircase was further four-panel door **FD25**.

- 4.3.7 The staircase was lit from above by a single skylight and had a moulded skirting board at the base of each wall. All the walls, ceilings, risers and treads were painted white. A moulded timber handrail was attached to both walls of the lower flight and a carpet runner had been fitted to the steps, each with a brass stair rod at the base of the riser.

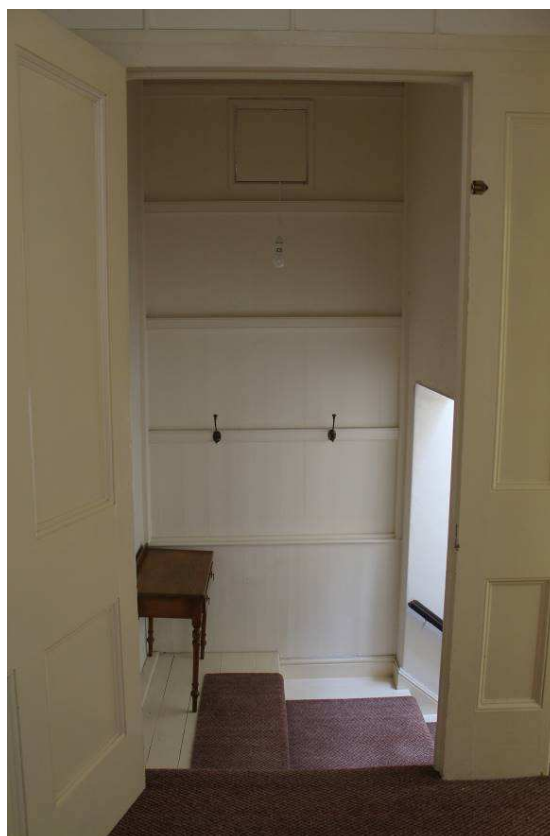
Plate 26: First floor landing at top of staircase **Room F14c**, facing north

- 4.3.8 The northern wall of the mid-floor landing appeared to be of relatively lightweight timber construction and had a pair of coat hooks fastened to one of its horizontal battens (Plate 26). At the head of this partition lay a blocked square aperture, that may possibly once have been a window or vent of some kind.

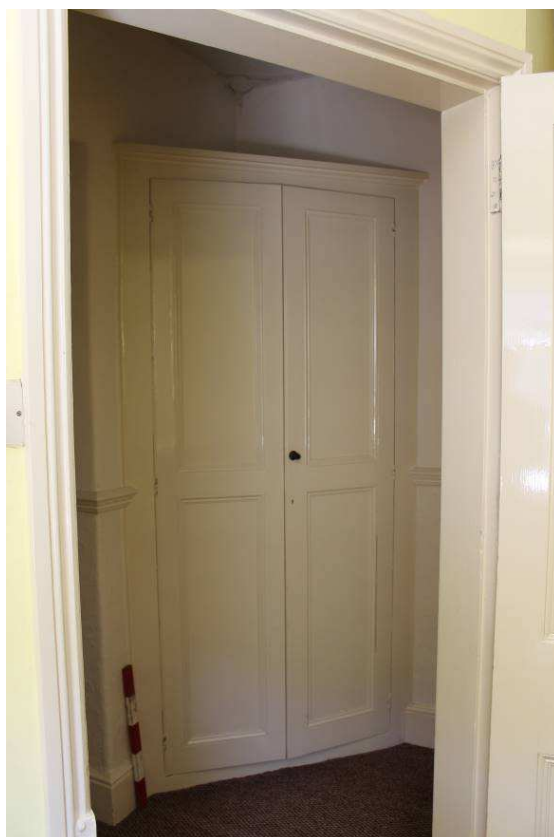
Plate 27: Corridor **Room F14d**, facing north, 0.5m scale

- 4.3.9 **Room F14d** formed a small linking corridor, connecting corridor **F14a** to the west with the first-floor Kitchen **F14e** at the centre of the building. It was a small rectangular space with a doorway at its south-eastern corner **FD26**, but evidently there had been another in the eastern wall, only the architrave of which remained. The space had a moulded skirting and chair rail, with the walls and ceiling above the rail painted white and below covered in embossed wallpaper. The floor was carpeted as a continuation of corridor **F14a** and a built-in corner cupboard fitted

with a pair of two-panel timber doors and topped by a moulded cornice occupied the north-western corner of the space (Plate 27).

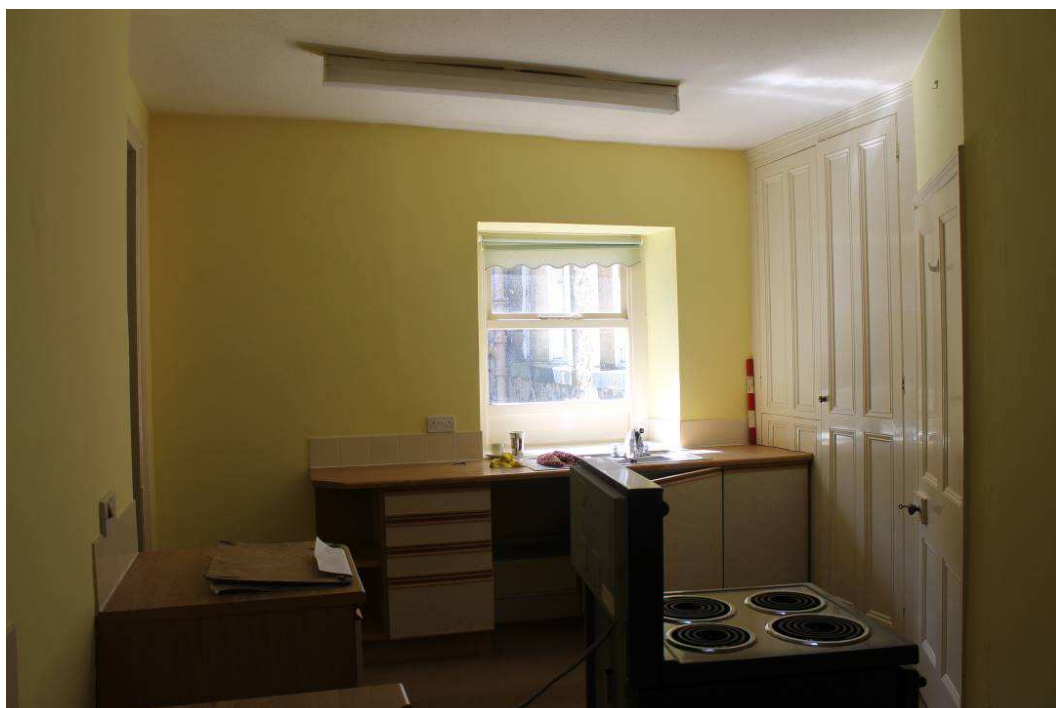
Plate 28: **Room F14e**, facing south, 0.5m scale

- 4.3.10 **Room F14e (Fig 2):** this room occupied the centre of the building and was an L-shaped space, fitted out as a basic modern kitchen (Plate 28). To the west, it was joined to linking corridor **Room F14d** via doorway **FD26** while to the east, a short flight of steps led through doorway **FD27** into corridor **Room F14f**.

- 4.3.11 The room was decorated in a plain modern style, with a white ceiling, yellow walls, skirting board and carpet. It was lit from above by a rectangular skylight and to the south by a modern window installed within an earlier stone surround **FW38**. A chimney breast projected from the centre of the eastern wall, although any fireplace there may have been, had been blocked. Above this was a circular ceiling mounted metal vent. To the south of this vent an east/west scar on the ceiling appeared to denote the former position of a partition wall that may once have divided the room.

- 4.3.12 The only features of historic significance to survive were a circular bell pull, which was mounted on the rooms western wall towards its northern end and a set of built in cupboards in the south-western corner. The cupboard doors each had four panels with moulded margins and a cornice ran across the head. The northern door of the pair was still in operation, but the southern door had been sealed with the installation of the modern kitchen sink and cupboard units to the east.

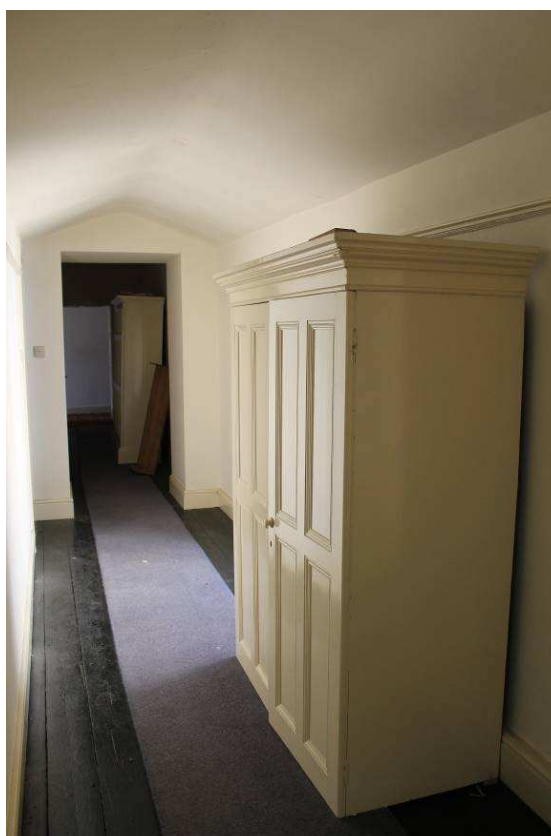
Plate 29: Corridor **Room F14f**, facing south

- 4.3.13 **Room F14f (Fig 3)**: this room was an L-shaped corridor located towards the centre of the building (Plate 29). To the south, it continued into corridor **Room F28** while a doorway **FD28** to the north, led down to staircase **Room F14g**. At its northern end, the corridor turned to the east, where it provided access via a short flight of steps and doorway **FD30**, to the bedrooms in the north-eastern part of the house. An adjacent doorway **FD29** set into the north wall, led into bathroom **Room F14h**, while another doorway **FD27** at the northern end of the west wall, opened on to the kitchen **Room F14e**. To the east of the corridor lay a pair of service rooms **Room F14j** and **Room F14i**, both of which were entered from doorway **FD35** at the southern of the corridor.

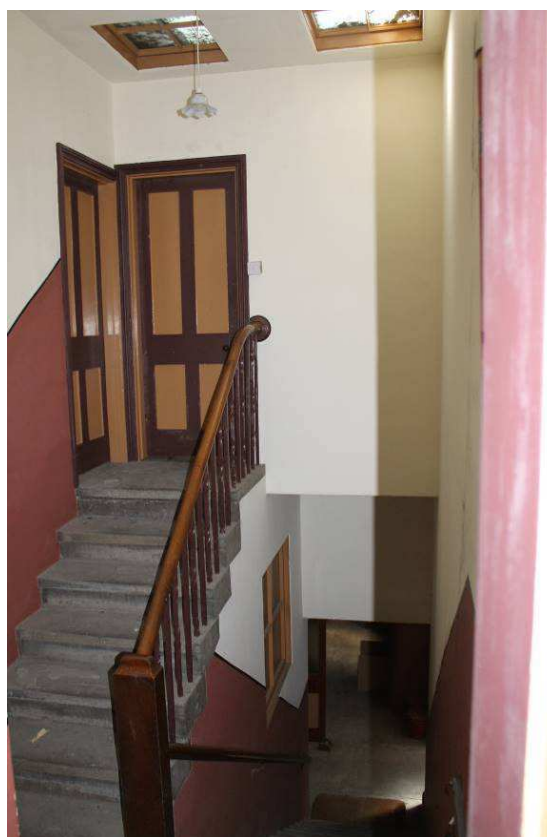
Plate 30: Stairwell **Room F14g**, facing south

- 4.3.15 **Room F14g (Fig 3)**: this room served as a stone-built dogleg staircase with a half-pace mid-floor landing and connected the service rooms at ground-floor level to corridor **F14f** at first-floor level via doorway **FD28** (Plate 30). A second doorway to the east at first-floor landing height had been sealed shut to accommodate a change in the building's layout but it retained its four-panel door. The staircase also gave access to room **F21c** from a four-panel doorway that opened to the north from the mid-floor landing.

- 4.3.16 The room was decorated in the same red and white paint scheme commonly employed within the service corridors of the ground-floor and it had a timber hand-rail bolted to the inner wall of the lower flight and another on the inner string of the upper flight, set upon a series of twisted wrought iron spindles. The room was lit from above by a pair of four-light skylights and by a four-light window that illuminated the lower flight of steps from the east. A small access hatch was noted on the eastern wall of the mid floor landing, although its purpose was unclear.

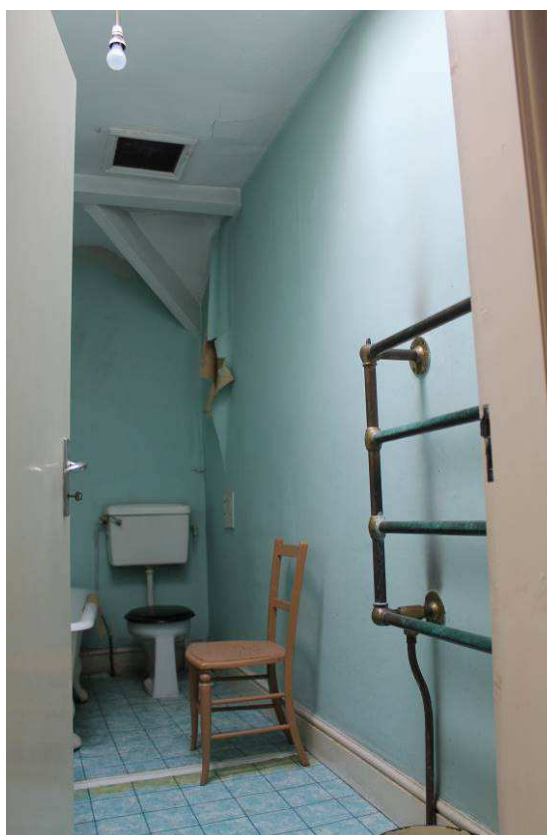
Plate 31: **Room F14h**, facing north

- 4.3.17 **Room F14h (Fig 3):** this was a small bathroom approached from corridor **Room F14f** through doorway **FD29**, a modern door at the southern end of the room. The room was decorated with blue wallpaper, white ceiling, vinyl covered floor and a skirting board. The toilet was set against the northern wall and a free-standing roll top bath occupied the north-western corner of the room along with a sink (Plate 31). There was a brass towel rail, opposite which was a blocked four-panel door also seen in **Room F14g**. The northern end of the ceiling contained a loft access hatch.

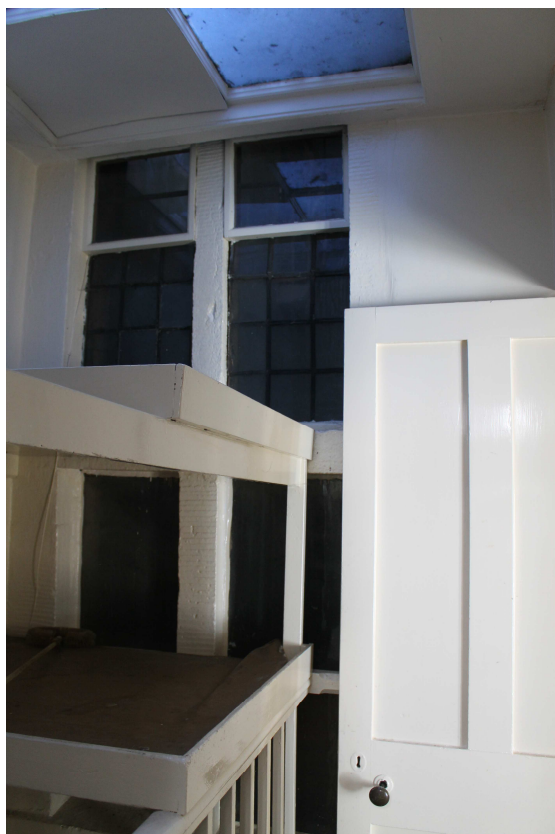
Plate 32: Mullion and transom window in **Room F14i**

- 4.3.18 **Room F14i (Fig 3):** this room was a small rectangular space, linking corridor **Room F14f** to the west via doorway **FD35** to **Room F14j**, a service room to the north. The room was painted white, had a skirting board and was lit from above by a skylight. It also displayed the lower portion of a tall stone mullion and transom stair window on the south wall, indicating that this wall must once have been an external elevation (Plate 32). The floor was covered in vinyl, except to the east where it was glazed in an attempt to increase light to the room below from the skylight in the ceiling above. The glazed portion of the floor had been partitioned off with a timber rail set upon a series of square section spindles, and above this a set of shelves had been erected.

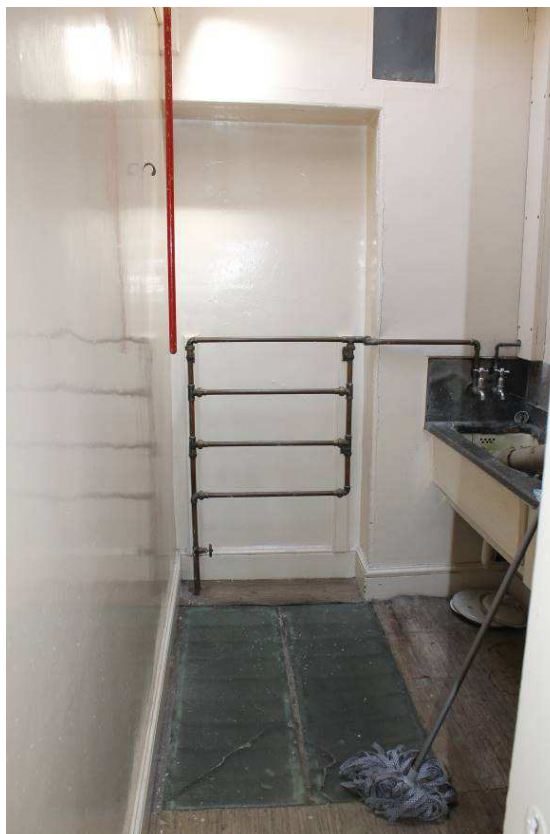
Plate 33: **Room F14j**, facing north

- 4.3.19 **Room F14j (Fig 3):** lay to the north of **Room F14i**, to which it was connected via a doorway at the south-west corner. It was a small rectangular functional space identical in decoration to **Room F14i** (Plate 33). A rectangular recess at the northern end suggested the previous existence of a doorway and the room was lit from above by a large rectangular skylight. In a similar manner to **Room F14i**, the western half of the floor was glazed to provide light for the floor below. A brass towel rail had been fitted to the northern wall and a Belfast sink with a lead shroud occupied the north-east corner. High on the northern wall was an additional small rectangular vertically-set aperture, the function of which was not clear.

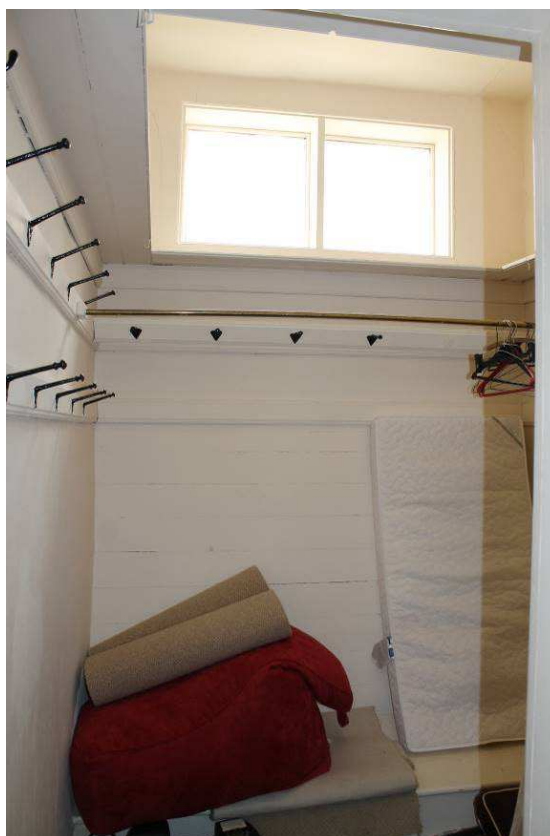
Plate 34: Cupboard **Room F20**, facing east

4.3.20 **Room F20 (Fig 3):** this room formed a small square walk-in wardrobe accessed from doorway **FD24** at the north-east corner of **Room F17a** (Plate 34). The lower three quarters of each wall was lined with horizontal boards and a wooden bench had been erected at the base of the eastern wall. The upper parts of the walls were plastered and all the surfaces were white painted. A shelf ran across all four walls above the height of the timber lining and beneath this coat hooks had been attached to battens in rows. Lighting was provided by a twin-light fixed-frame window high on the eastern wall.

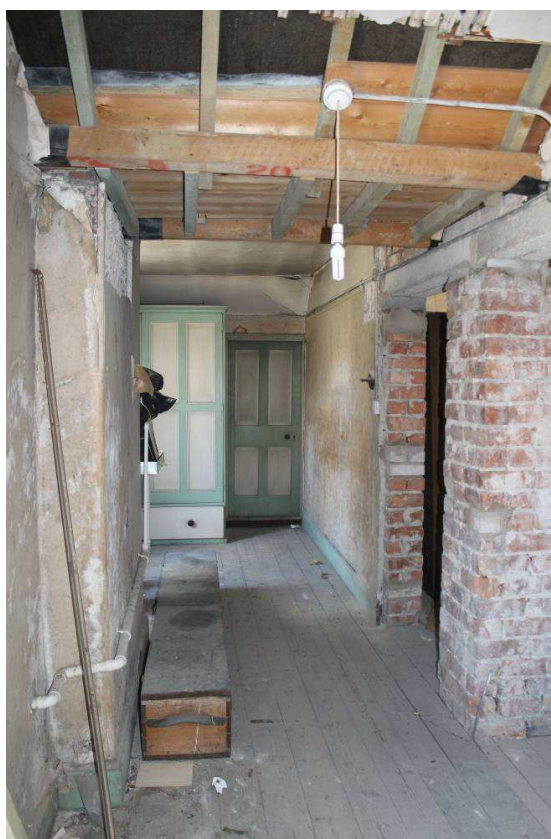
Plate 35: Corridor **Room S3**, facing south

4.4.1 **Room S3 (Fig 4):** this room formed a north/south-aligned corridor that provided access to a range of rooms that once functioned as night nurseries in the north-western corner of the house (Plate 35). It was accessed from the south by **Room S1** via doorway **SD4** and a doorway **SD8** in its northern wall led into room **S9**. On its western wall there were three doorways, the southern leading into room **S4**, the central leading along corridor **Room S5** and the northernmost leading, via doorway **SD7**, into **Room S8**. The room was lit to the east by a pair of two-over-two sash windows, one at the northern end **SW14** and another to the south **SW13**.

4.4.2 The room was partially decorated with plaster removed from portions of the west wall to reveal brick construction. A small area of plaster had been removed from the eastern wall exposing rubblestone construction, and the surviving parts of the

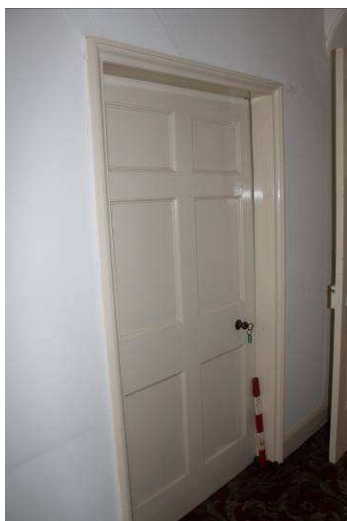
**FD6**

*Plate 78: Wide six-panel timber door, with simple moulded margins and raised insets. Upper two panels smaller than the lower two pairs. Hinged to the east with brass door knobs and a metal locking plate attached to the south face. Late 18th-19th century.*

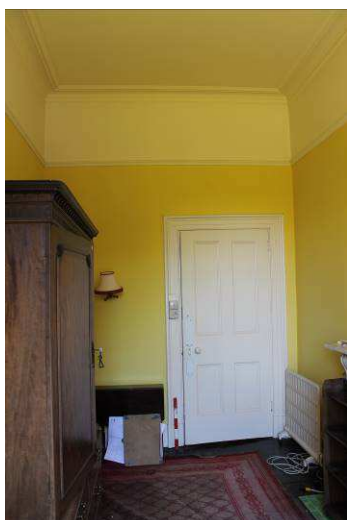
**FD9**

*Plate 79: Four-panel timber door, with moulded margins. Upper panels larger than lower panels. Hinged to the east, with brass door knobs and finger plates on the southern face. Late 19th century.*

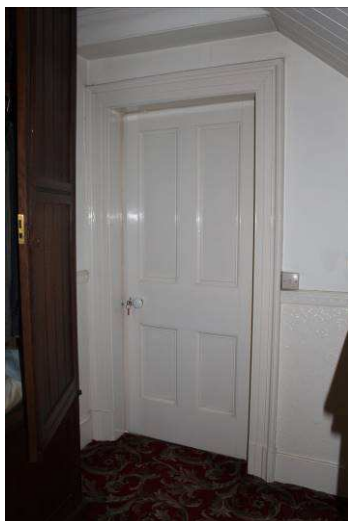
**FD11**

*Plate 80: Four-panel timber door, with moulded margins. Upper panels larger than lower panels. Hinged to the south, with brass door knobs. Late 19th century.*

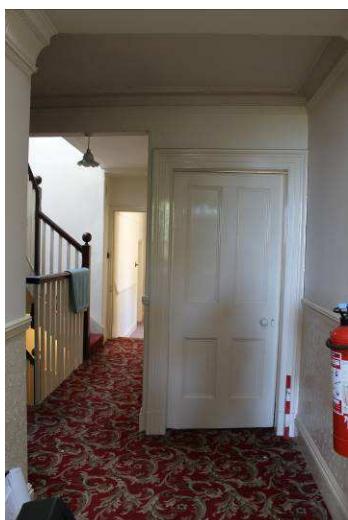
**FD15**

*Plate 81: Four-panel timber door, with moulded margins. Upper panels larger than lower panels. Hinged to the west, with brass door knobs. Late 19th century.*

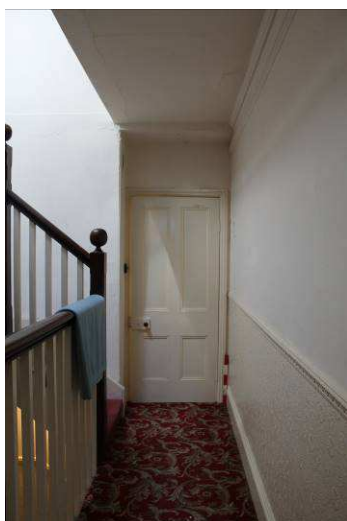
**FD16**

*Plate 82: Four-panel timber door, with moulded margins. Upper panels larger than lower panels. Hinged to the east, with brass door knobs and locking plate on the south face. Late 19th century.*

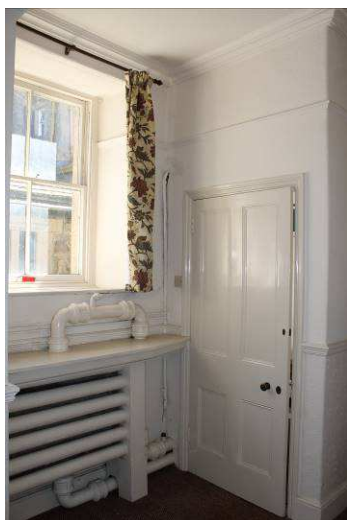
**FD17**

*Plate 83: Four-panel timber door, with moulded margins. Upper panels larger than lower panels. Hinged to the east, with brass door knobs and locking plate on the south face. Late 19th century.*

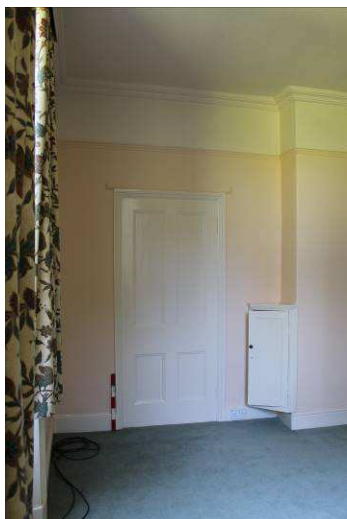
**FD19**

*Plate 84: Four-panel timber door, with moulded margins. Upper panels larger than lower panels. Hinged to the east, all door furniture removed and door sealed. Late 18th – 19th century. Late 19th century.*

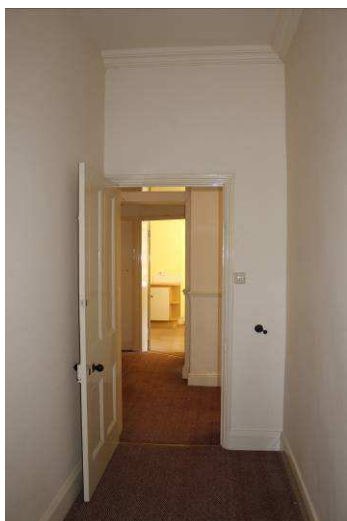
**FD20**

*Plate 85: Four-panel timber door, with moulded margins. Upper panels larger than lower panels. Hinged to the north, with brass door knobs and locking plate on the east face. Late 19th century.*

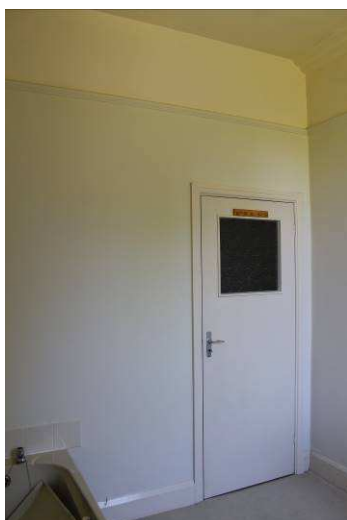
**FD21**

*Plate 86: Hollow core timber door with frosted glass panel to upper third. Hinged to the south with modern door handles to east and west. 20th century.*

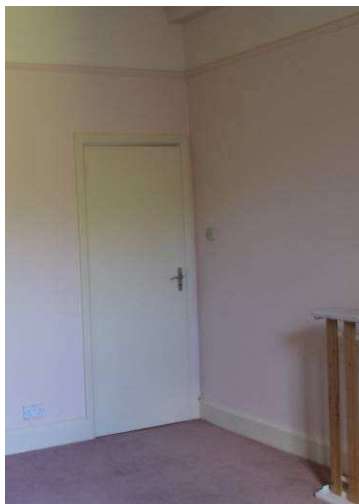
**FD23**

*Plate 87: Hollow core timber door. Hinged to the east with modern door handles to north and south. 20th century.*

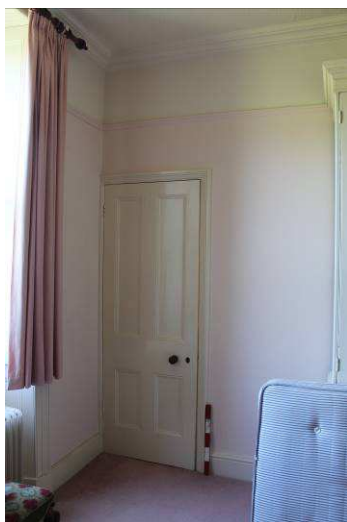
**FD24**

*Plate 88: Four-panel timber door, with moulded margins fitted to walk in wardrobe. Upper panels larger than lower panels. Hinged to the north, with brass door knobs. Late 19th century.*

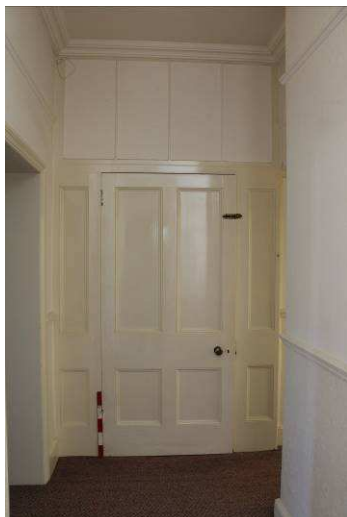
**FD25**

*Plate 89: Large four-panel timber door, with moulded margins. Upper panels larger than lower panels. Hinged to the west, with brass door knobs, draw bolt on south face towards top. Late 19th century.*

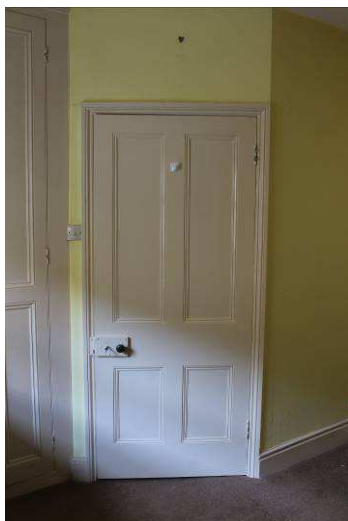
**FD26**

*Plate 90: Four-panel timber door, with moulded margins. Upper panels larger than lower panels. Hinged to the north, with brass door knobs and locking plate on the east face. Late 19th century.*

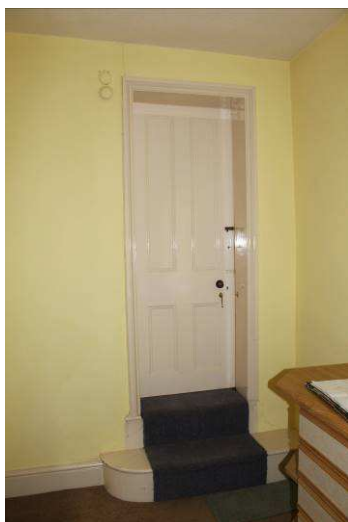
**FD27**

*Plate 91: Narrow four-panel timber door, with moulded margins. Upper panels larger than lower panels. Hinged to the north, with brass door knobs and locking plate on the east face. Late 19th century.*

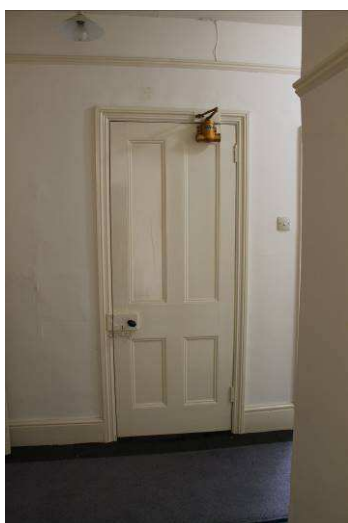
**FD28**

*Plate 92: Four-panel timber door, with moulded margins. Upper panels larger than lower panels. Hinged to the east, with ovoid brass door knobs, locking plate on the south face over a draw bolt. Late 19th century.*

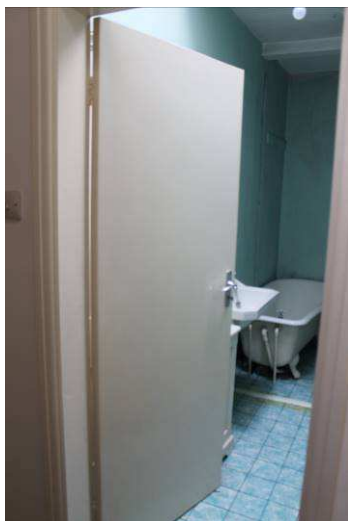
**FD29**

*Plate 93: Hollow core timber door. Hinged to the west with modern door handles. 20th century.*

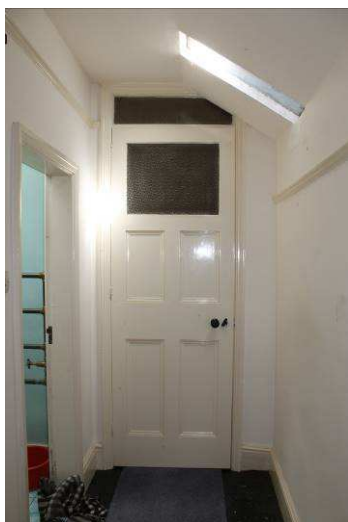
**FD30**

*Plate 94: Tall, five-panel timber door, with glazed and frosted rectangular top panel. Panels below mid rail larger than those above, both pairs with moulded margins. Hinged to the north with brass door knobs. Frosted over-lighter above. Late 19th century*

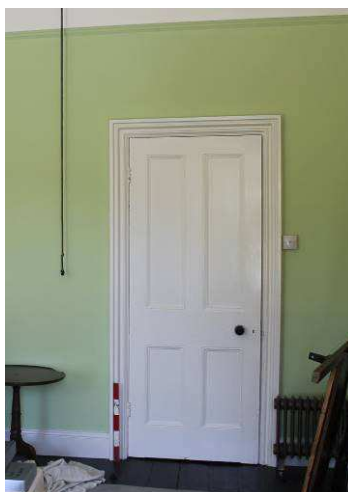
**FD32**

*Plate 95: Four-panel timber door, with moulded margins. Upper panels larger than lower panels. Hinged to the south, with brass door knobs. 19th century.*

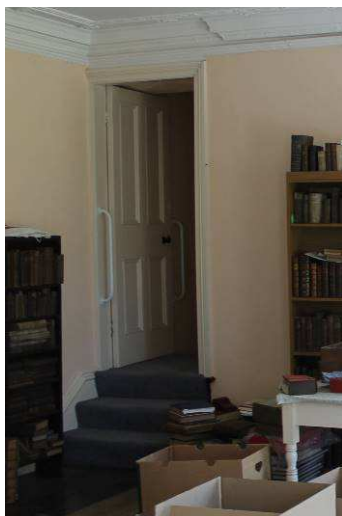
**FD33**

*Plate 96: Four-panel timber door, with moulded margins. Upper panels larger than lower panels. Hinged to the west, with brass door knobs. Late 19th century.*

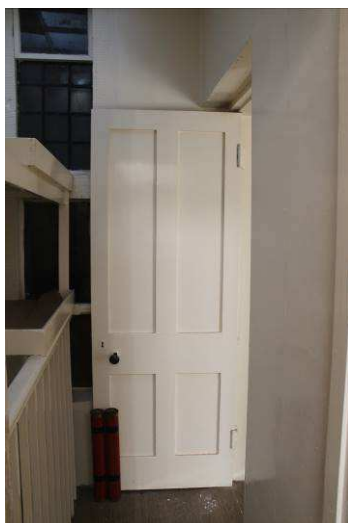
**FD35**

*Plate 97: Plain four-panel timber door, without moulded margins. Upper panels larger than lower panels. Hinged to the south, with brass door knobs. Late 19th century.*

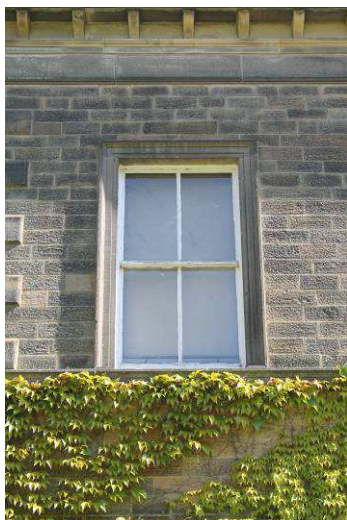
### FW27

*Plate 98: Two-over-two light timber sash window. Moulded external stone surrounds, with regular perpendicular tooling pattern. No evidence of the window internally, although it is unclear if it was built as a dummy or later blocked on the interior face. Mid-19th century.*

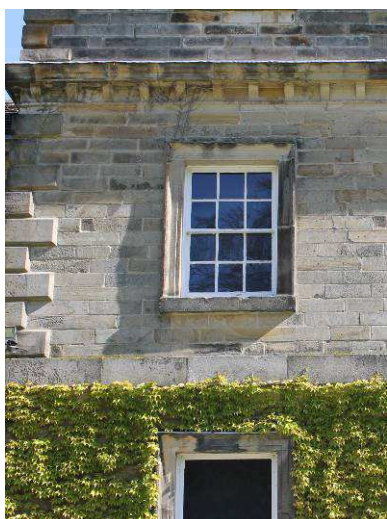
### FW33

*Plate 99: Six-over-six light timber frame sash window. Moulded external stone surrounds with projecting stone sill. No evidence of the window internally, although it is unclear if it was built as a dummy or later blocked on the interior face. Mid-eighteenth century.*

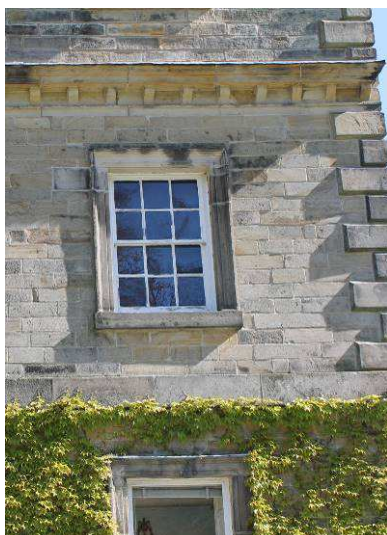
### FW34

*Plate 100: Six-over-six light timber frame sash window. Moulded external stone surrounds with projecting stone sill. No evidence of the window internally, although it is unclear if it was built as a dummy or later blocked on the interior face. Mid-eighteenth century.*

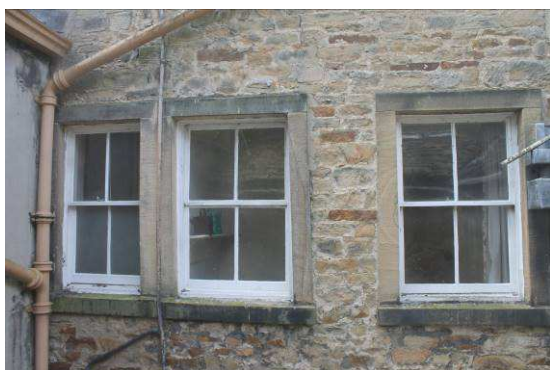
**FW35**

*Plate 101: Narrow two-over-two light timber sash window. Plain square section external stone surrounds, with regular tooling pattern. Shares its northern jamb with window **FW36**. Sash fastener on interior meeting rail. Late 19th century.*

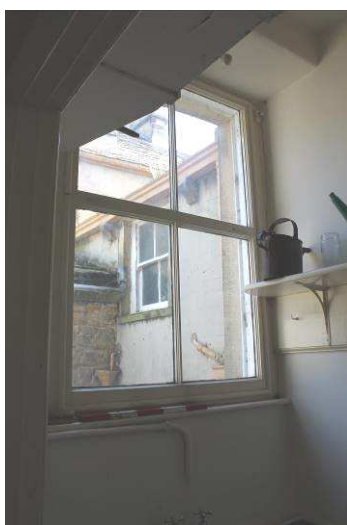
**FW36**

*Plate 102: Faux two-over-two light timber sash window. Plain square section external stone surrounds, with regular tooling pattern. Shares its northern jamb with window **FW35**. Hinged on the meeting rail to allow the two upper lights to open inwards as a ventilator. Late 19th century.*

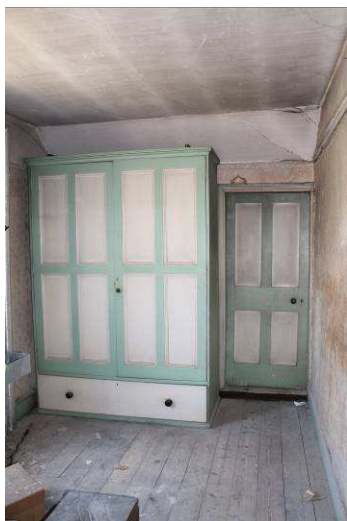
#### SD4

*Plate 107: Plain four-panel timber door, without moulded margins. Upper panels larger than lower panels. Hinged to the east, with brass door knobs. Late 19th century.*

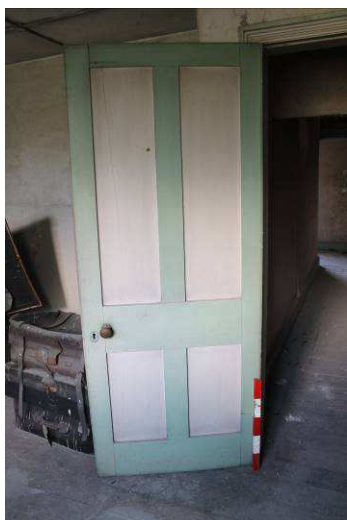
#### SD6

*Plate 108: Plain four-panel timber door, without moulded margins. Upper panels larger than lower panels. Hinged to the north, with brass door knobs and a locking plate on the western face. Late 19th century.*
